Field reconnaissance following the April 6, 2009 L`Aquila Earthquake in Italy

Gian Paolo Cimellaro

Assistant professor,
Department of Structural and Geotechnical engineering,
Politecnico di Torino

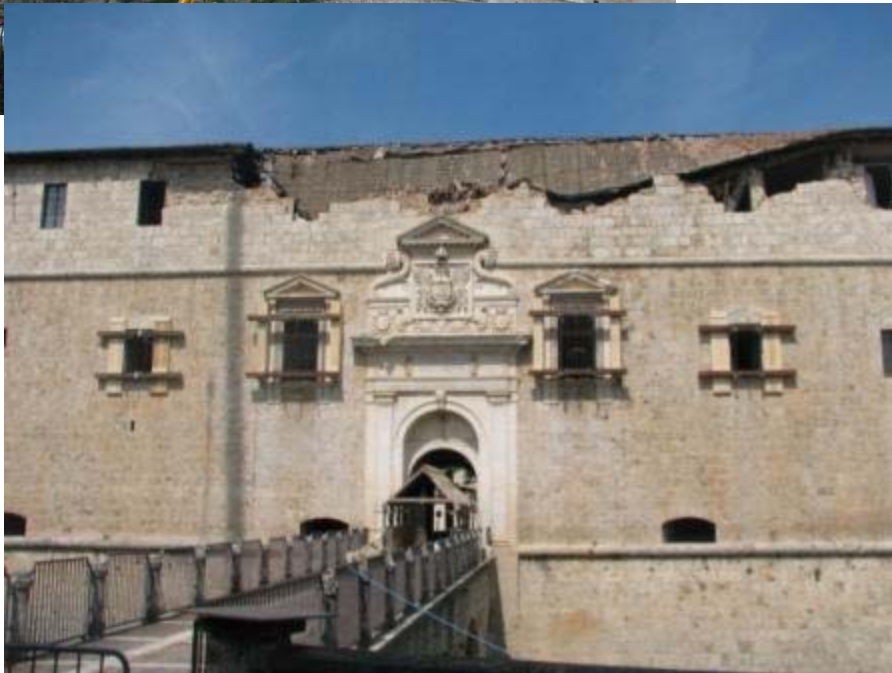
Fortezza Spagnola

Damage:

- partial collapse of the floor slab;
- Partial collapse of the roof;
- Partial collapse of the upper lateral wall;
- Severe cracks on the vertical walls;
- Severe overturning of the arcades (loggiate) and of the columns on the ground floor;
- Severe damage to historical heritage inside the National Museum of Abruzzo;

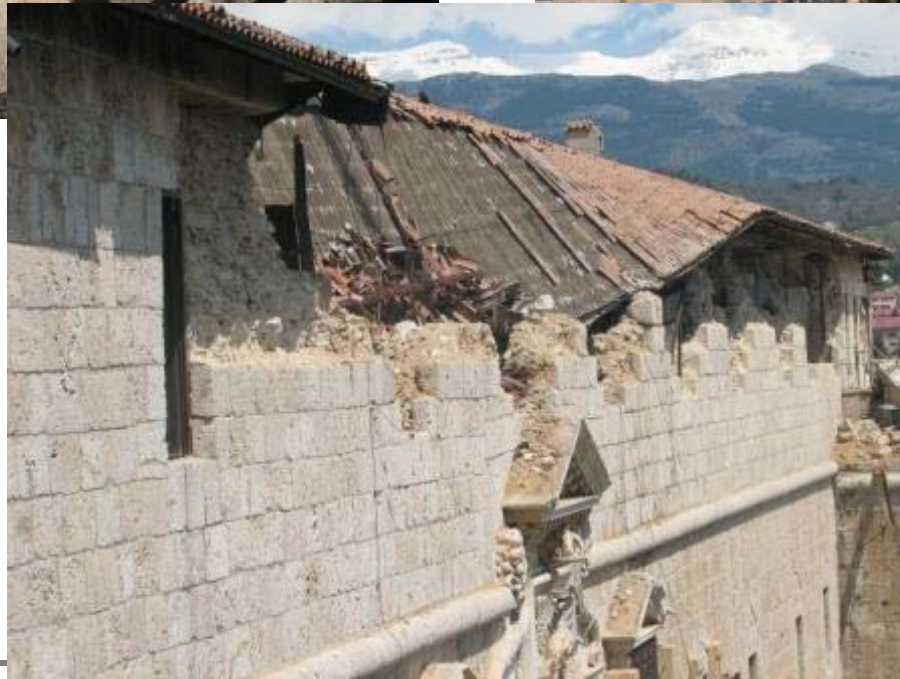
Damage to roof coverage

Damage:

- Partial Collapse of the roof coverage;

Mechanism:

- rolling out the plan due to horizontal flexure of the upper part of the façade;

Structural causes:

- Poor connection between the roof slab and the lateral wall weaker due to the presence of openings;
- Poor quality of the masonry;

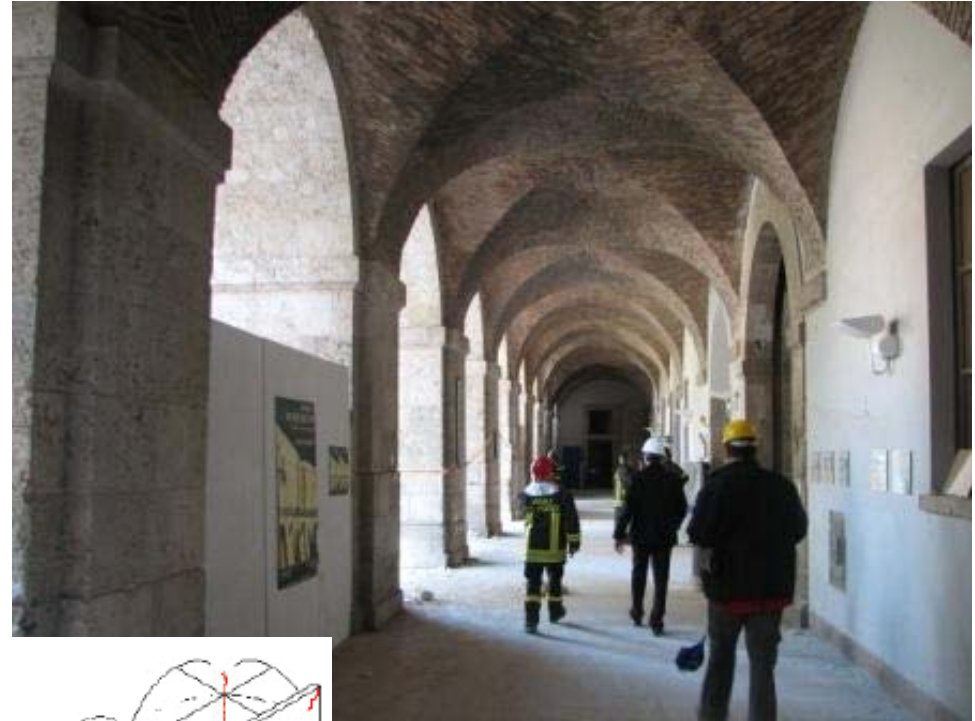
Overturning of the wall

Damage:

- overturning of the internal arcade facing the internal yard and severe damage in the internal columns of the arcade;

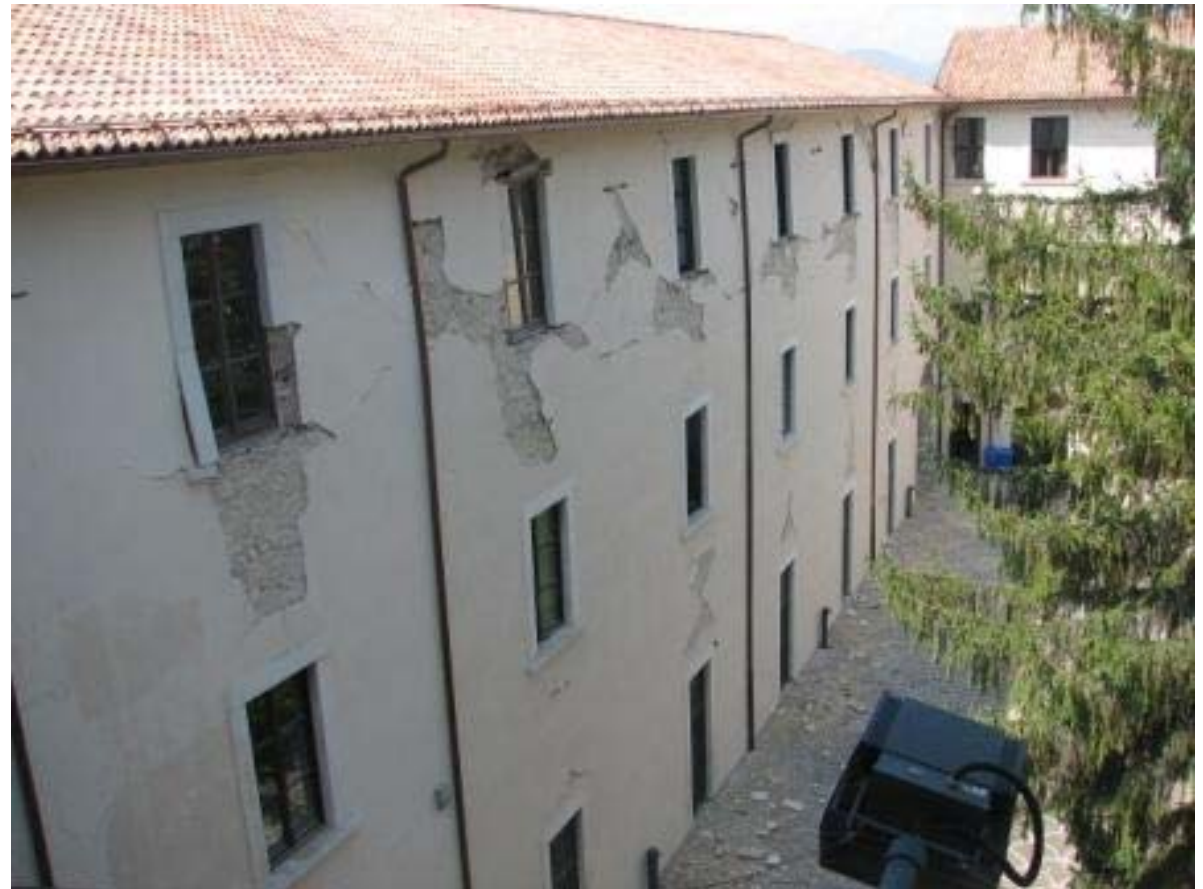
Damage in the wall strips

Damage:

- typical cross cracks in the wall strips above and below the window openings;

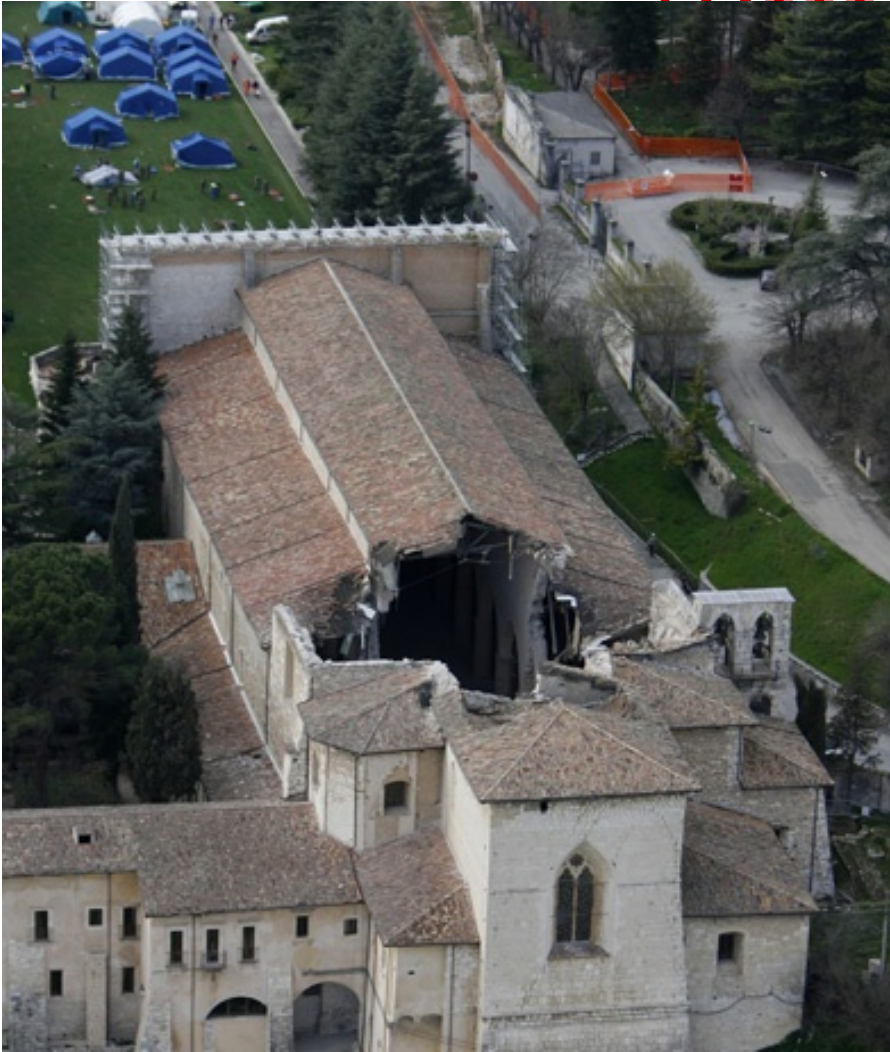
Figure. Basilica Santa Maria di Collemaggio

Damage:

- Collapse of the vault of the transept;
- Collapse of the Triumphal arches;
- Collapse of the "tamburo" and of the Dome;
- Collapse of the roof elements of the transept;
- Severe cracks with imminent collapse in the apse and in the presbitery;
- Moderate cracks in the tower and the tower room;

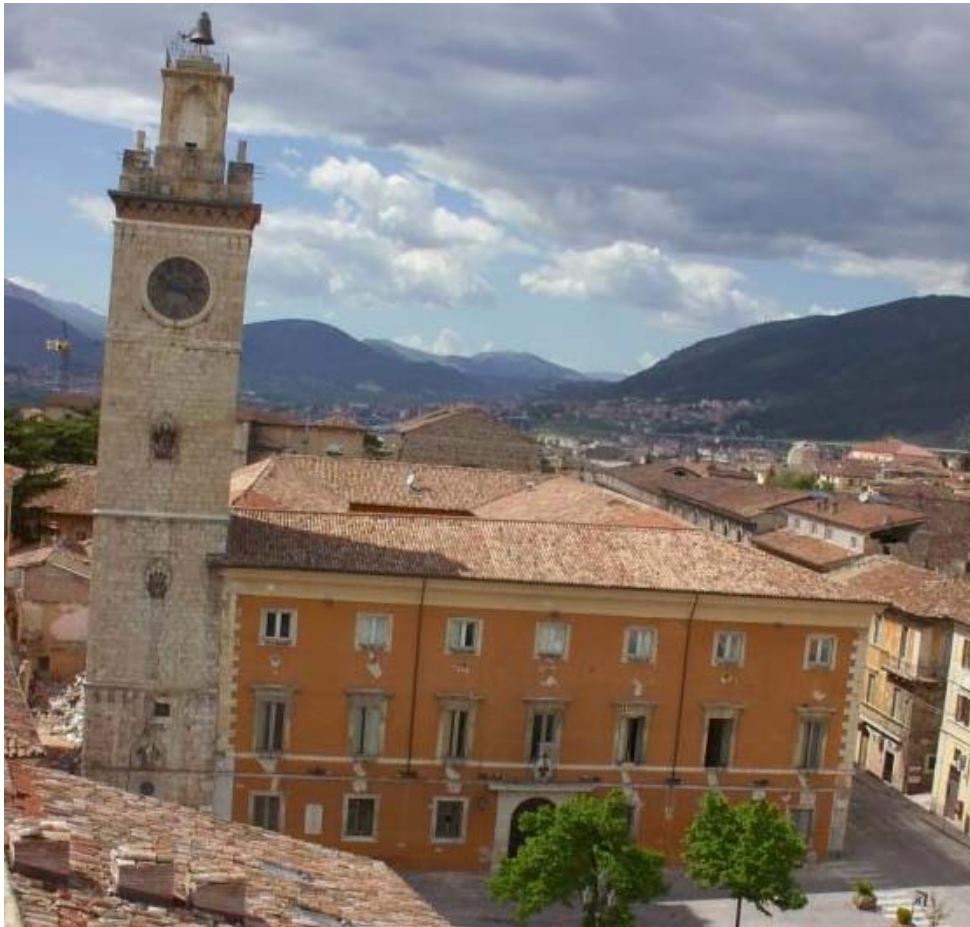
Palazzo Margherita, L'Aquila, XIII sec.

Damage:

- Overturning of the external walls;
- Damage to the arcades "Loggiato" and to the columns;
- partial collapse of the floor slab on the second floor;
- Damage on the strips walls;
- The internal vaults in the stairs are seriously damaged;
- Damage in the facade, due to the hammering of floor beam;
- The civic Tower presents cracks at the basement level

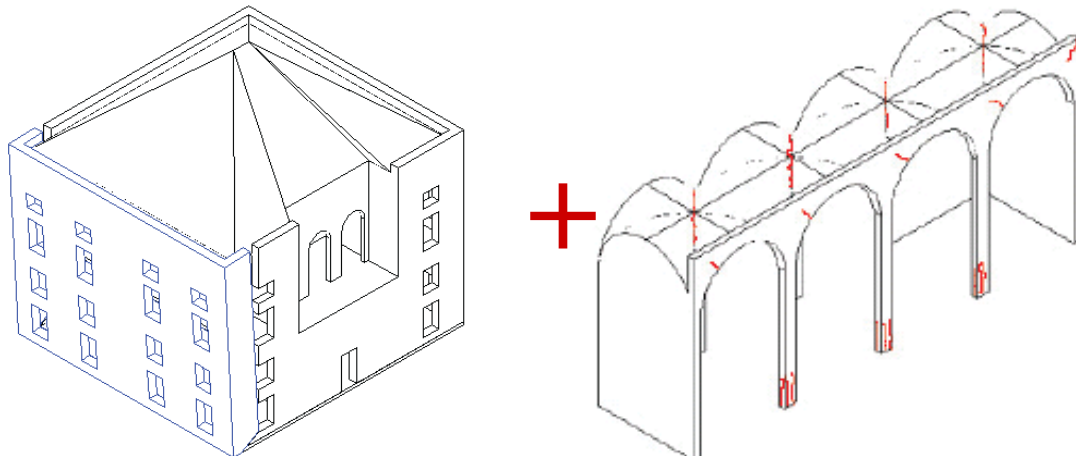
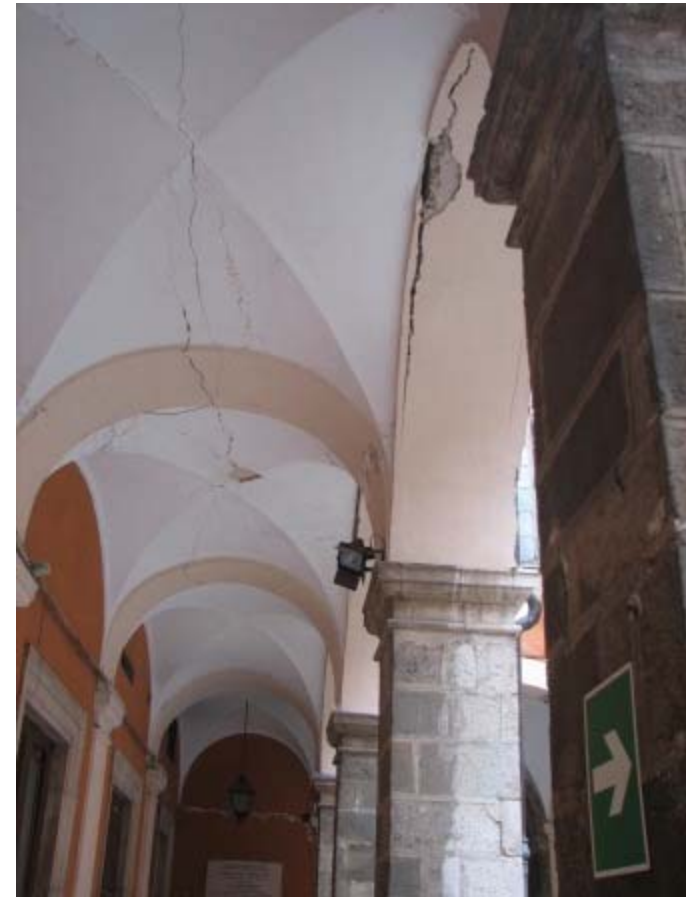
Damage to Arcades

Damage:

- Overturning of the internal arcades "Loggiato" and of the columns;

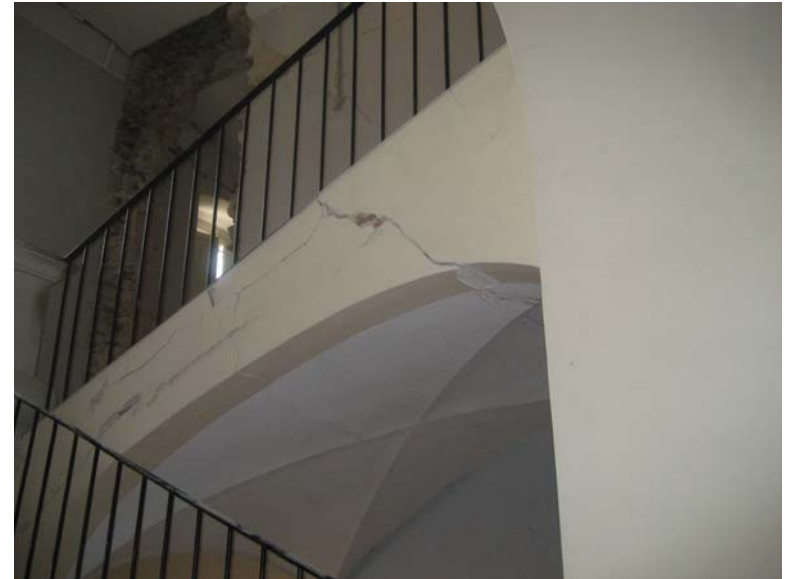
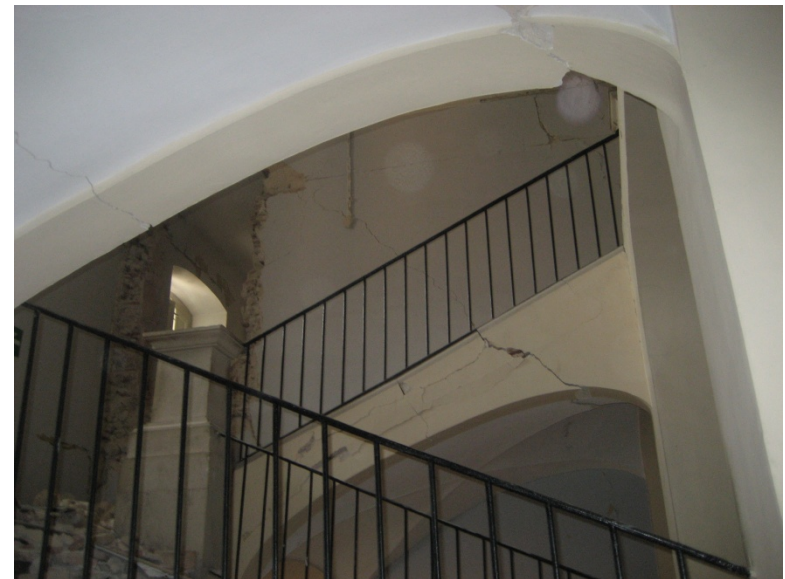
Damage to the stairs

Damage:

- shear cracks in the stairs especially at the second and third floor level;

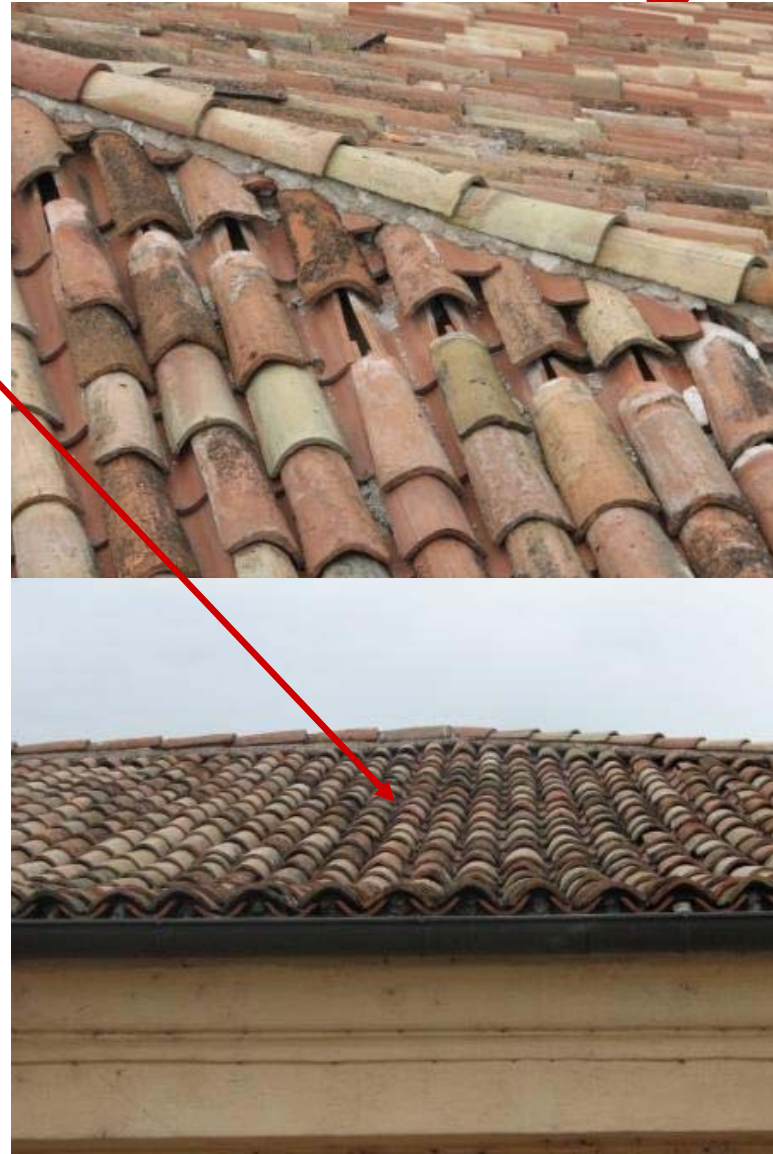
Damage to roof coverage

Damage:

- Partial sag of the roof coverage and dislocation of tiles;

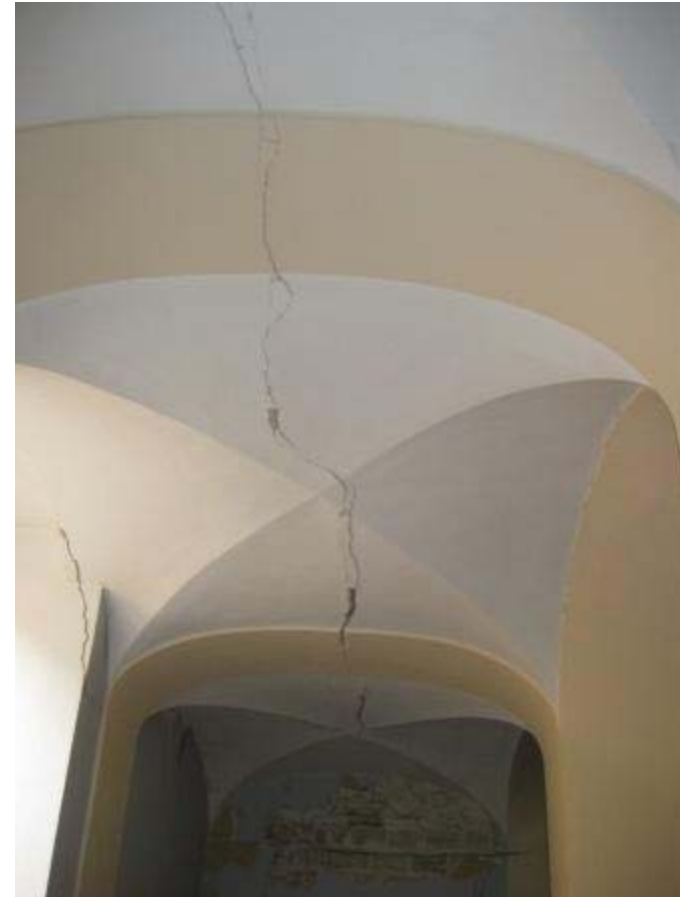
Damage to Vaults

Damage:

- cracks in the arch, the cross vaults and barrel vault;

Structural causes:

- Rotation of the lateral walls.

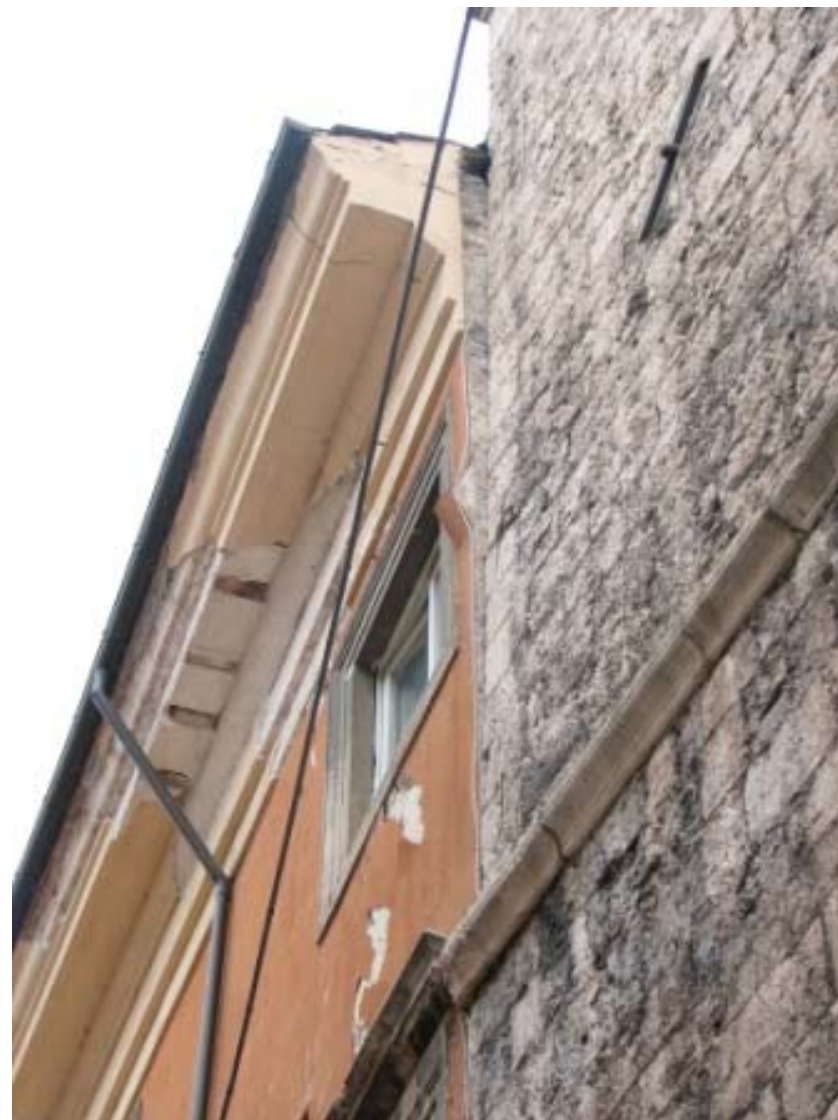
Overturning of the wall

Damage:

- overturning of the external wall;

Structural causes:

- Eccentric gravity loads due to section reduction;

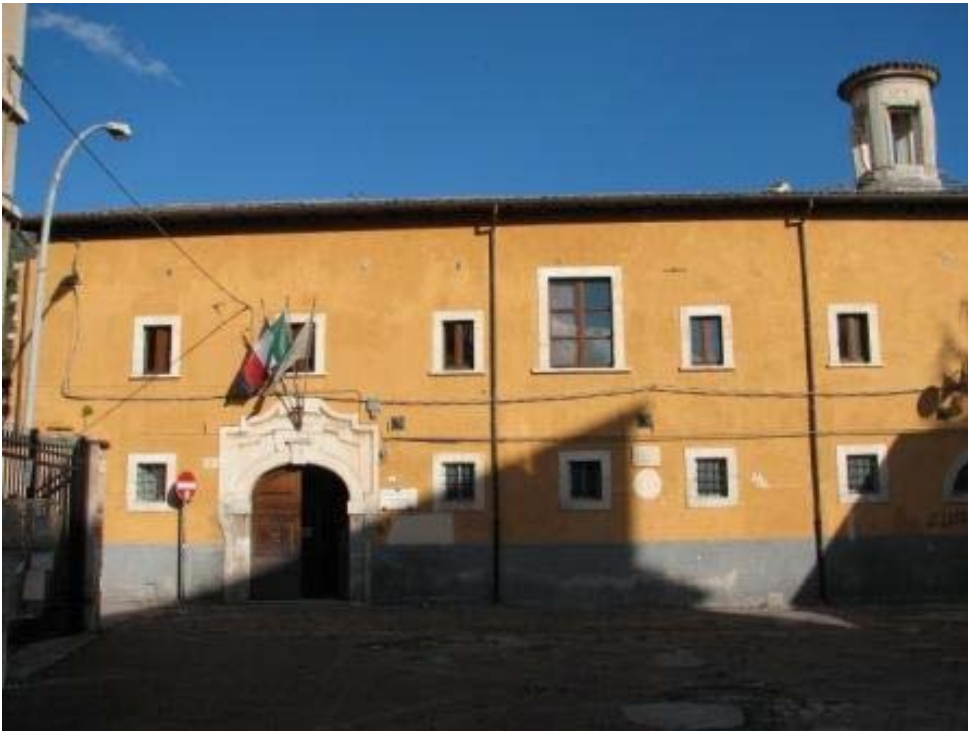
Ex-monastery of the Lauretana (XV sec.)

Damage:

- Severe risk of collapse of the lantern;
- Damage in the attached body;
- Damage in building A and B due to hammering of the ridge beam;
- Longitudinal cracks in the barrel vault of the corridor in building A;
- Overturning of the lateral walls of building C facing the internal back yard;
- Collapse of the internal gypsum walls;
- Collapse of the confinement wall of the garden;

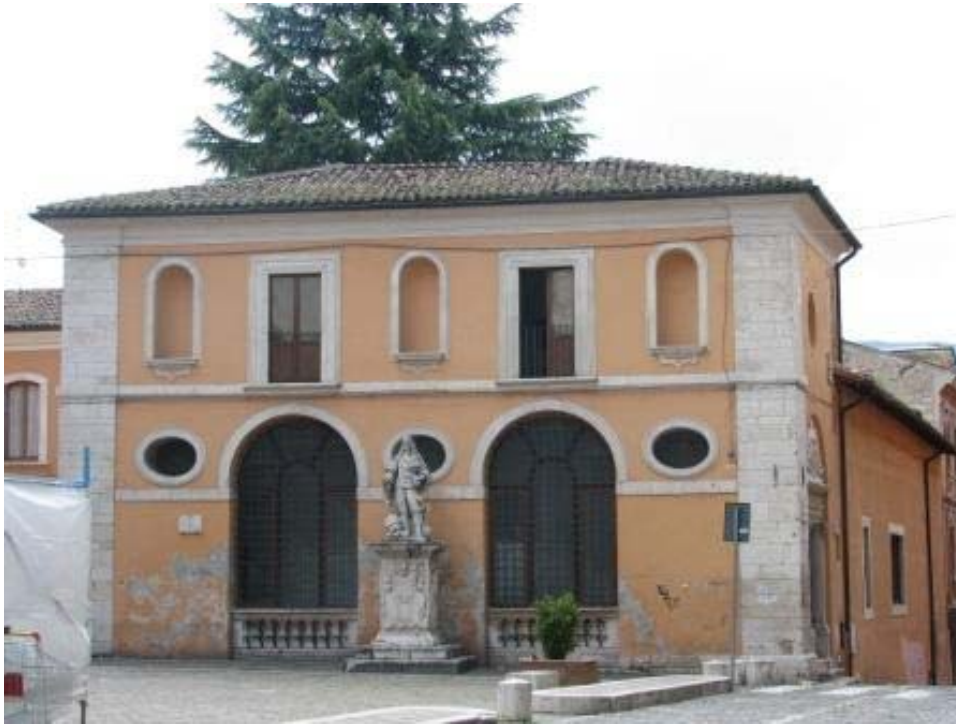
Palazzetto dei Nobili, L'Aquila, XVII sec.

Damage:

- Damage to Vaults
- Damage to floor slabs;
- Damage on the main masonry structural walls;

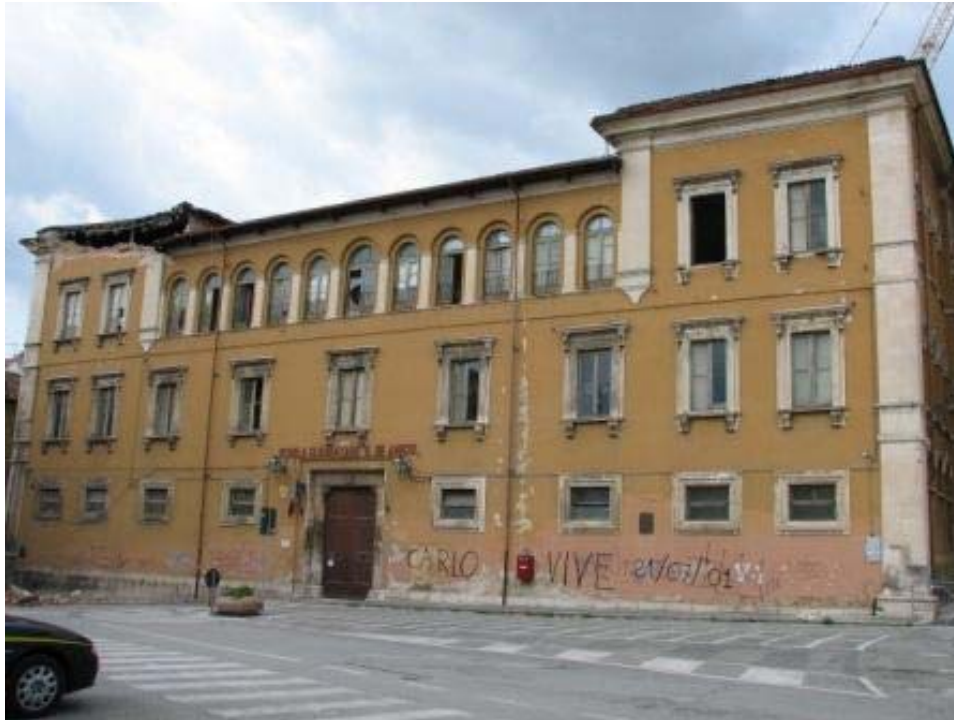
School De Amicis, L'Aquila, (XV sec)

Damage:

- Partial collapse of the roof;
- Partial collapse of the upper lateral wall;
- Cracks in the internal walls with partial collapse of ceilings;
- Dislocations of horizontal slabs;
- Collapse of cross vault;

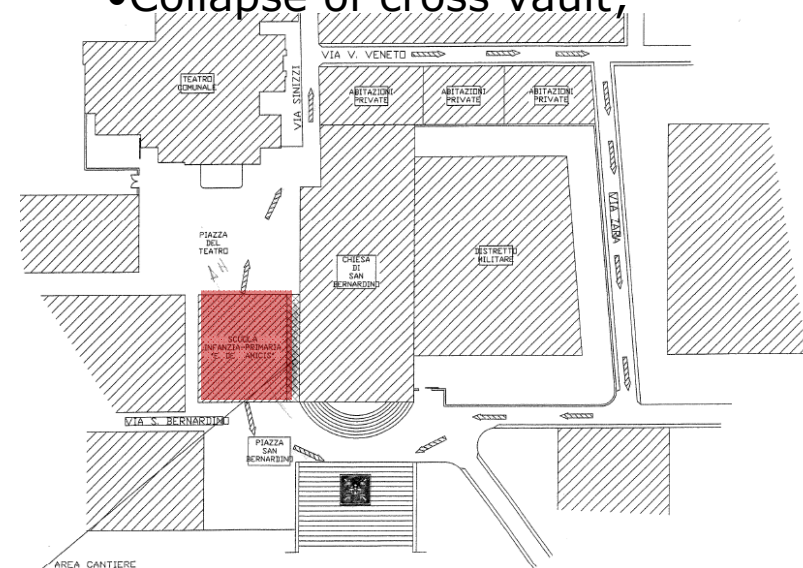
Damage to roof coverage

Damage:

- Overturning of the upper corner lateral wall;
- Partial collapse of the roof cover;

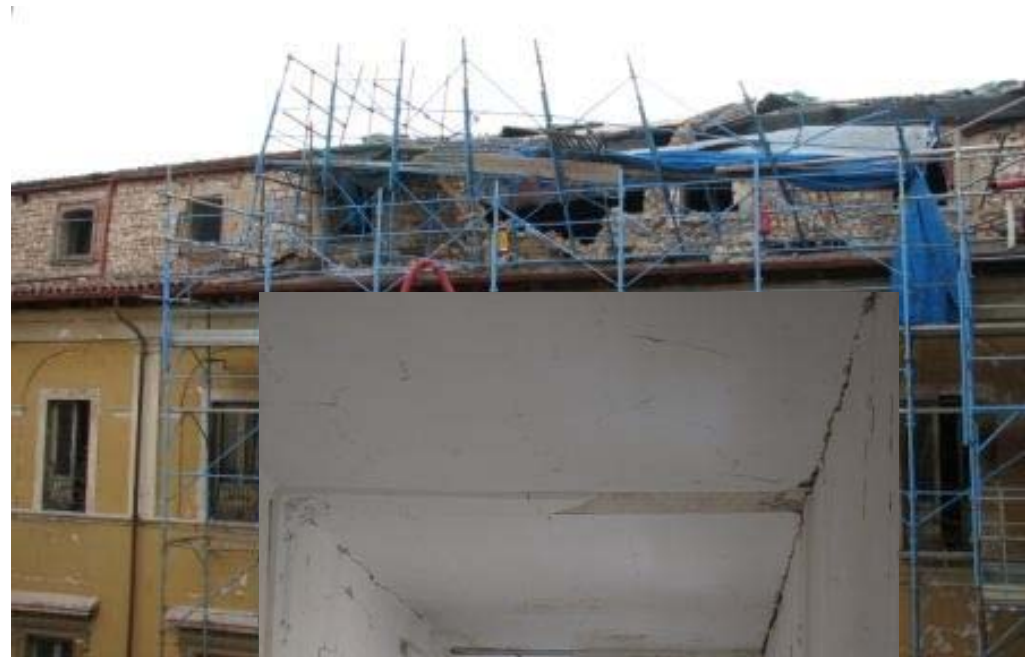
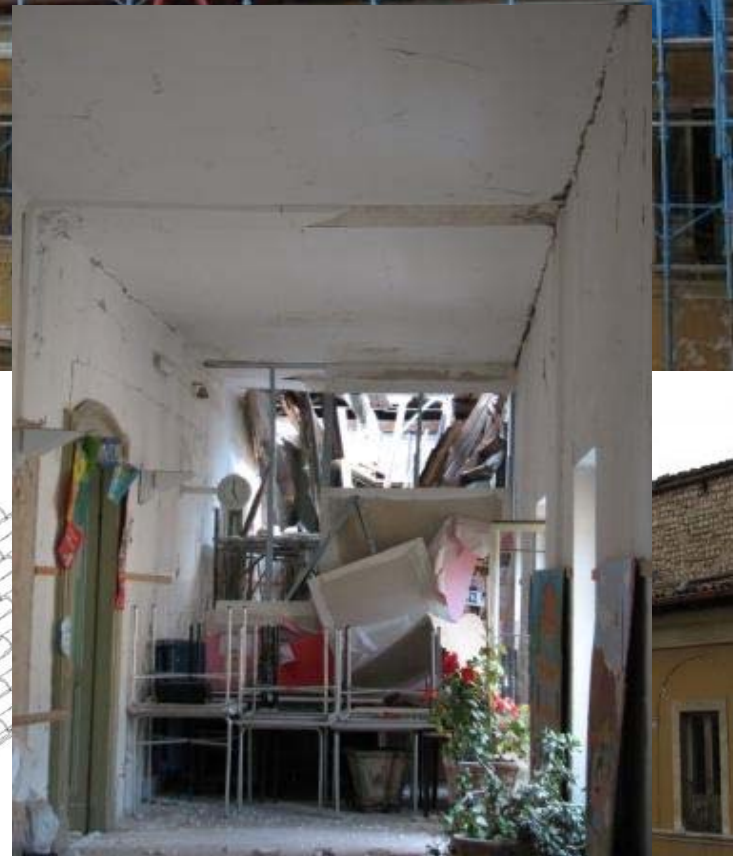
Damage to roof coverage

Damage:

- Local collapse of the lateral wall and the roof;

Mechanism:

- Overturning of the lateral wall;

Structural causes:

- Poor connection between lateral walls and roof slab. The poor quality of masonry and presence of openings initiate the mechanism;

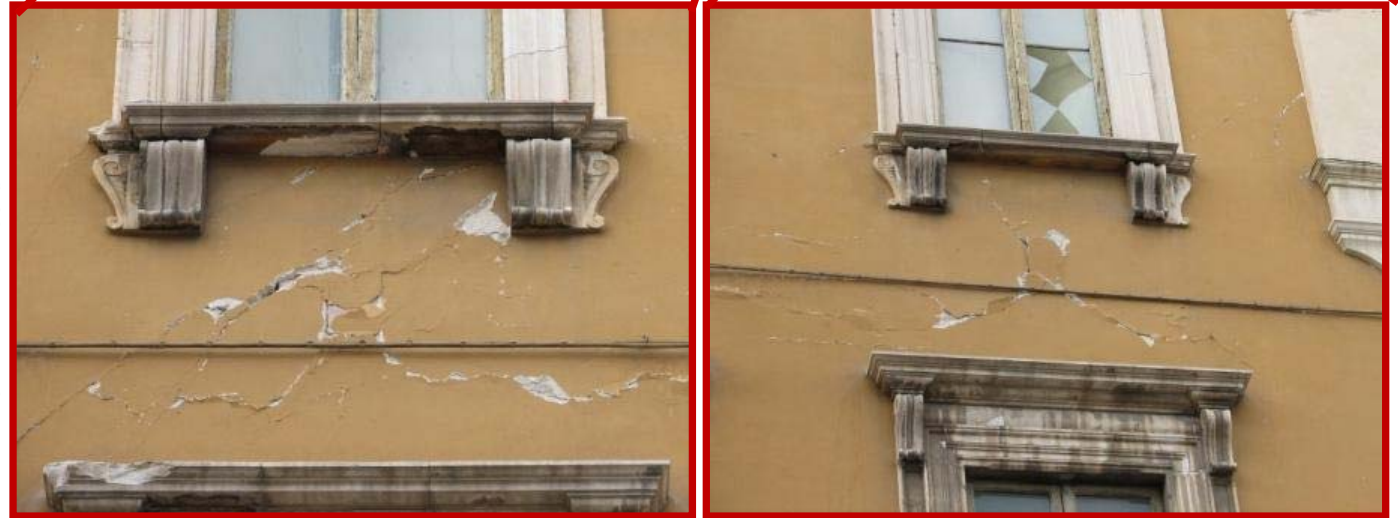
Damage in the wall strips

Damage:

- typical cross cracks in the wall strips above and below the window openings of the external lateral wall;

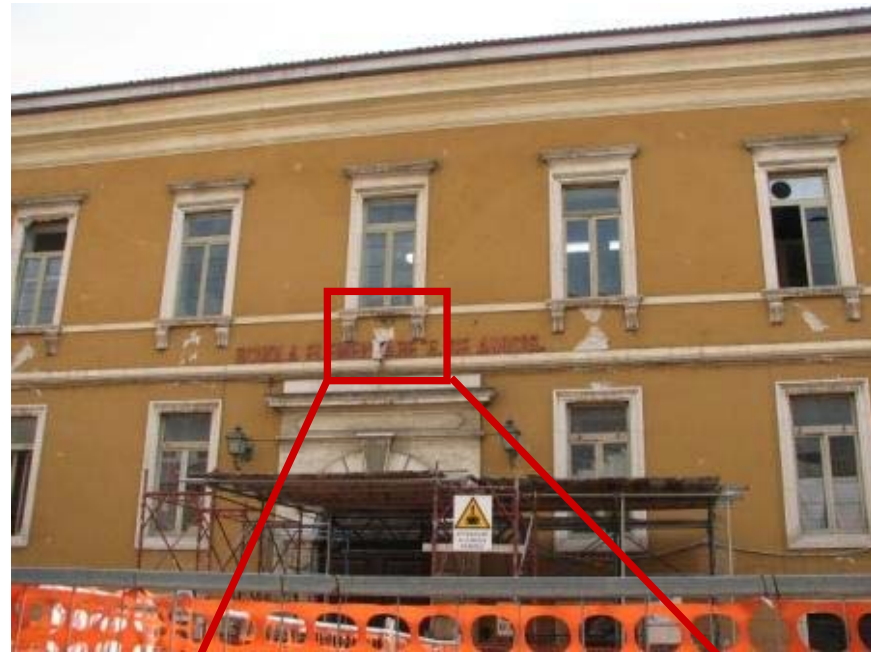
Hammering of the floor beams

Damage:

- local damage in correspondence of the wall strips in the facade;

Mechanism:

- damage to the front facade, due to the hammering of the floor beams;

Structural causes:

- Floor slab not effectively connected to the wall masonry.

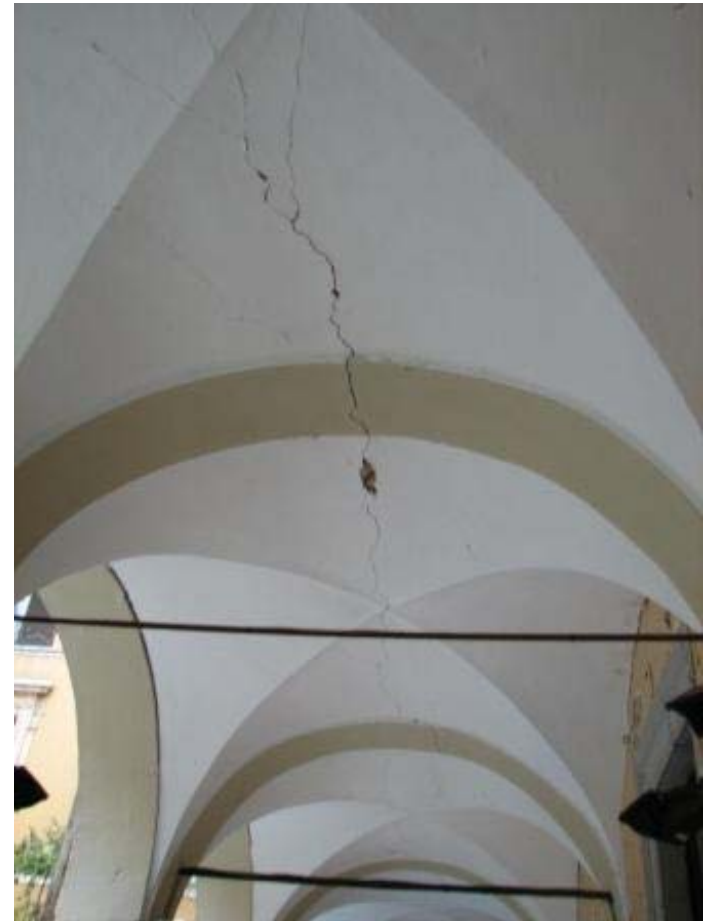
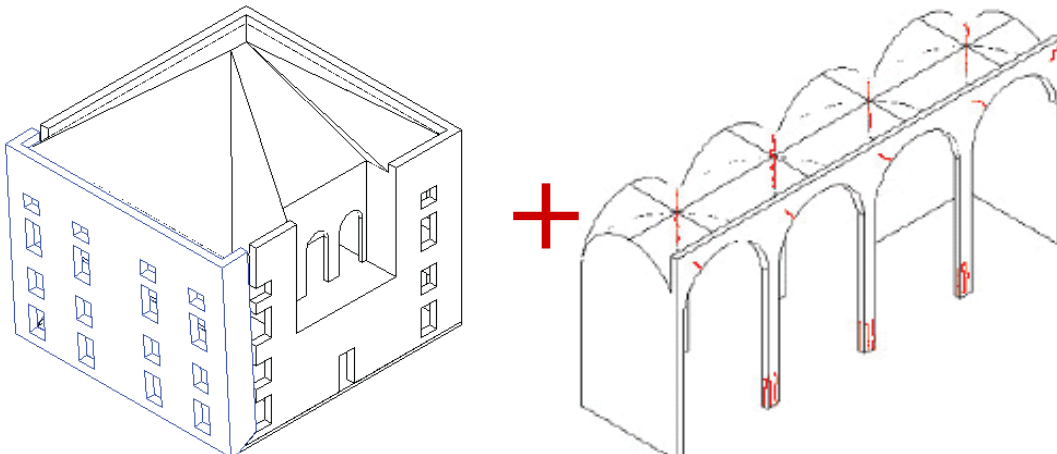
Damage to Arcades

Damage:

- Overturning of the internal arcades "Loggiato" and of the columns;

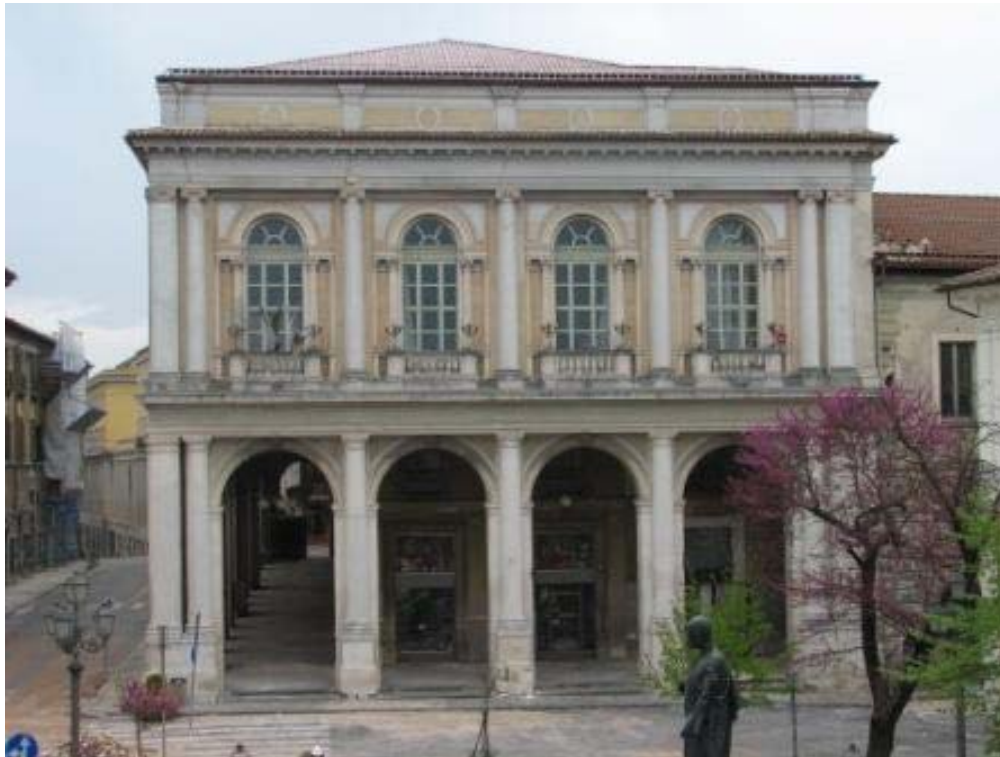
Biblioteca Provinciale, L'Aquila, (1877)

Damage:

- Severe overturning of the façade with signs of compressions on the column of the ground floor;
- Severe shear cracks on the strip and keep walls;
- The internal vaults in the stairs are seriously damaged;

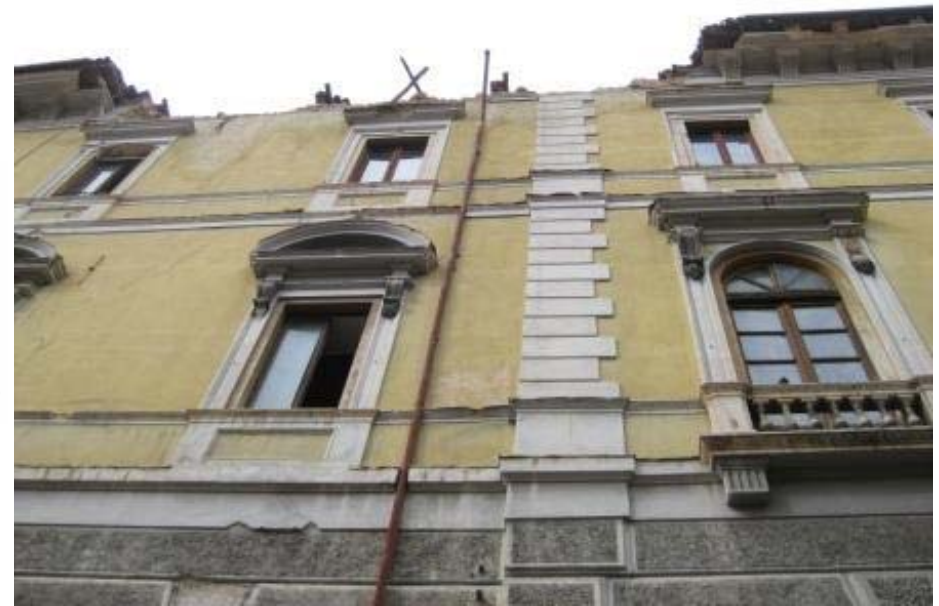
Horizontal flexure

Damage:

- local damage in the front façade wall with severe risk of collapse;

Mechanism:

- overturning due to lack of resistant to traction forces;

Structural causes:

- hammering of the roof beams on top of the lateral wall.

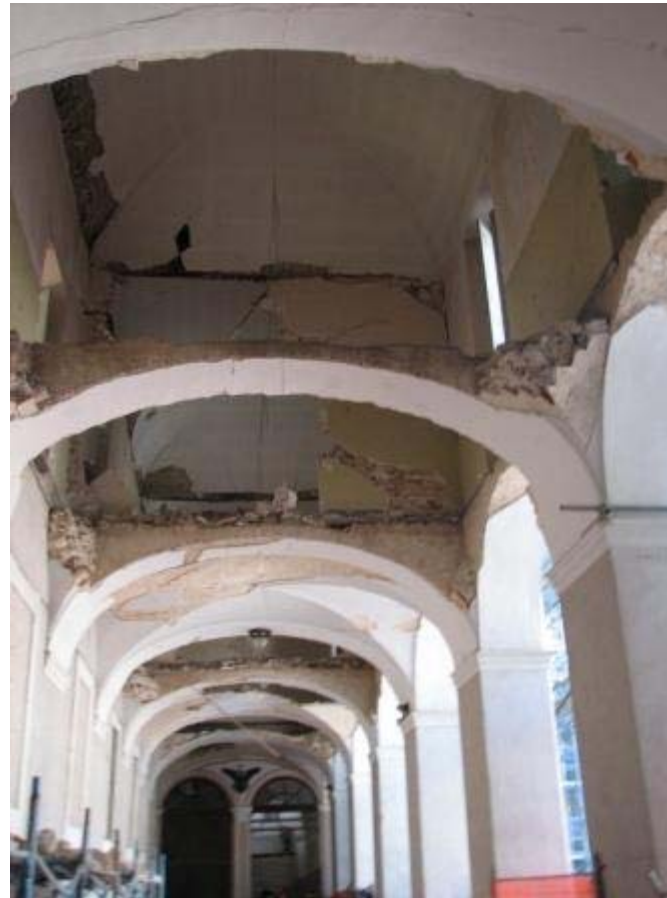
Total collapse of the vaults of the arcades

Damage:

- local collapse of the cross vaults of the arcades of the main yard of the Convitto;

Mechanism:

- rotation of the supports;

Structural causes:

- poor construction of the masonry vaults.

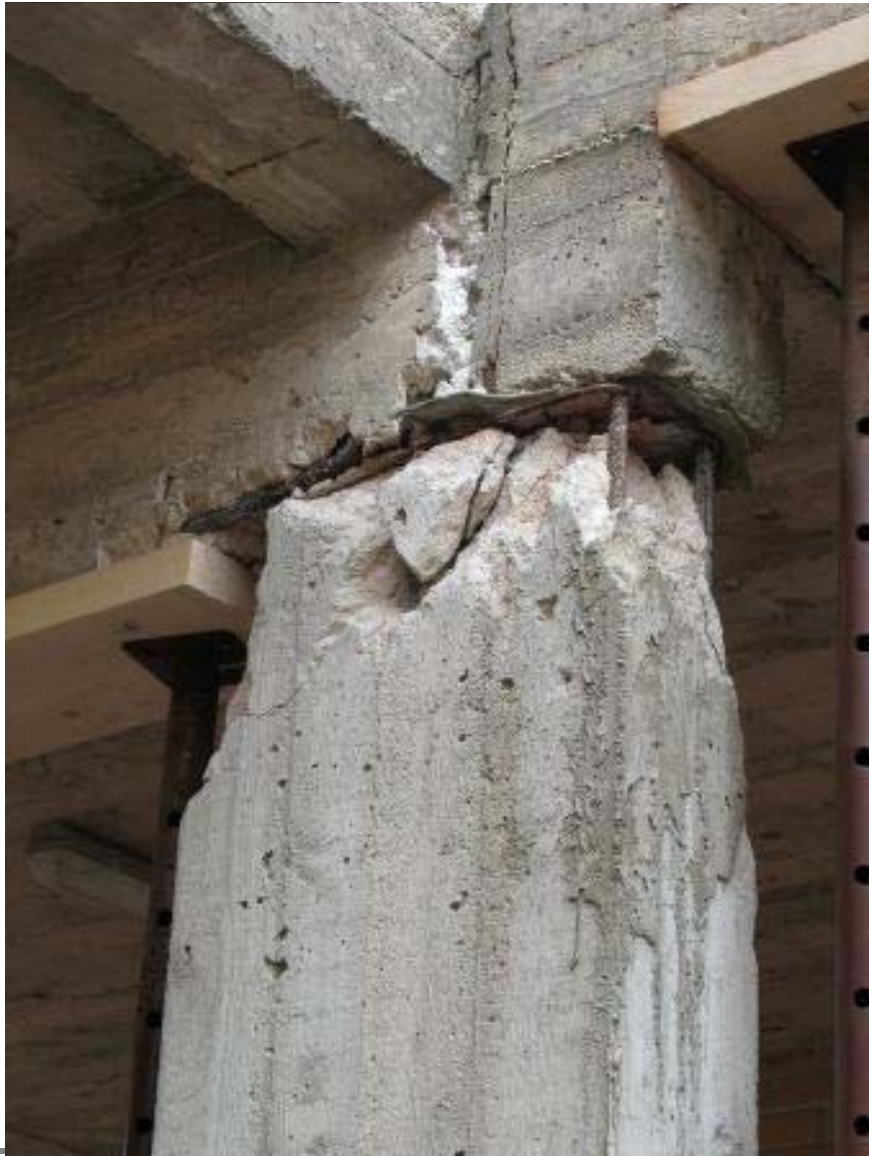
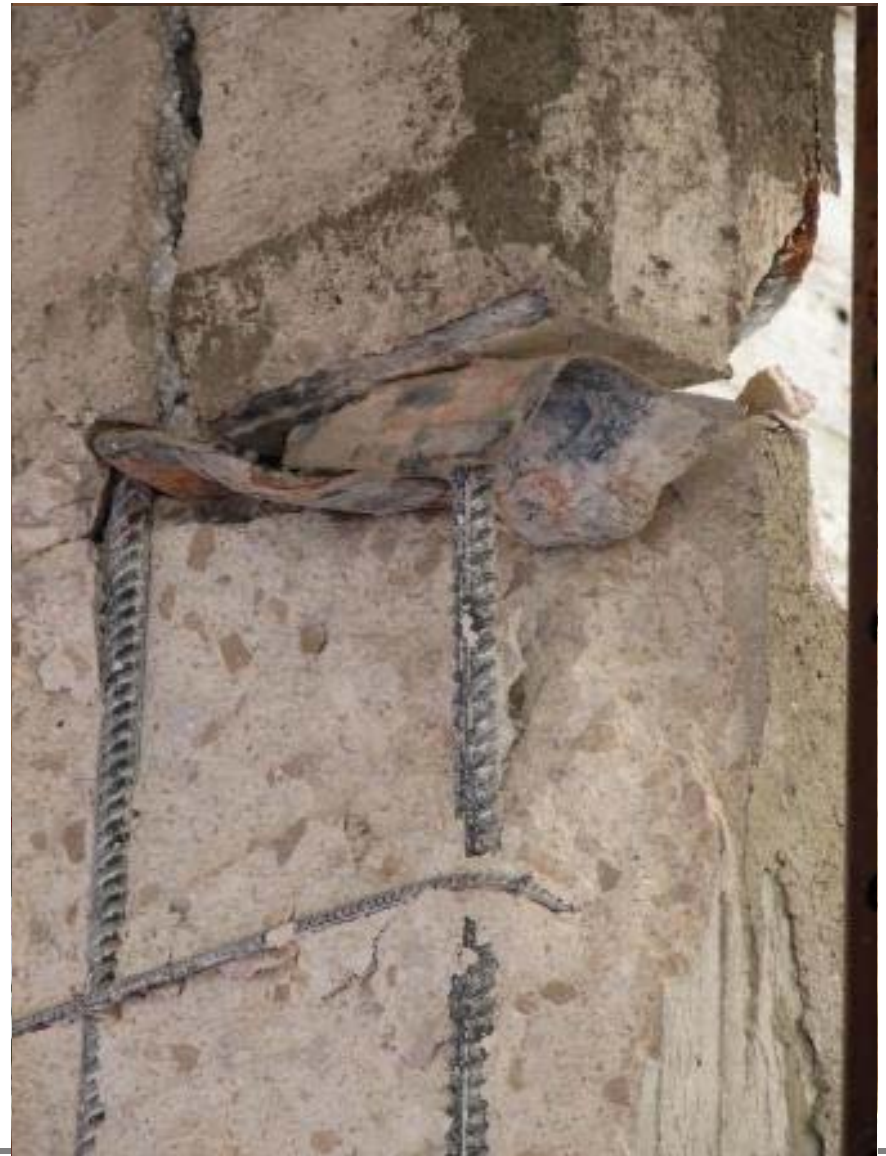
Poor quality of expansion joints

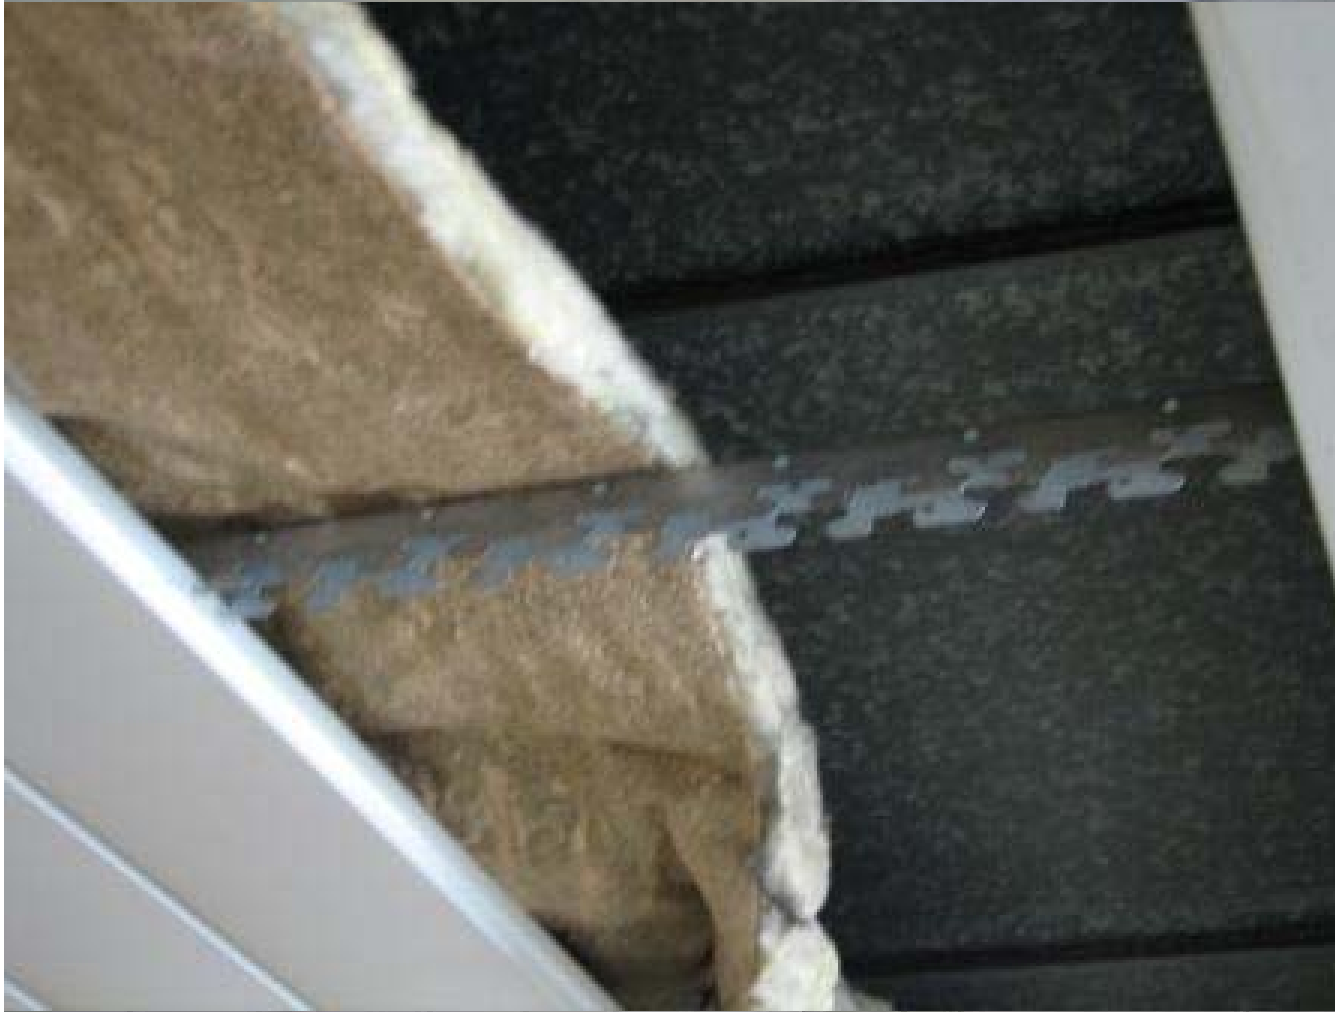
Damage to Suspended Ceilings system

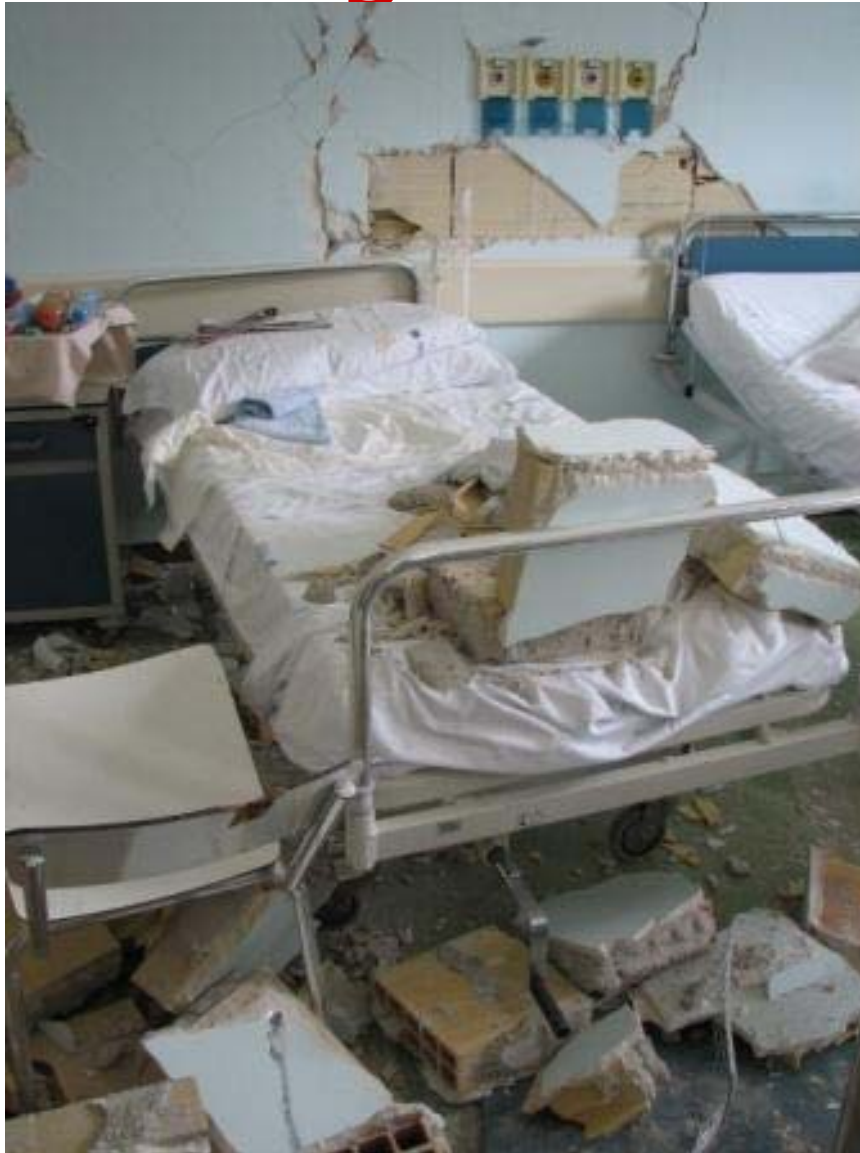
Damage to internal infill walls
