**PRELIMINARY REPORT ON DAMAGES  
SUFFERED BY MASONRY BUILDINGS  
IN CONSEQUENCE OF THE L'AQUILA  
EARTHQUAKE OF 6<sup>th</sup> APRIL 2009**

**Bruno Calderoni, Emilia A. Cordasco, Costantino Giubileo & Luciano Migliaccio**

*Department of Structural Engineering, University of Naples "Federico II"*

This preliminary report shows examples of the typical damages suffered by masonry buildings during the L'Aquila earthquake.

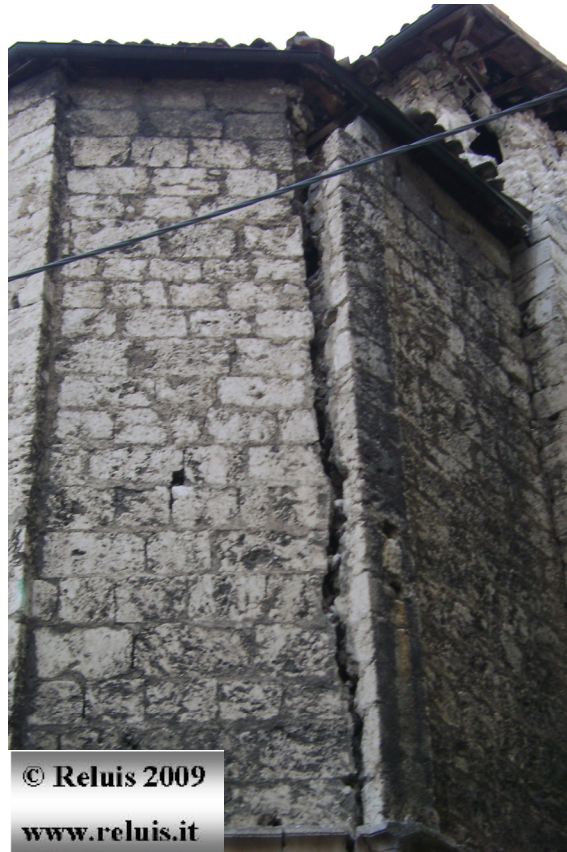
**Ancient masonry of a church located in the historical centre of L'Aquila**

Out of plane behaviour: separation between two masonry walls due to poor arrangement of the stones.

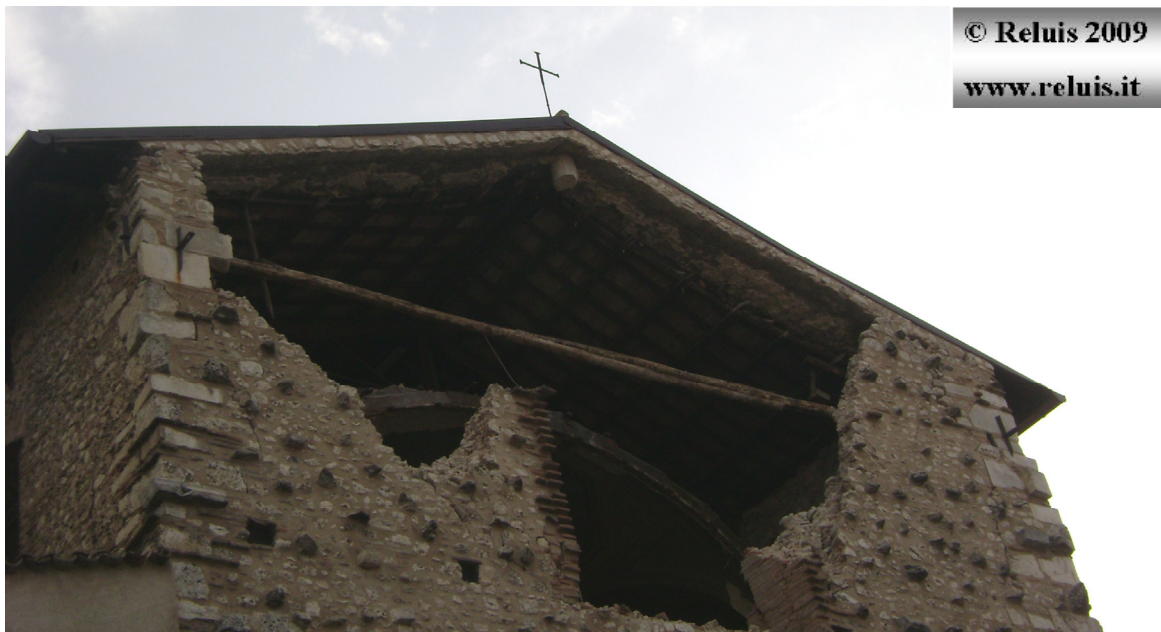
**Facade of a church located in the historical centre of L'Aquila**

Out of plane behaviour: flexural mechanism of facade wall. Note the inefficient connection of the barrel vault, while iron ties avoided global overturning.

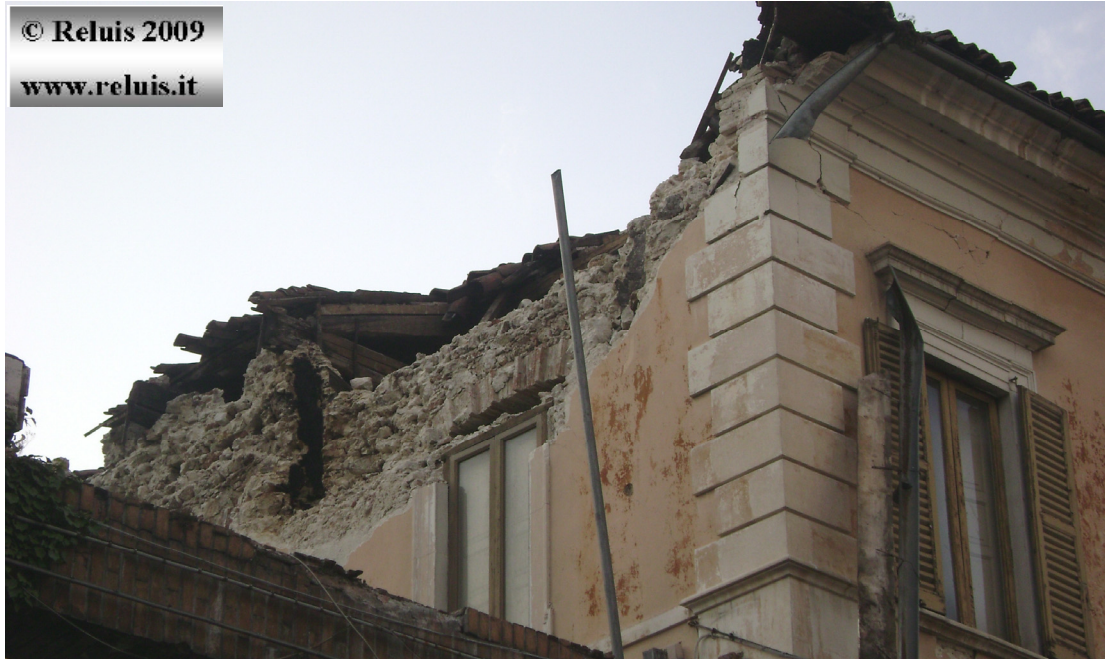
**Building located in the historical centre of L'Aquila**

Out of plane behaviour: collapse mechanism of the upper zone of the wall. Note the poor quality of masonry, without efficient transversal connection elements, and the roof structure not well anchored to the wall. Iron ties avoided global overturning.

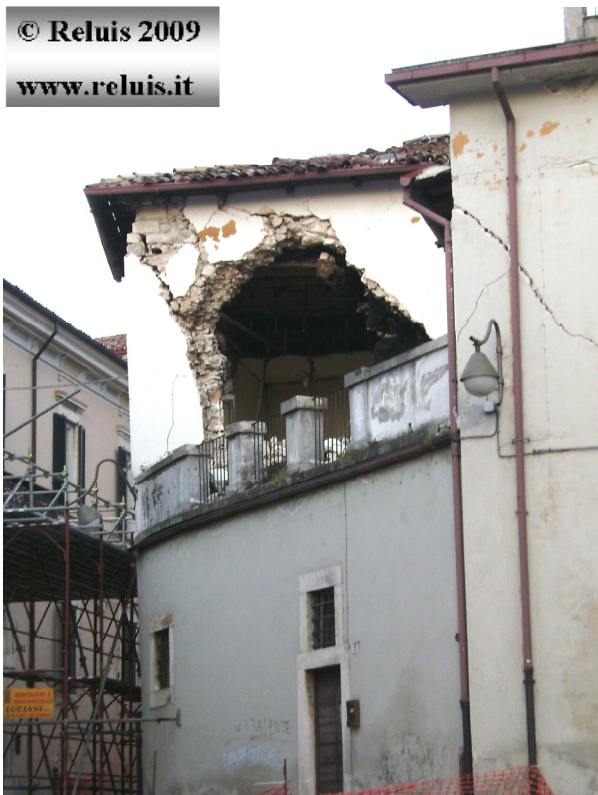
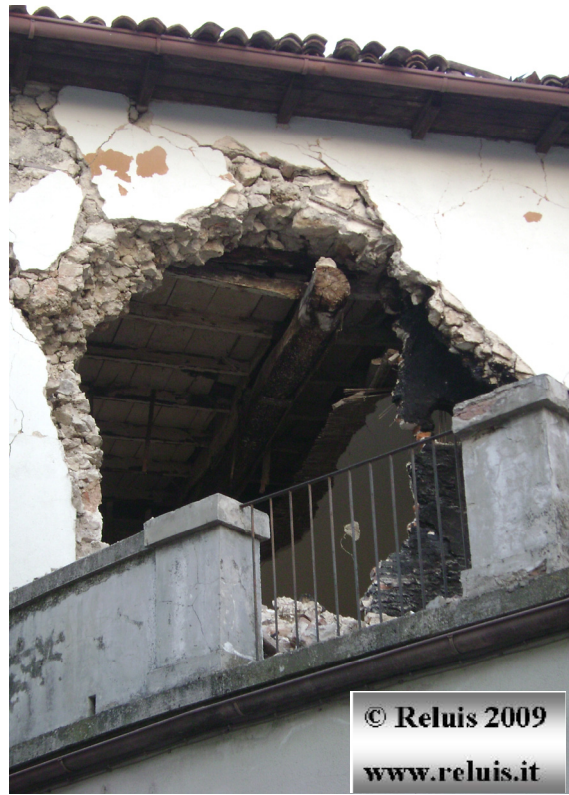
**Building located in the historical centre of L'Aquila**

Out of plane behaviour: collapse of the central zone of a wall determined by the horizontal action of the wooden beam. Good connection with the roof structure and iron ties avoided global overturning.

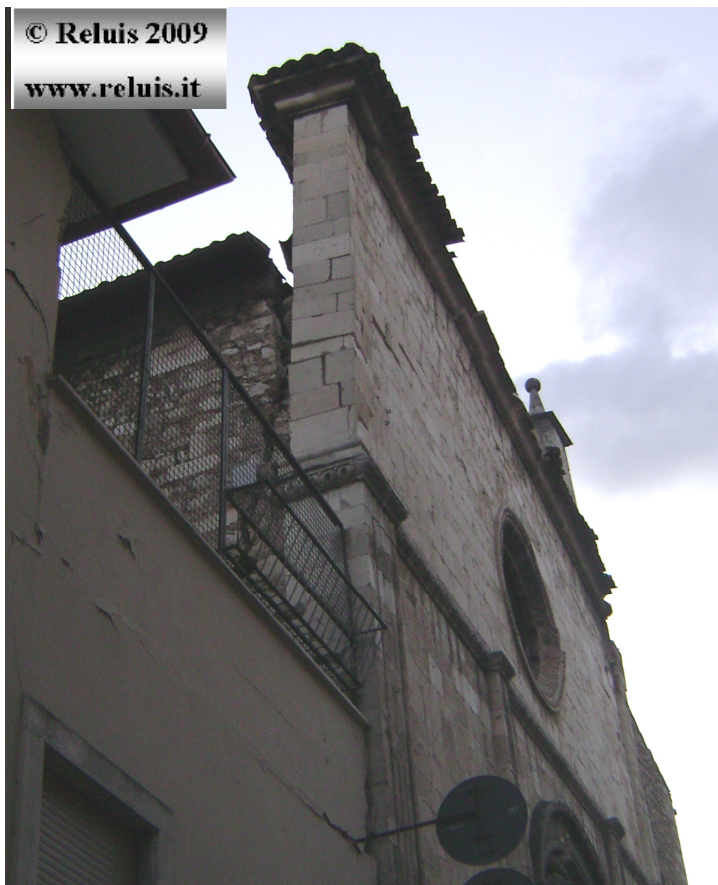
**Church located in the historical centre of L'Aquila**

Out of plane behaviour: overturning mechanism of the facade wall detached from orthogonal walls.

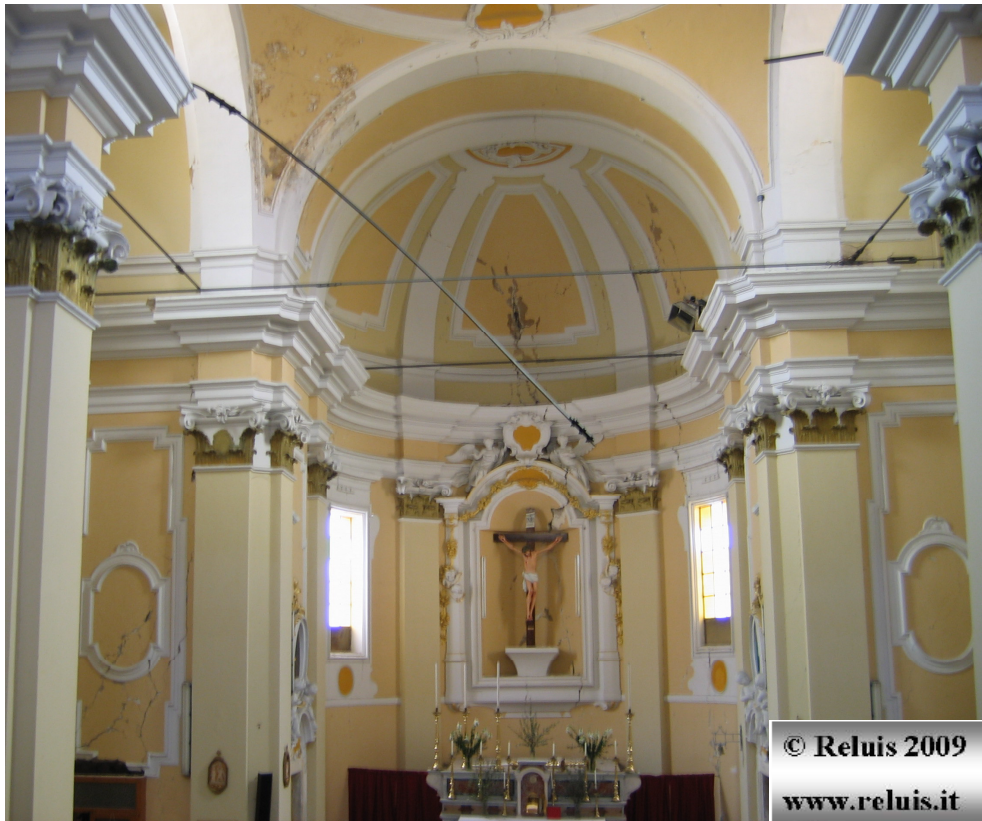
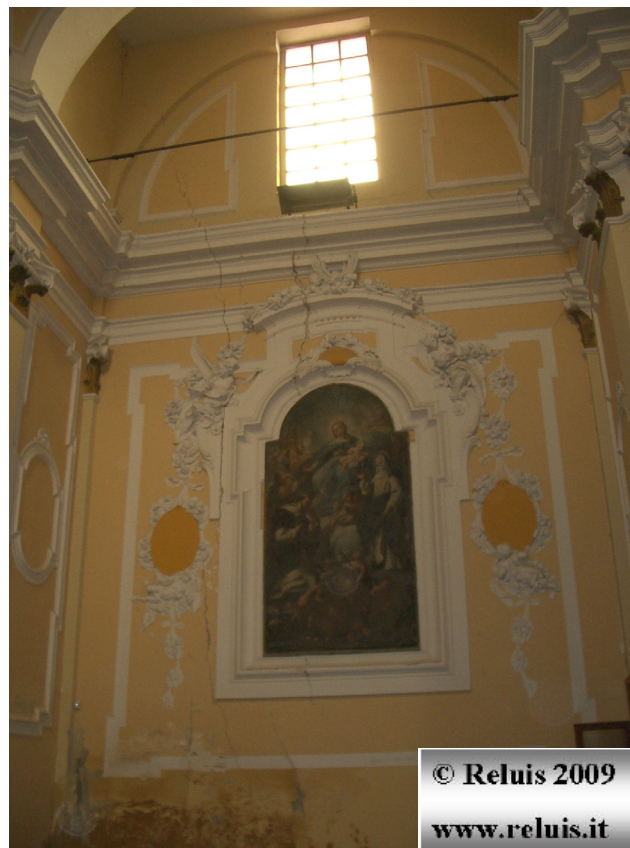
### **Church in the historical centre of Popoli (PE)**

Several iron ties, placed after Avezzano's earthquake, avoided out of the plane global failure of external walls, which resulted very damaged in their own plane. The tensile rupture of a tie testifies the strong engagement of these structural elements.

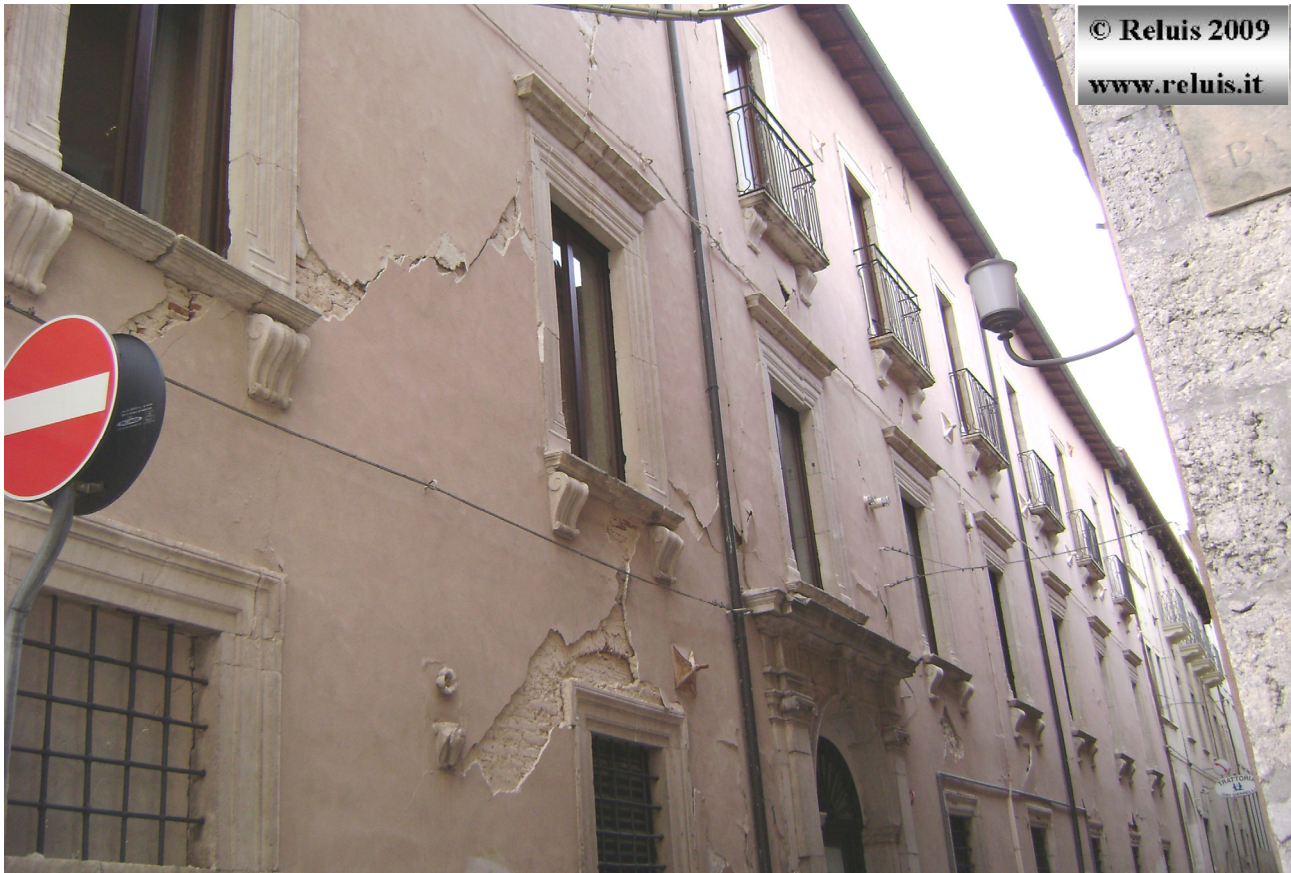
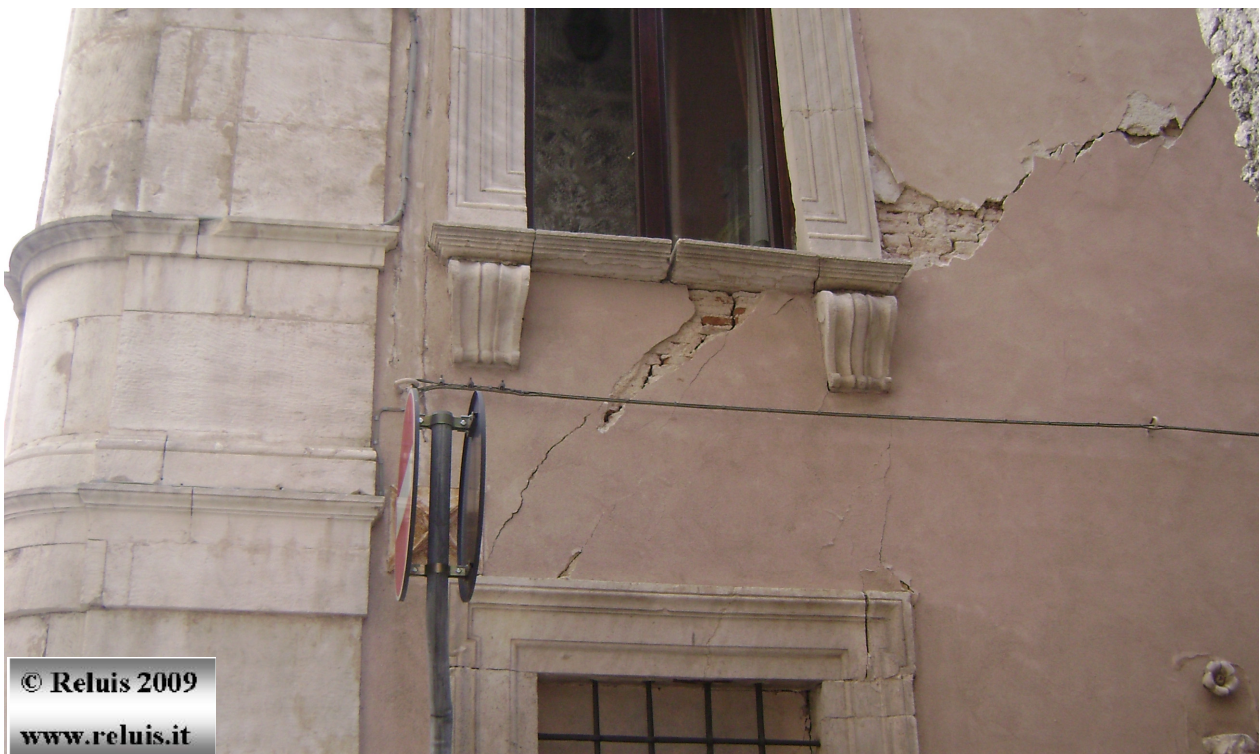
**Building located in the historical centre of L'Aquila**

In plane behaviour: several iron ties, placed in correspondence of orthogonal walls at each storey, avoided the out of the plane collapse. Diagonal cracks, in both spandrels and piers, testify the engagement of the wall in its own plane.

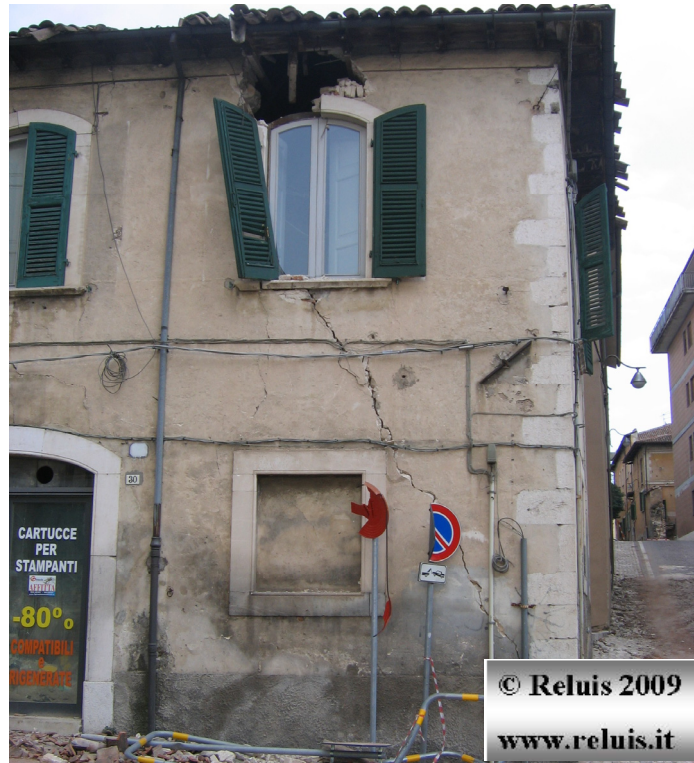
**Building located in the historical centre of L'Aquila**

In plane behaviour: the iron ties at floor level allowed the formation of diagonal struts in the masonry spandrels.

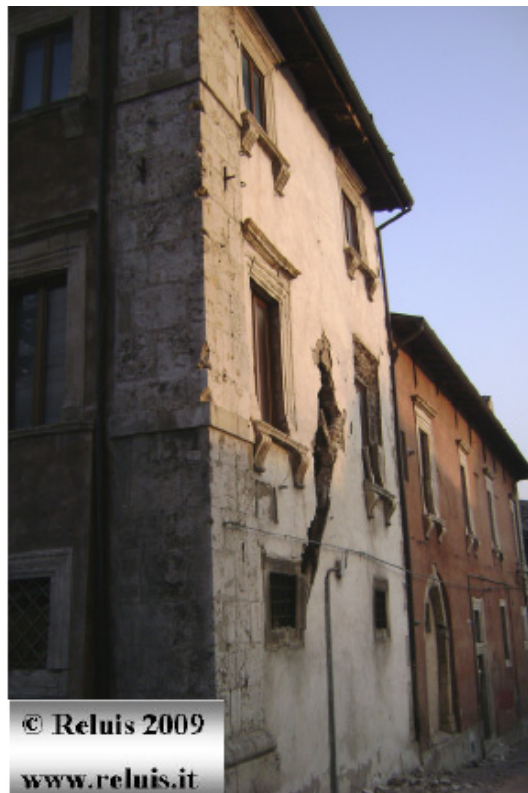
**Building located in the historical centre of L'Aquila**

In plane behaviour: the strong engagement in compression of the diagonal strut of a pier caused out of plane instability with expulsion of some masonry parts.

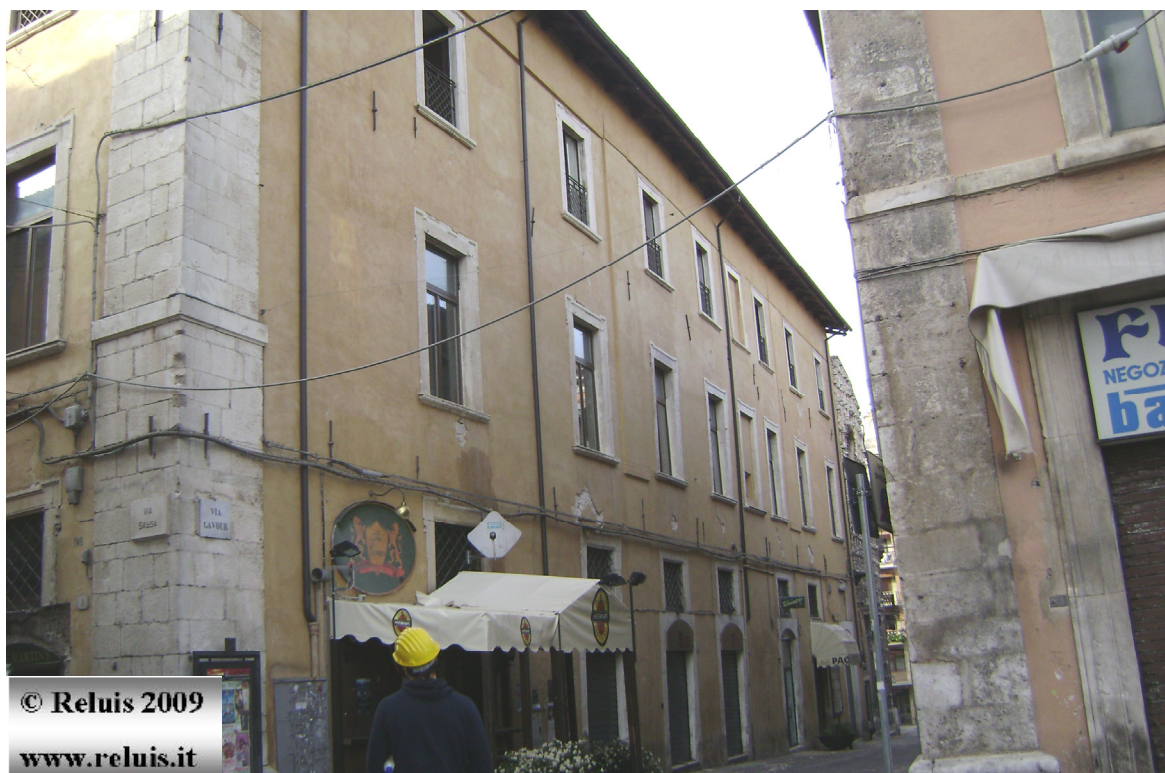
**Building located in the historical centre of L'Aquila**

Good behaviour of masonry buildings in presence of ancient iron ties: Only some negligible diagonal cracks are visible on the spandrels.

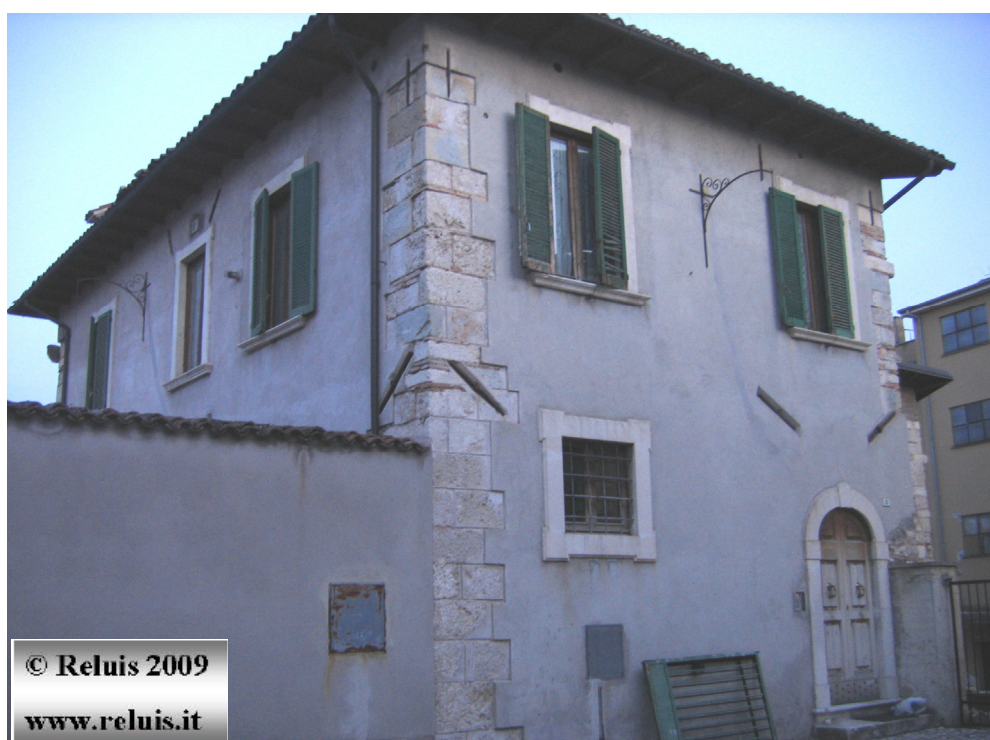
**Building located in the historical centre of L'Aquila**

Good behaviour of masonry buildings in presence of ancient iron ties: No damages are visible on the external walls.

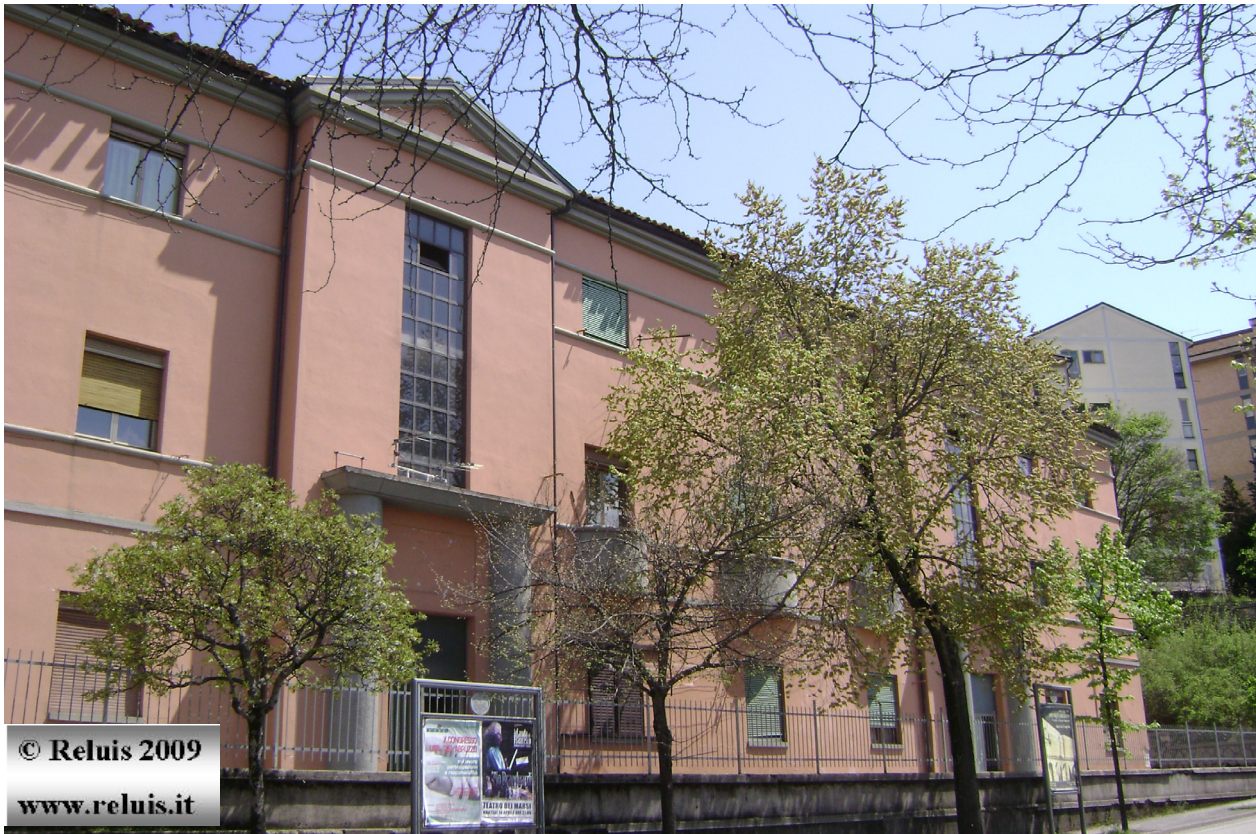
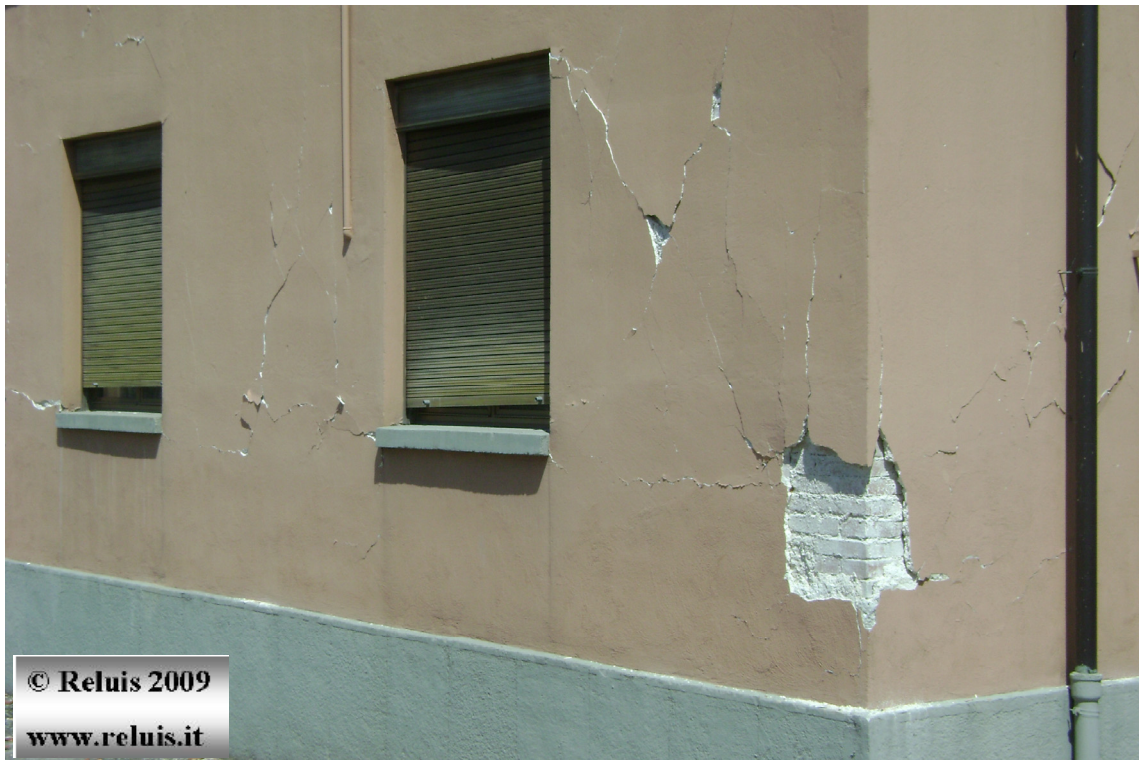
**Building located in the historical centre of L'Aquila**

Good seismic behaviour of a "modern" masonry building with r.c. floors (*"third class"* building). No out of plane behaviour is possible, while diagonal cracks in the piers testify the wall engagement in its own plane.

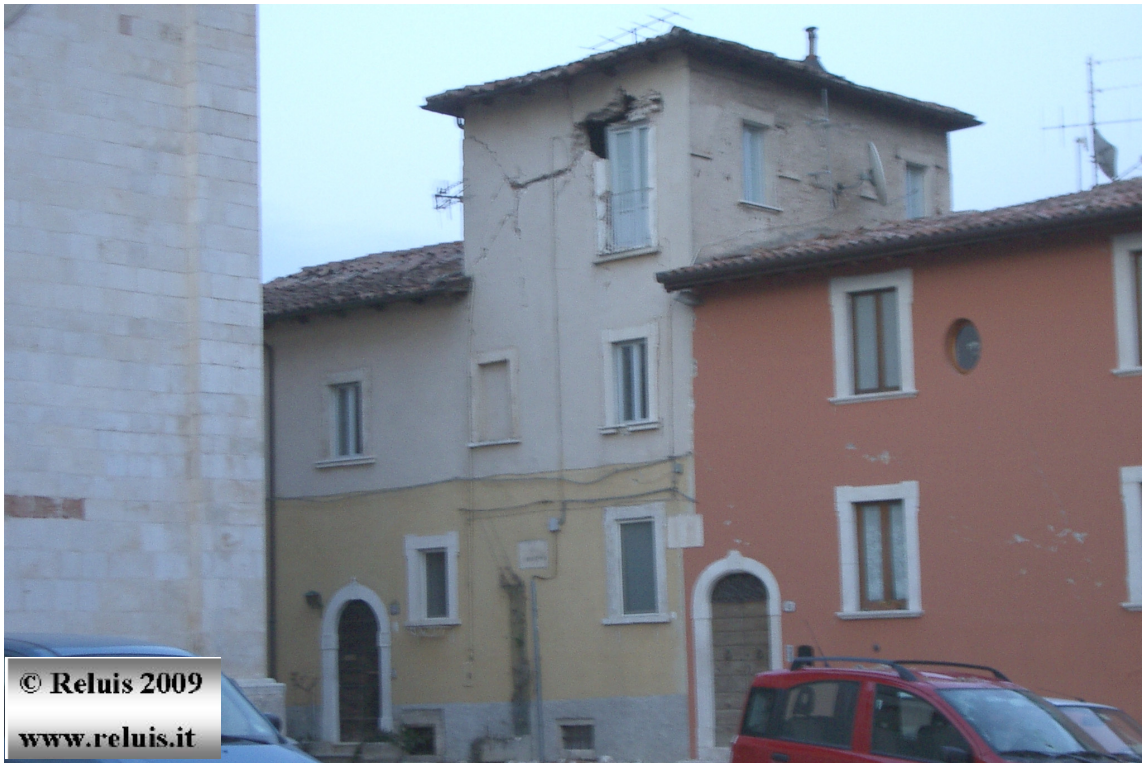
**Aggregates and complex buildings in the historical centre of L'Aquila**  
In plane damages of third storey due to different heights of adjacent buildings.  
*Photo by B. Calderoni, E.A. Cordasco, C. Giubileo and L. Migliaccio*

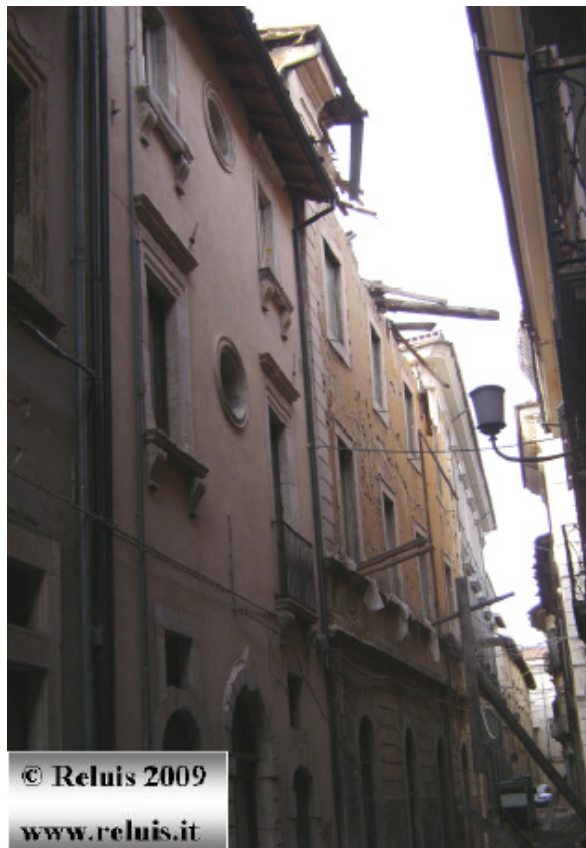
**Aggregates and complex buildings in the historical centre of L'Aquila**  
Collapse of the upper zone of masonry walls due to the out of plane action of roof.  
*Photo by B. Calderoni, E.A. Cordasco, C. Giubileo and L. Migliaccio*
