Field reconnaissance following the April 6, 2009 L`Aquila Earthquake in Italy

Gian Paolo Cimellaro

Assistant professor,
Department of Structural and Geotechnical engineering,
Politecnico di Torino

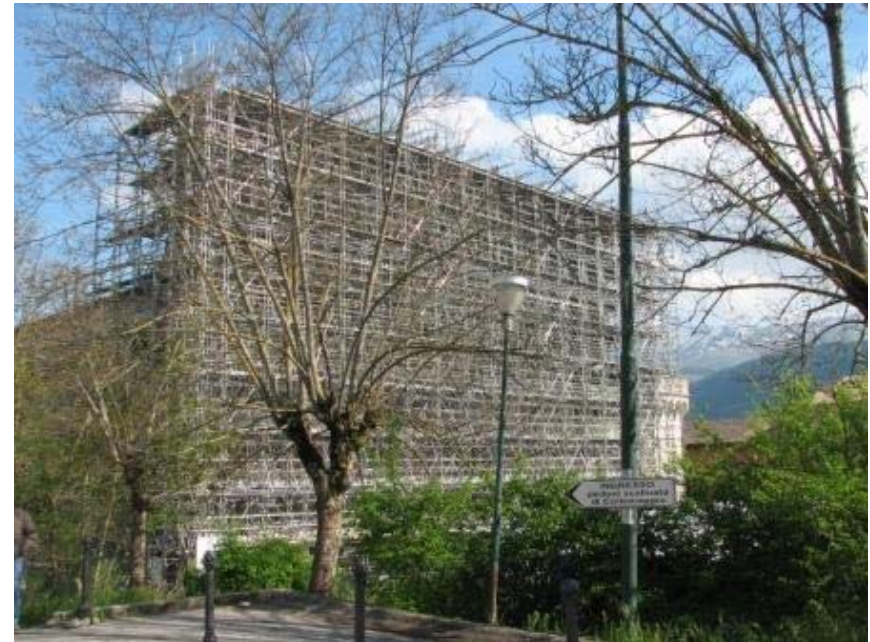
Figure. Façade at the moment of the earthquake
