Field reconnaissance following the April 6, 2009 L`Aquila Earthquake in Italy

Gian Paolo Cimellaro

Assistant professor,
Department of Structural and Geotechnical engineering,
Politecnico di Torino

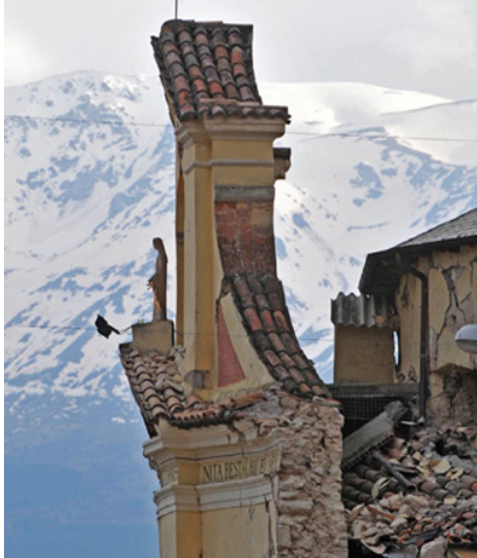
Figure. Church Santa Maria in Paganica

The experience of the earthquake which struck the Abruzzo (April 2009), showed that the type of collapse for existing masonry structures is based on kinematic mechanisms due to loss of equilibrium of walls or assemblies of walls, with out-of-plane mechanisms at the global and local level.

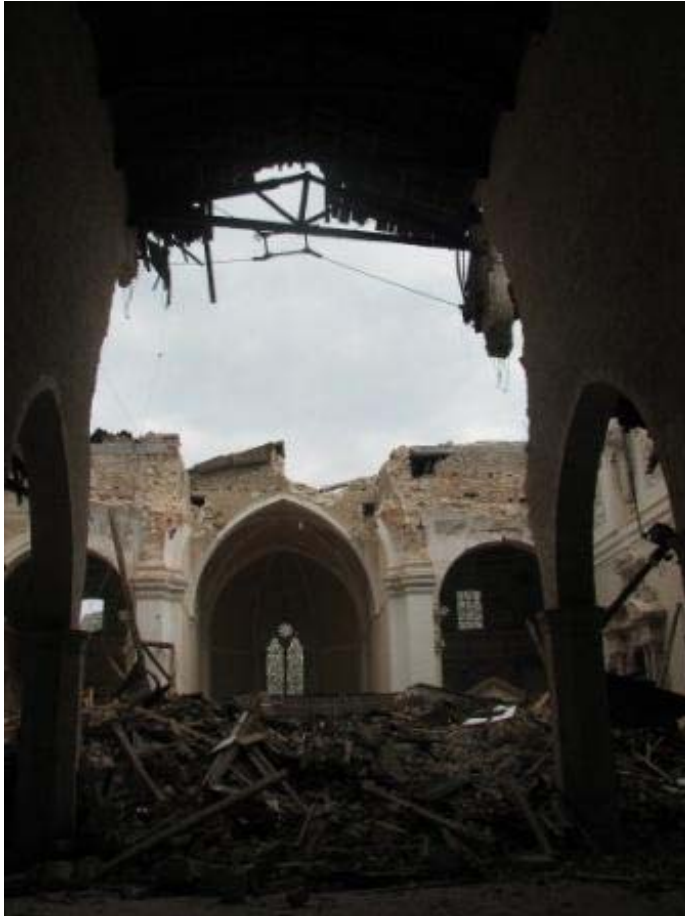
Figure. Basilica of Santa Maria di Collemaggio

It also highlighted the limitations of some traditional reinforcement techniques. Significant damage have been reported from buildings that had previously been consolidated after the earthquake of 1997, particularly due to questionable activities of the technical choices for incorrect or poor execution of the interventions themselves.

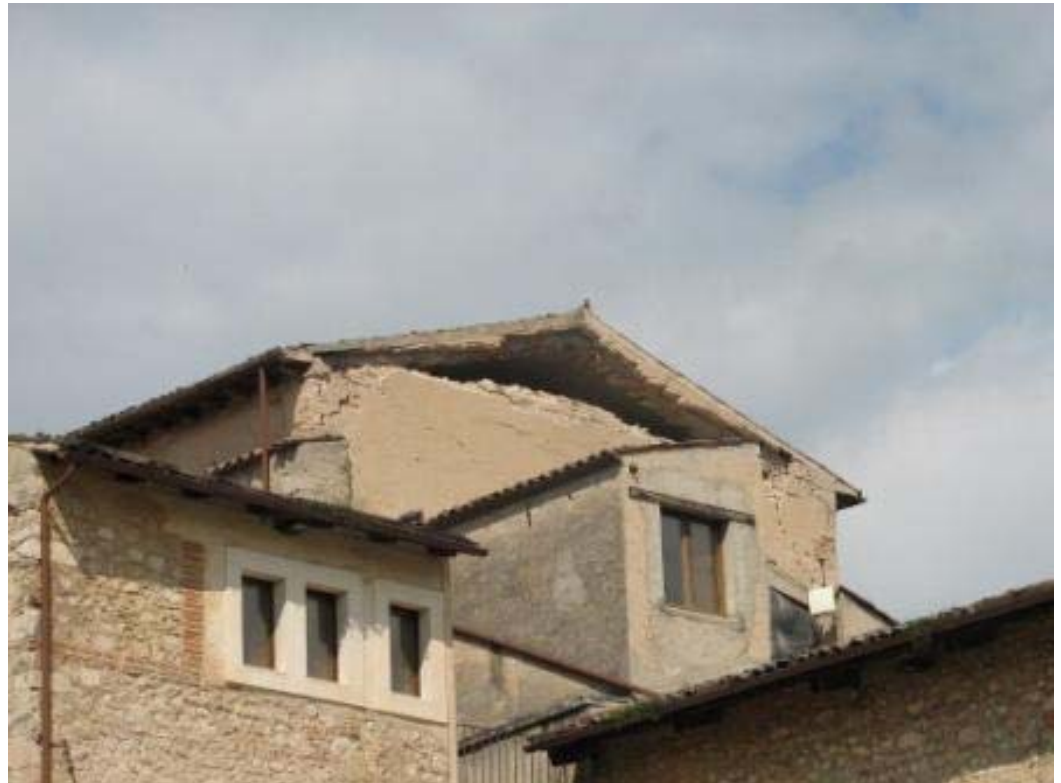
Figure. Convent of Santa Maria di Collemaggio

Structural causes:

- Roof not effectively connected to the masonry.

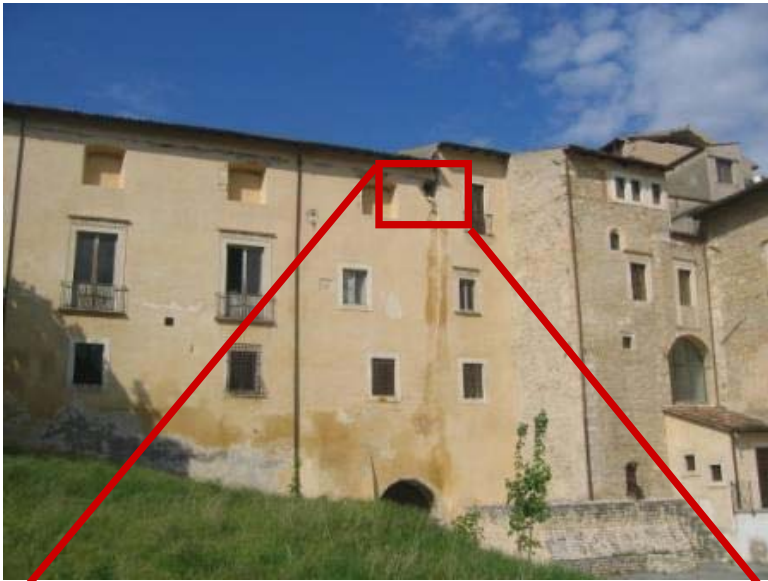
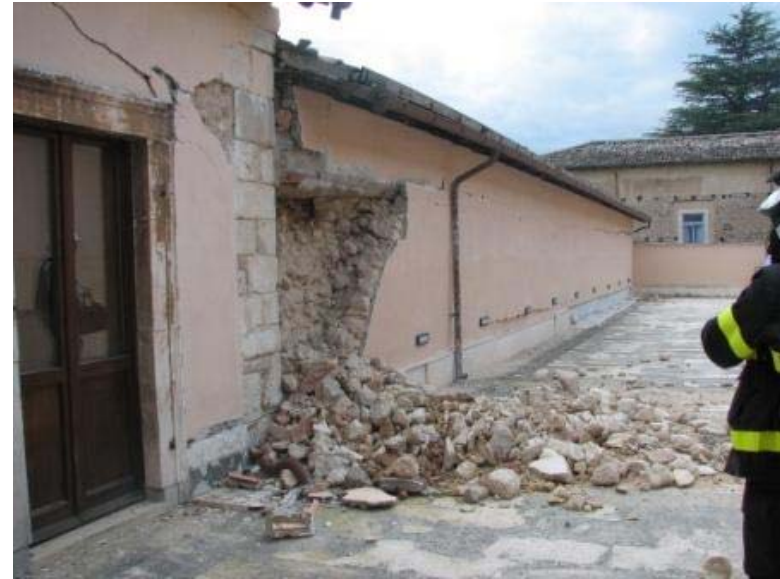
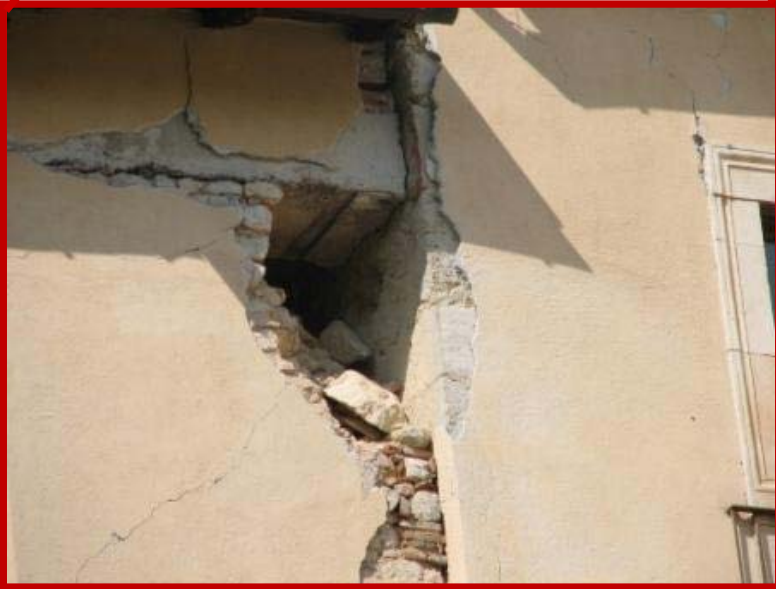
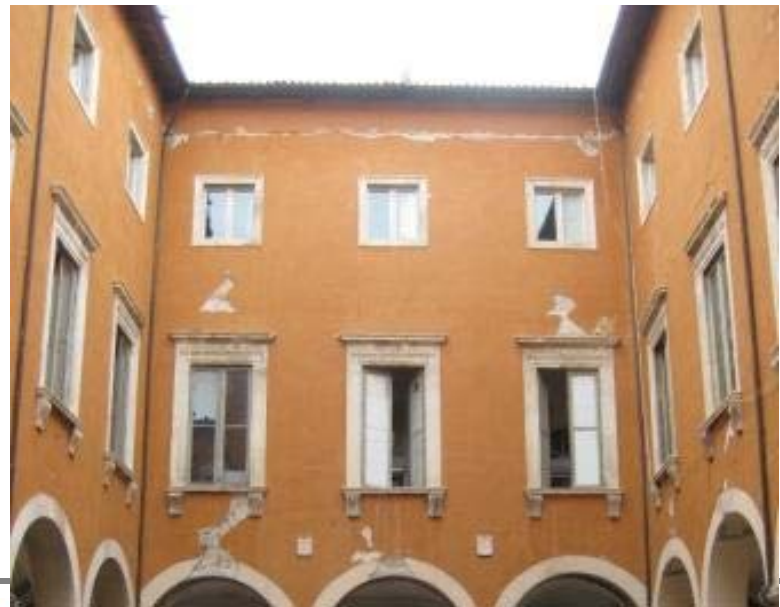
Poor connection between ring beam and masonry

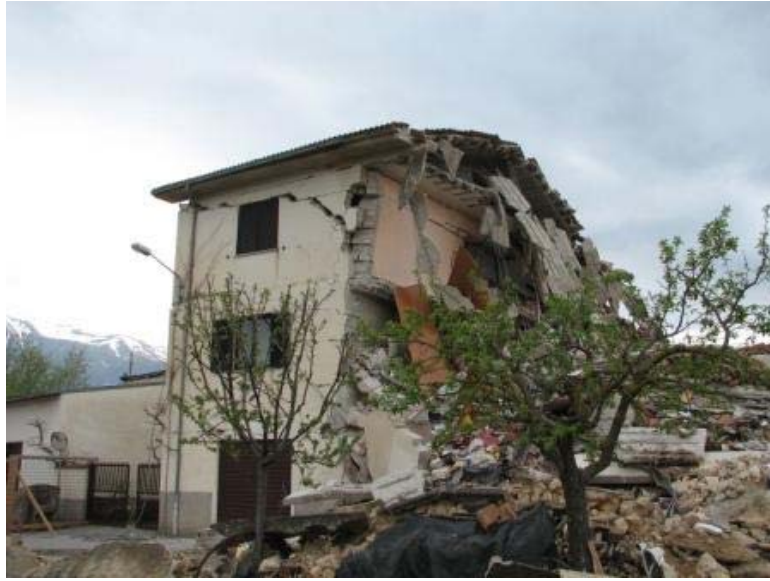
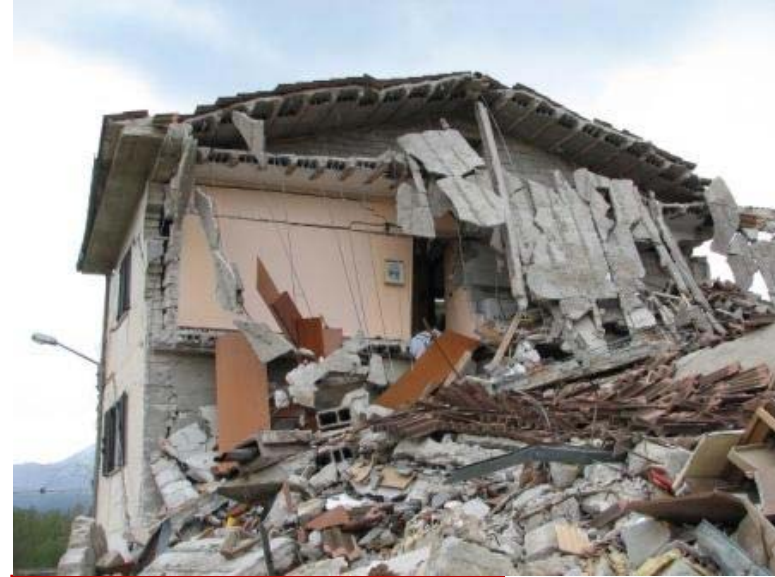
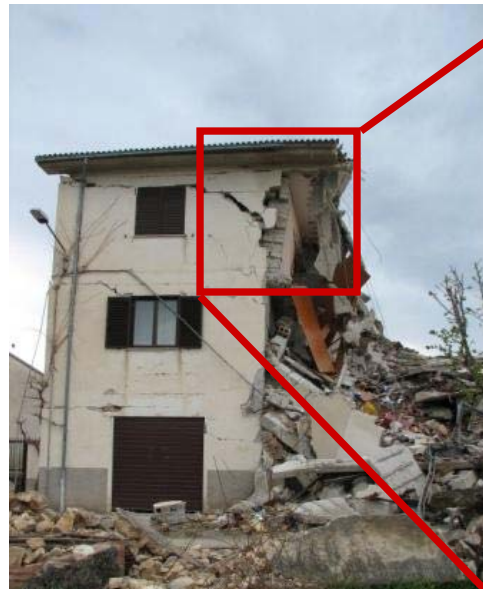
Collapse of half building triggered by the RC roof

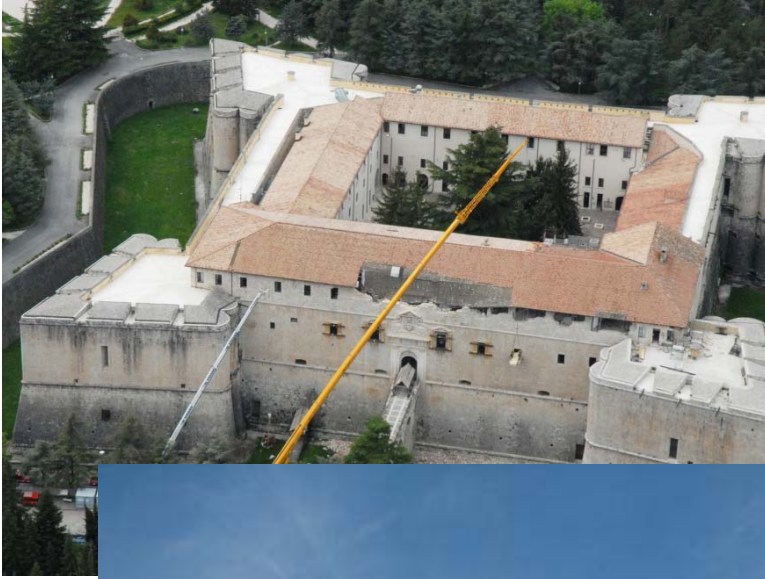
Fortezza Spagnola

Damage:

- partial collapse of the floor slab;
- Partial collapse of the roof;
- Partial collapse of the upper lateral wall;
- Severe cracks on the vertical walls;
- Severe overturning of the arcades (loggiate) and of the columns on the ground floor;
- Severe damage to historical heritage inside the National Museum of Abruzzo;

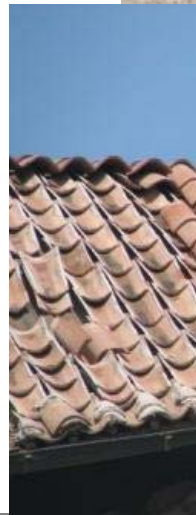
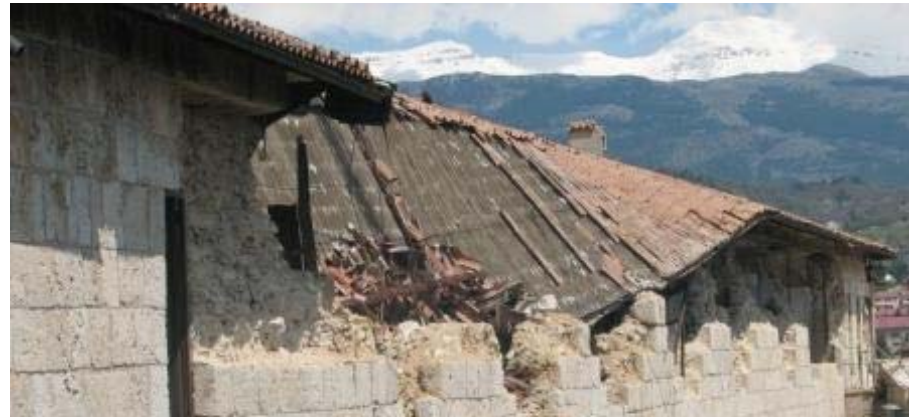
Damage to roof coverage

Damage:

Structural causes:

- Poor connection between the roof slab and the lateral wall weaker due to the presence of openings;
- Poor quality of the masonry;

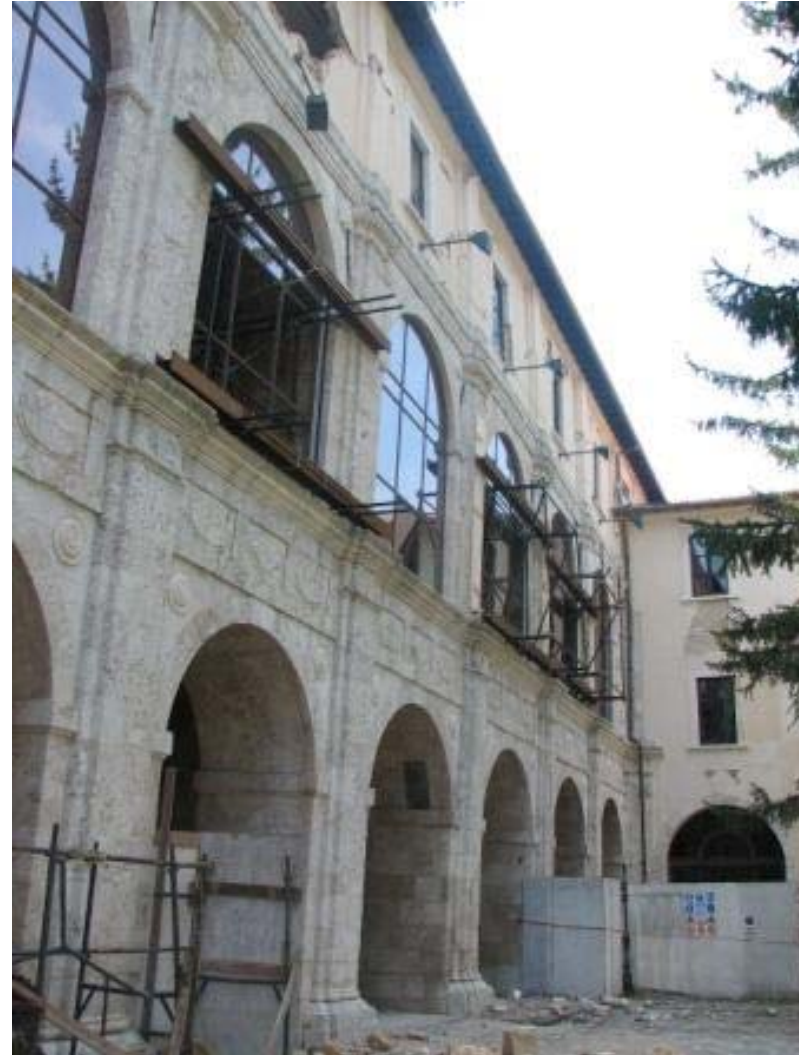
Signs of overturning wall

Damage:

- overturning of the internal arcade facing the internal yard and severe damage in the internal columns of the arcade;

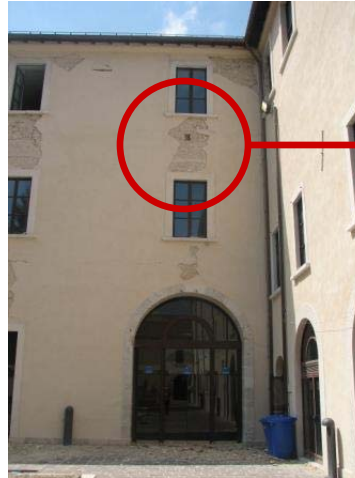
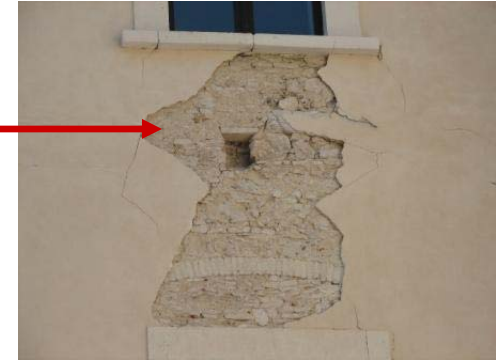
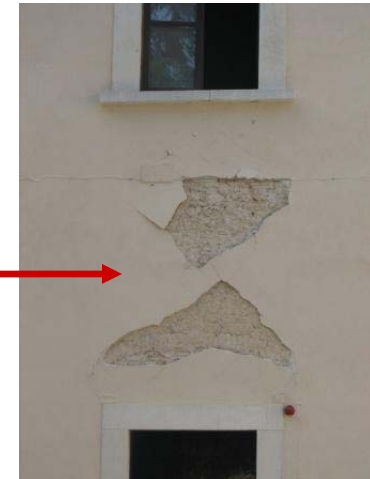
Damage in the lintels (Architrave)

Damage:

- typical cross cracks in the wall strips above and below the window openings;

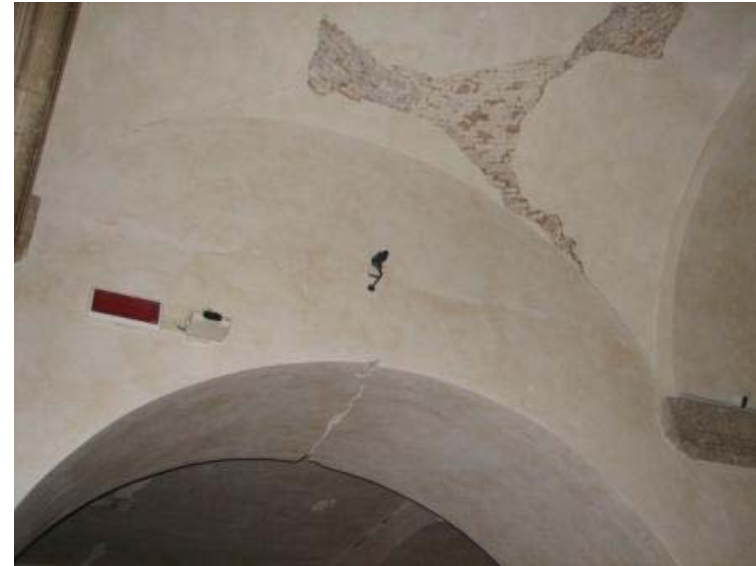
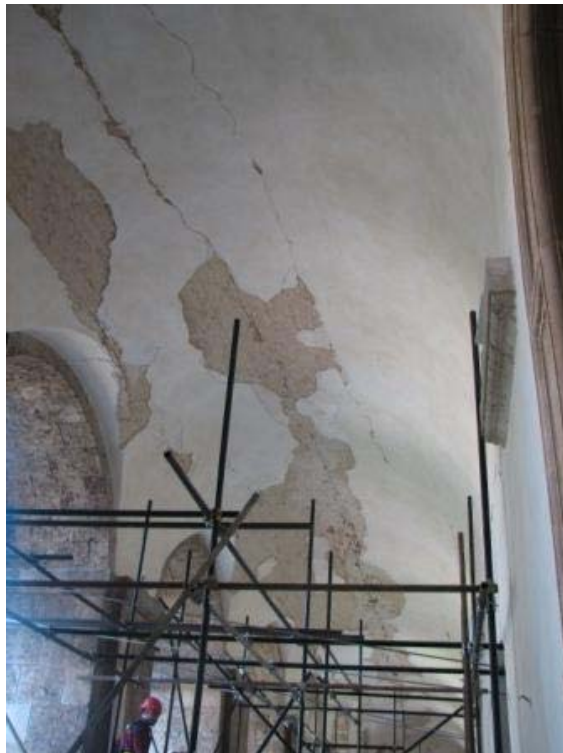
Damage in the lateral strips walls "maschi murari"

Damage:

- cracks in the arch, the cross vaults and barrel vault;

Structural causes:

- Rotation of the lateral walls.

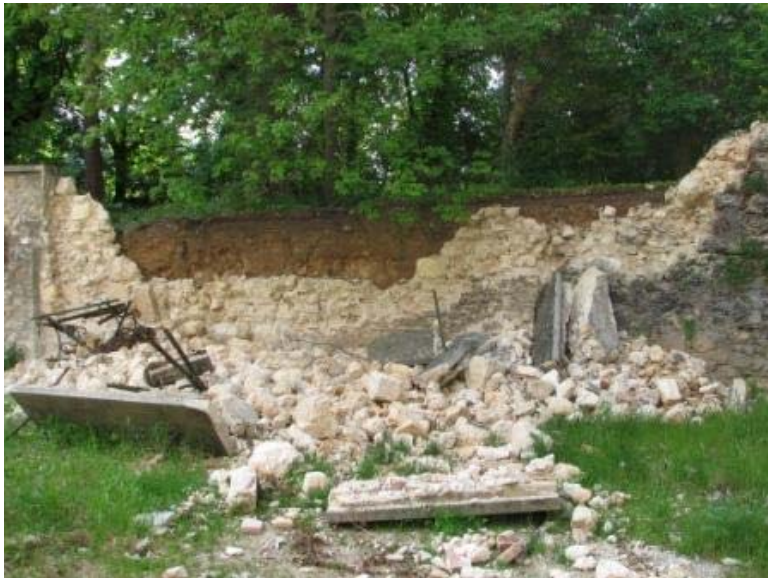
Figure Convento Santa Maria di Collemaggio

In existing masonry buildings local collapses appear because of loss of equilibrium of part of the walls.

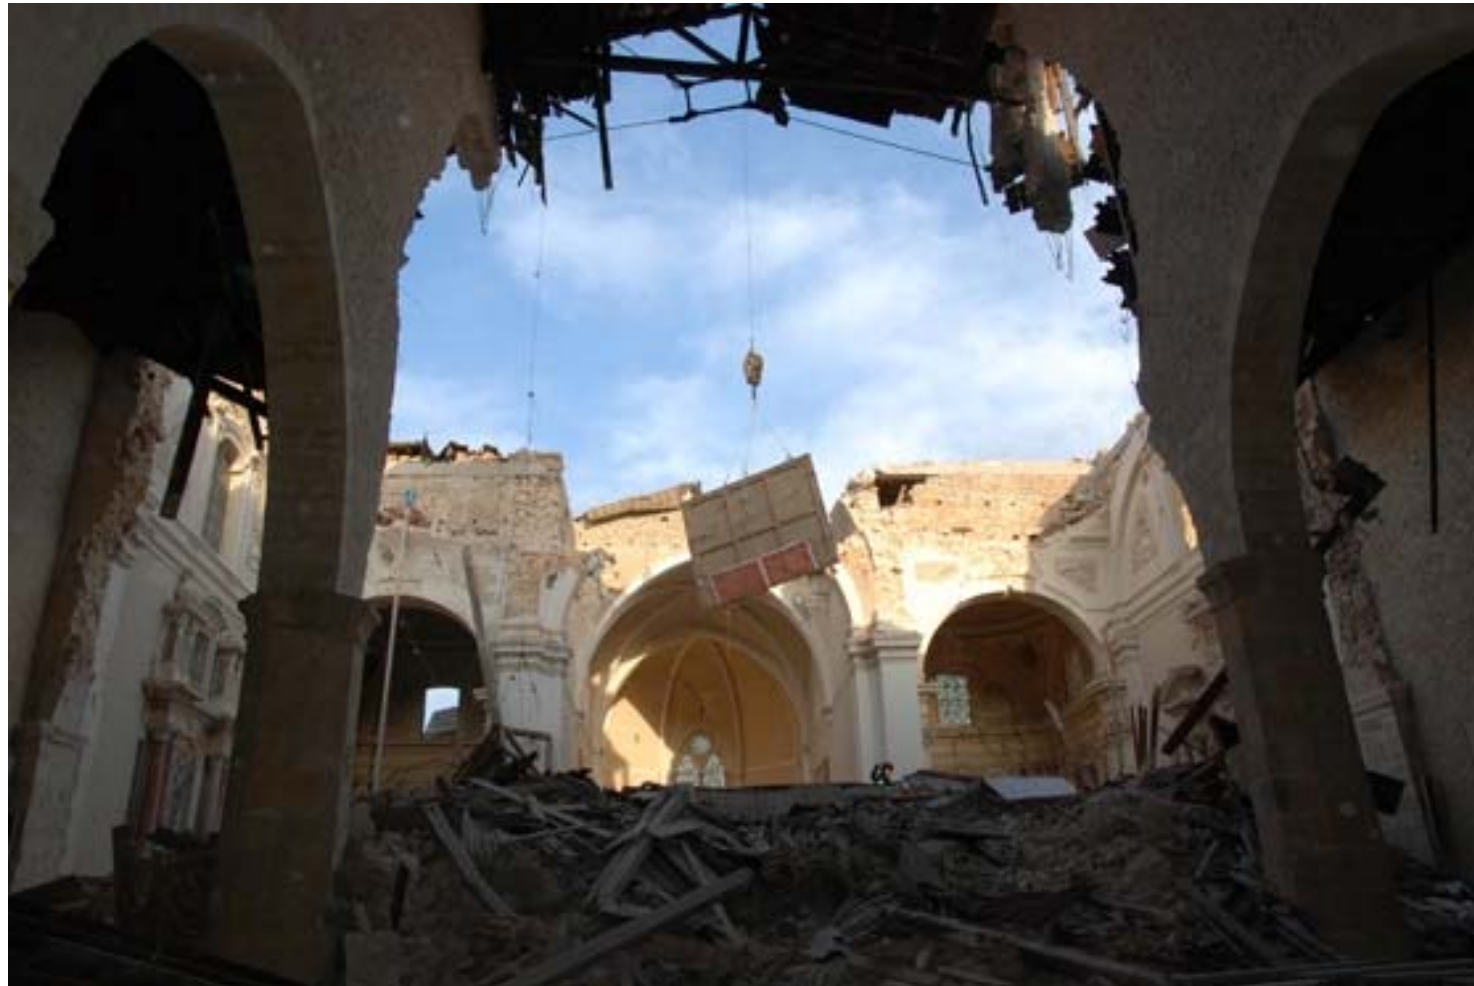
Interior of Santa Maria di Collemaggio

- Collapse of the vault of the transept;
- Collapse of the Triumphal arches;
- Collapse of the "tamburo" and of the Dome;
- Collapse of the roof elements of the transept;
- Severe cracks with imminent collapse in the apse and in the presbitery;
- Moderate cracks in the tower and the tower room;

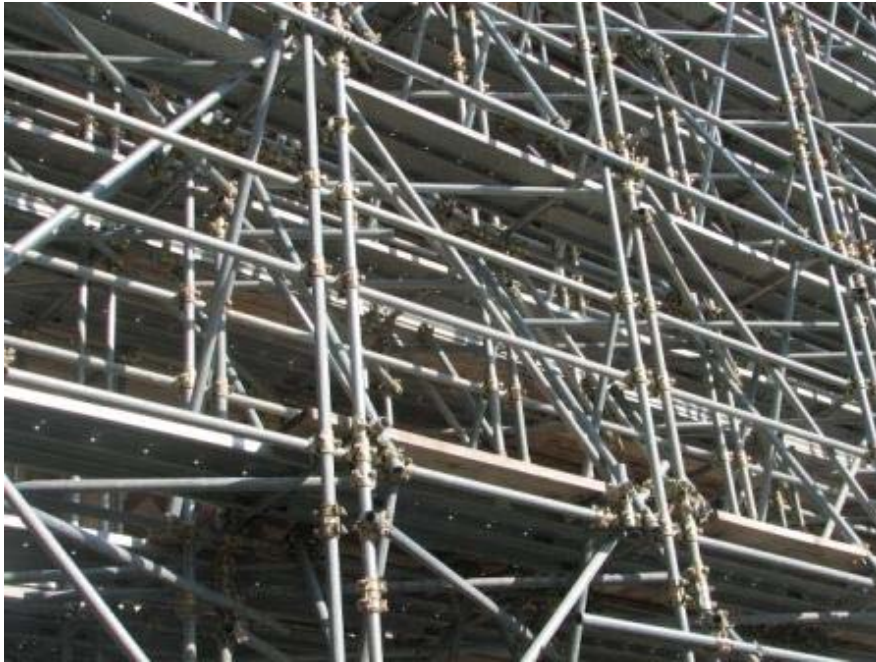
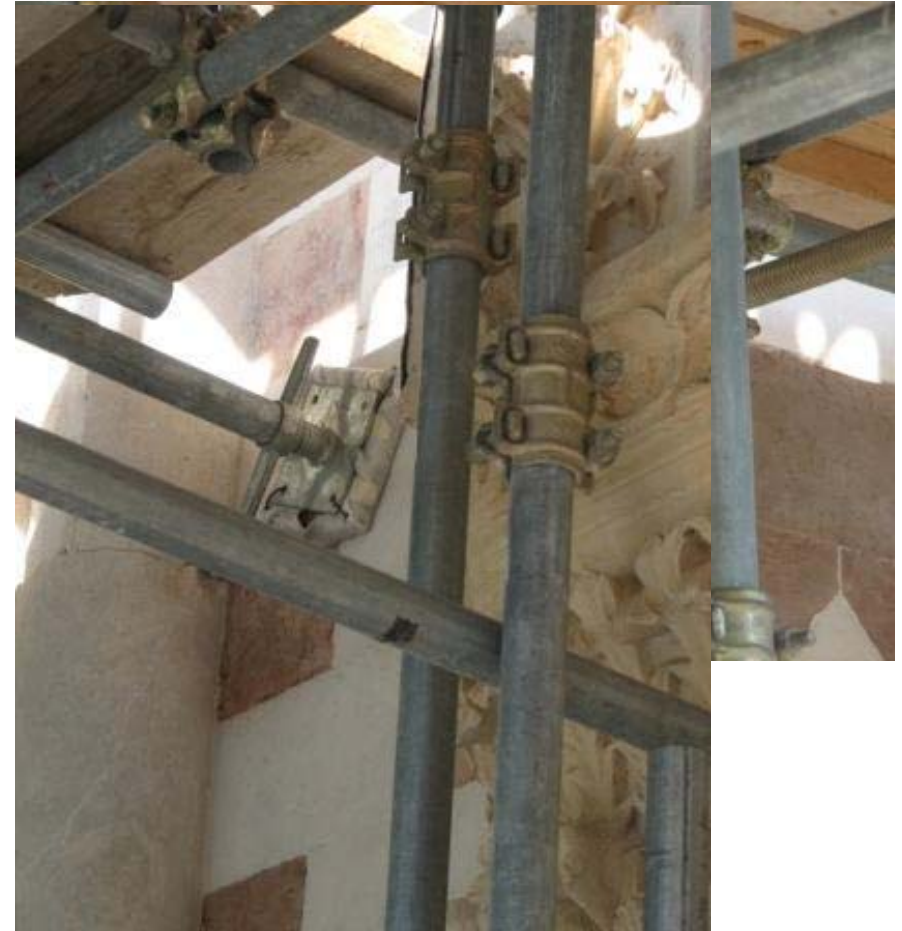
Details of the Facade scaffolds

The structural scaffolds supported the front façade avoiding its collapse.

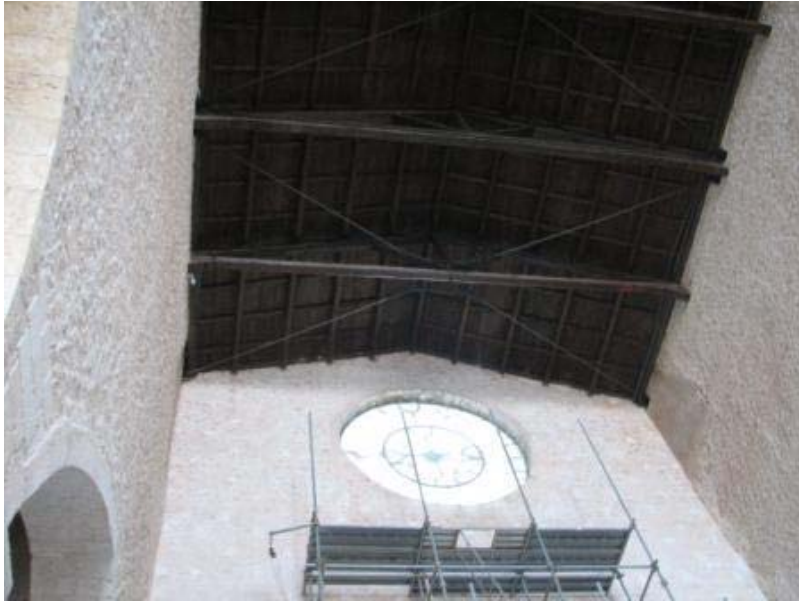
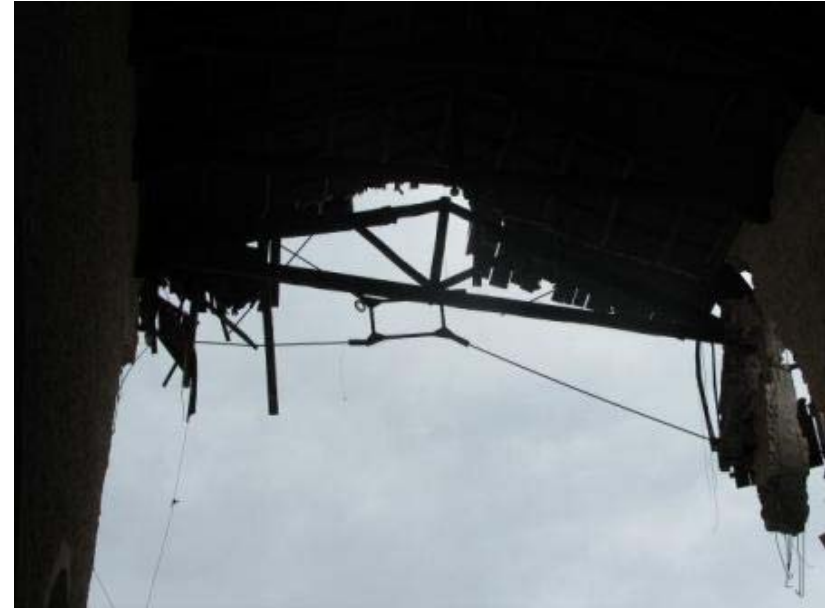
Figure. Location of one of the two hysteretic steel dampers at the edge of the nave

The steel dampers connected the two walls together making the nave laterally stiffer than the transept

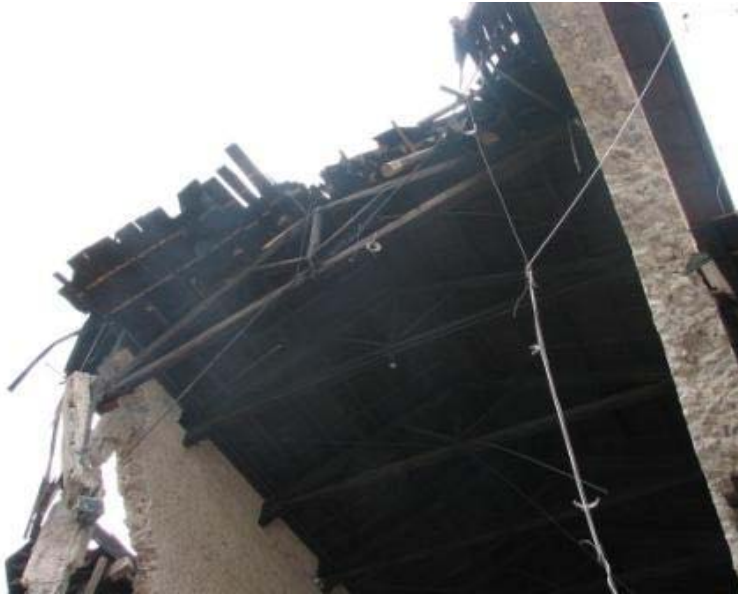
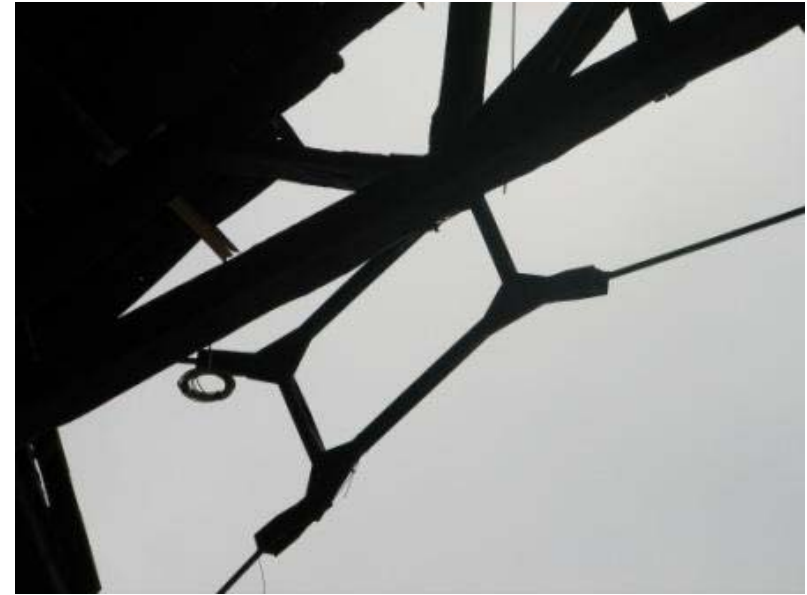
Figure. Hysteretic steel dampers located close to the transept

The steel dampers connected the two walls together making the nave laterally stiffer than the transept

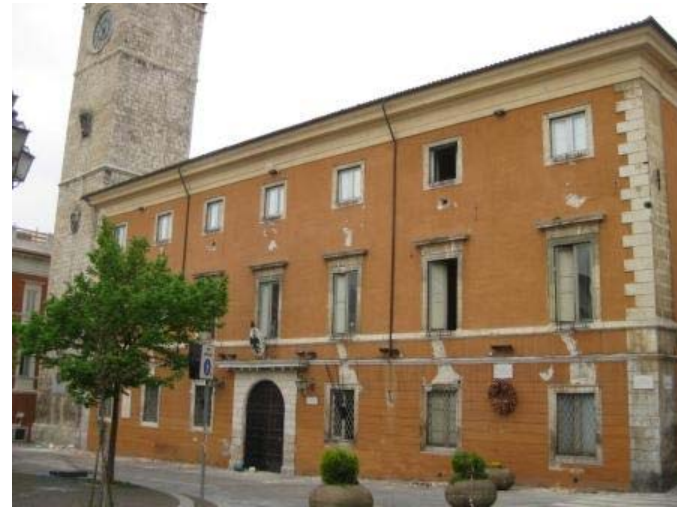
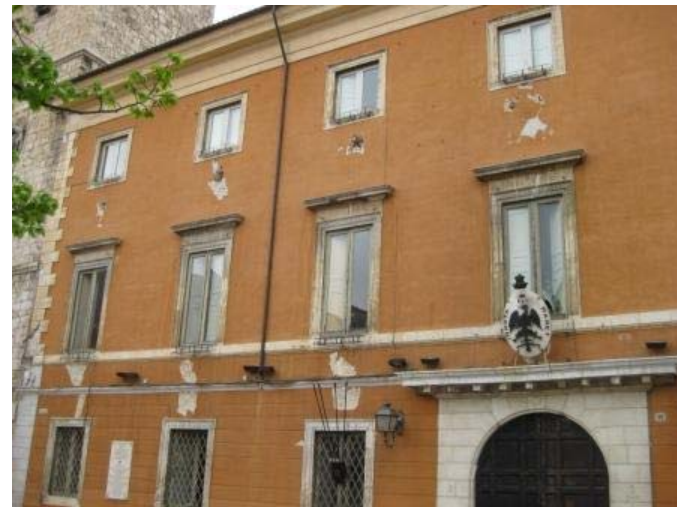
Hammering of the floor beams

- local damage in correspondence of the wall strips in the facade;

- damage to the front facade, due to the hammering of the floor beams;

- Floor slab not effectively connected to the wall masonry.

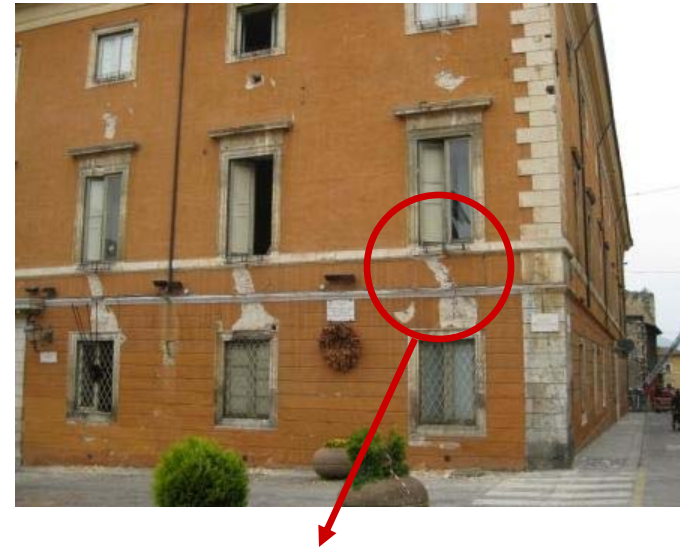
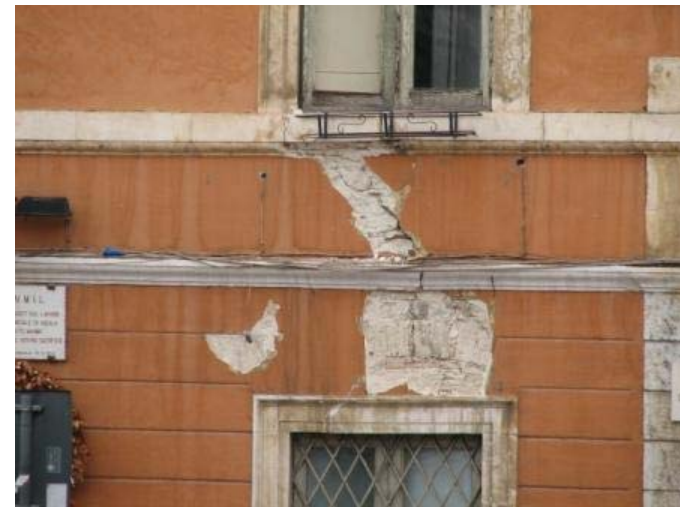
Damage in the wall strips

- typical cross cracks in the wall strips above and below the window openings of the internal arcade;

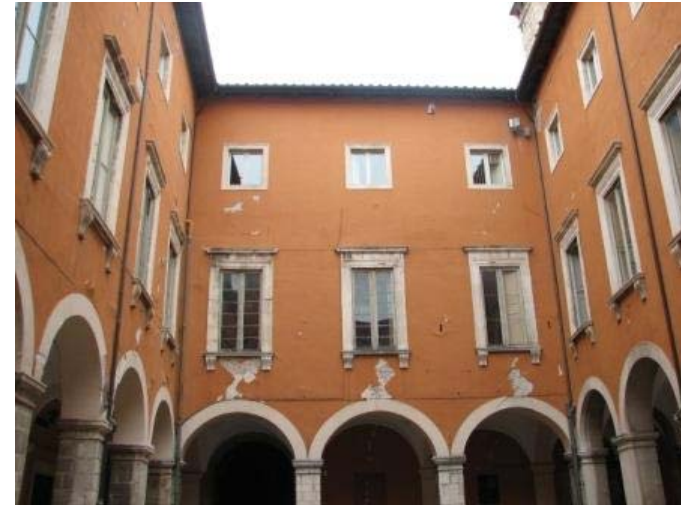
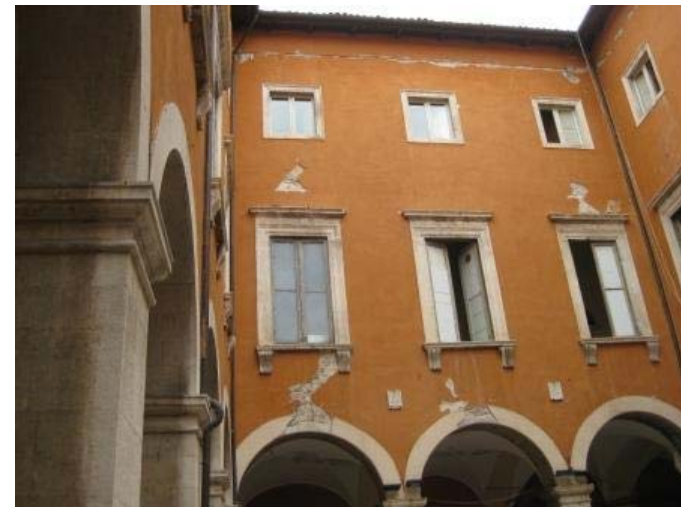
Damage in the wall strips

- typical cross cracks in the wall strips above and below the window openings of the internal arcade;

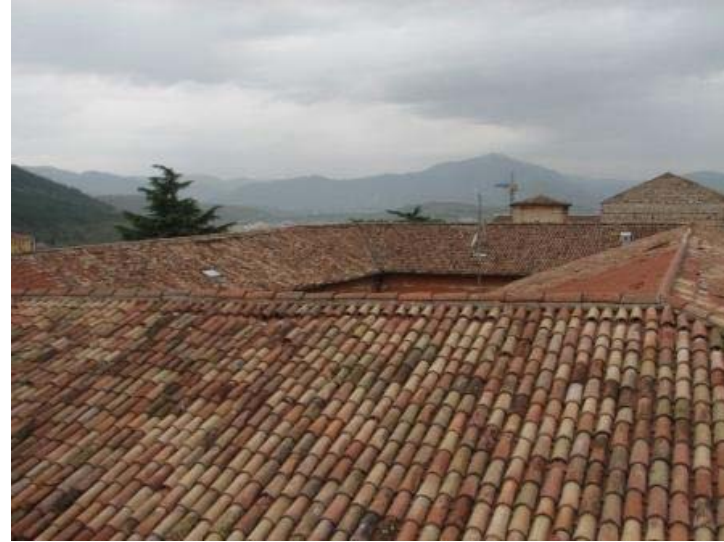
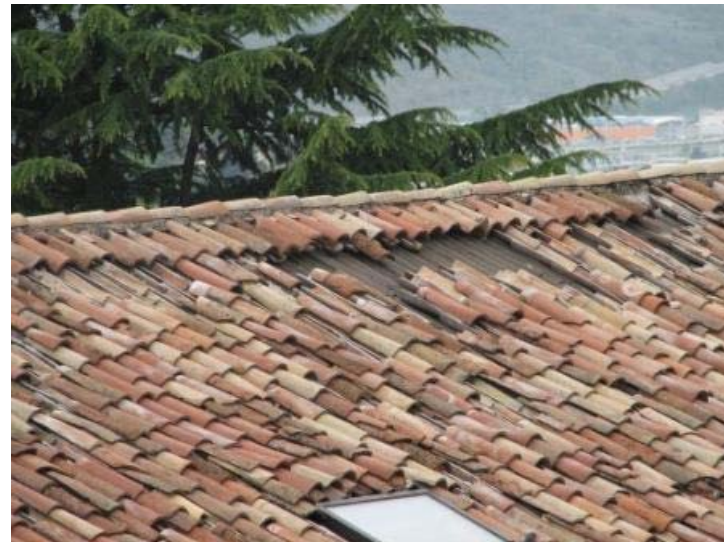
Damage to roof coverage

- Partial sag of the roof coverage and dislocation of tiles;

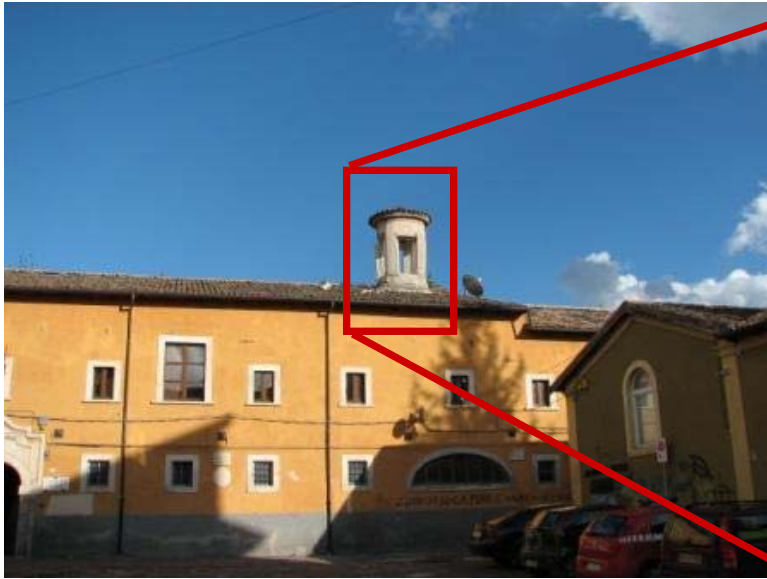
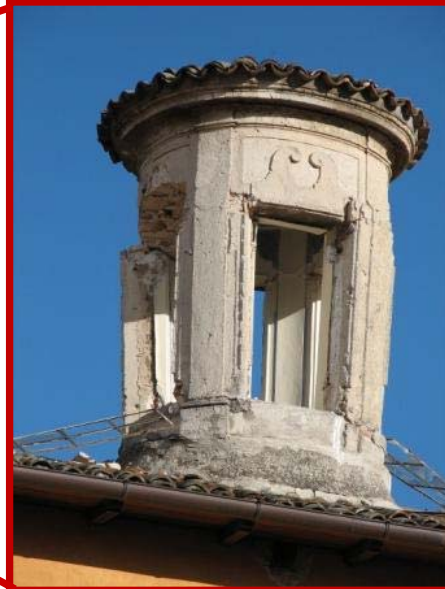
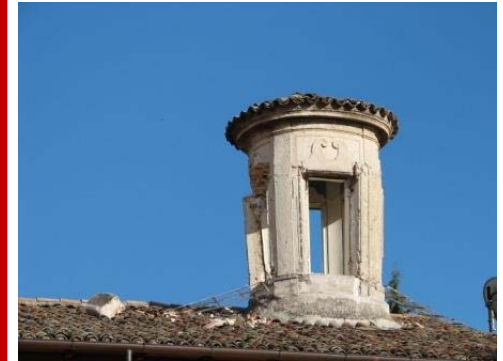
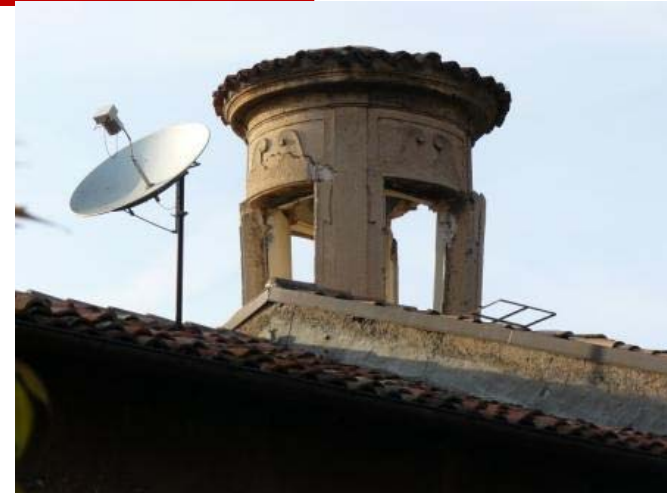
Torsion mechanism of the lantern

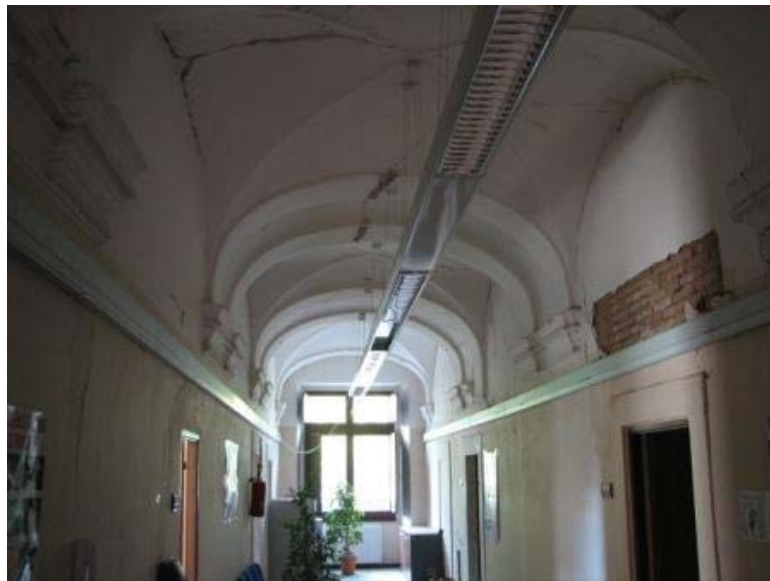
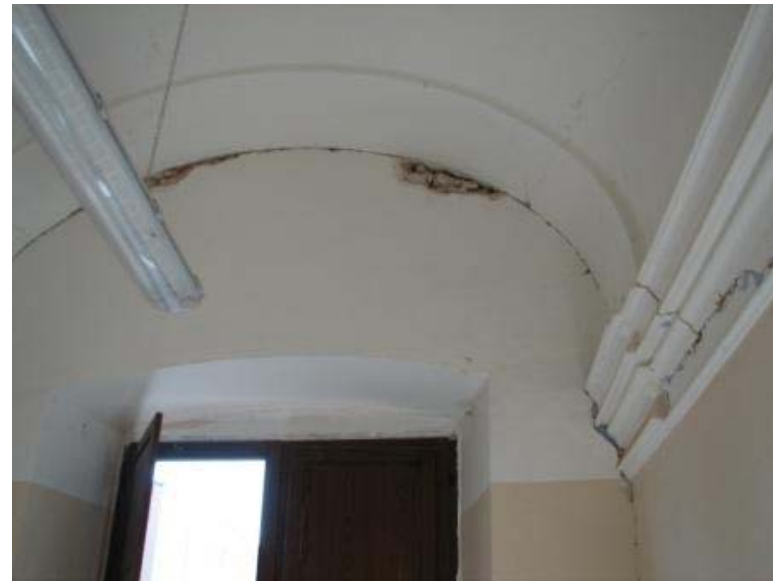
Out-of-plane wall mechanisms of building B

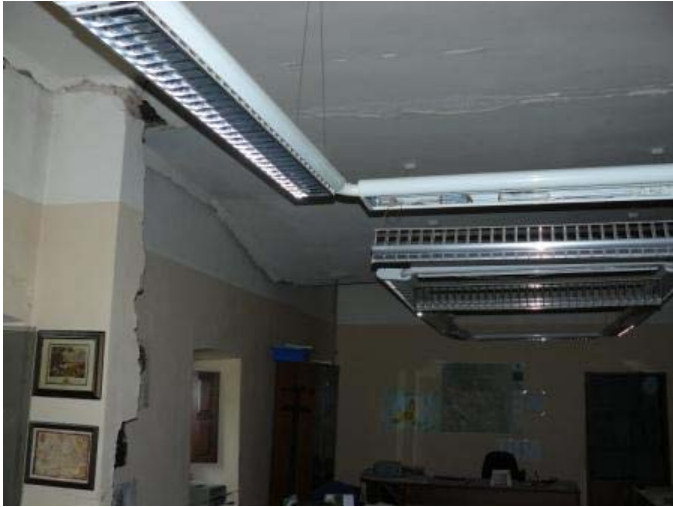
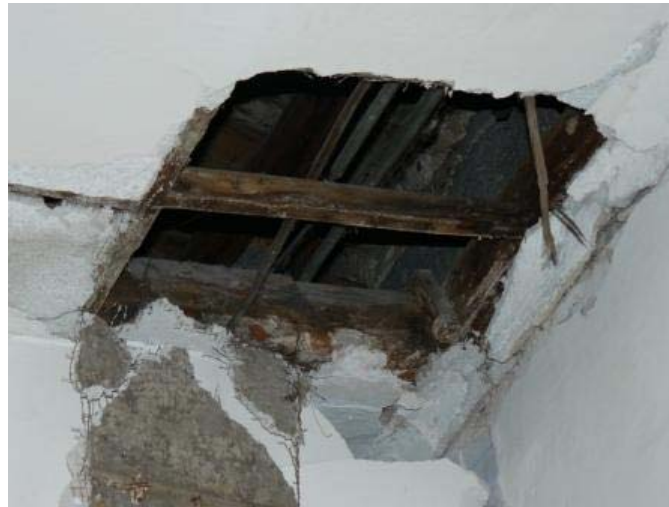
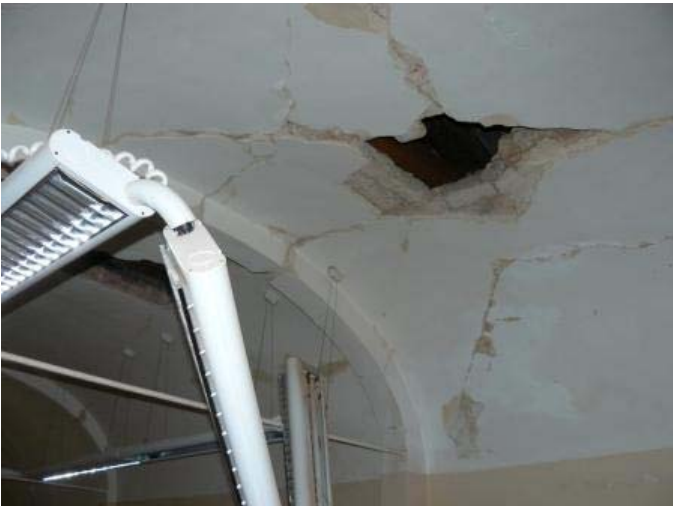
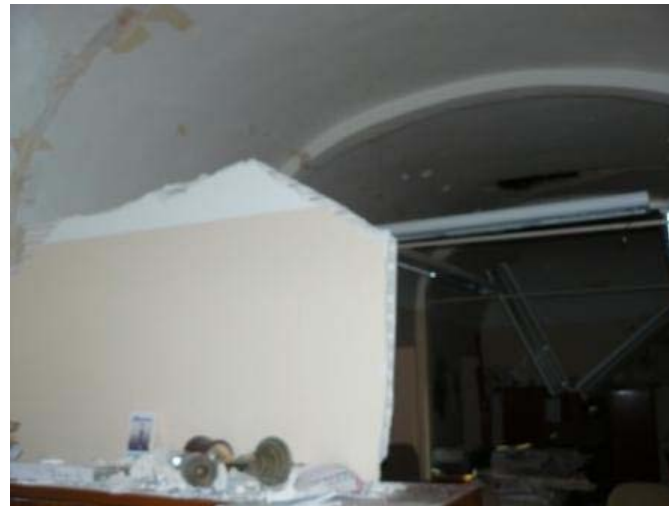
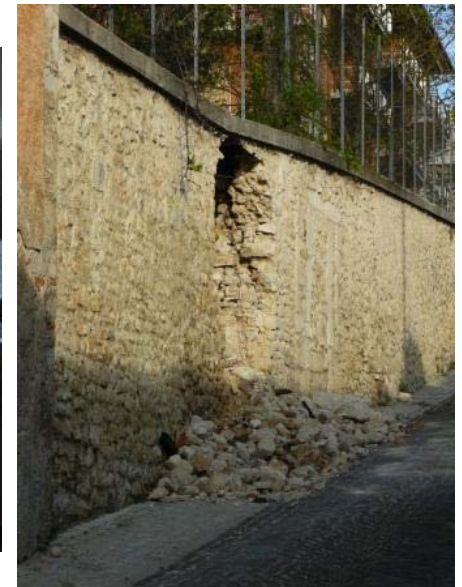
Other damages

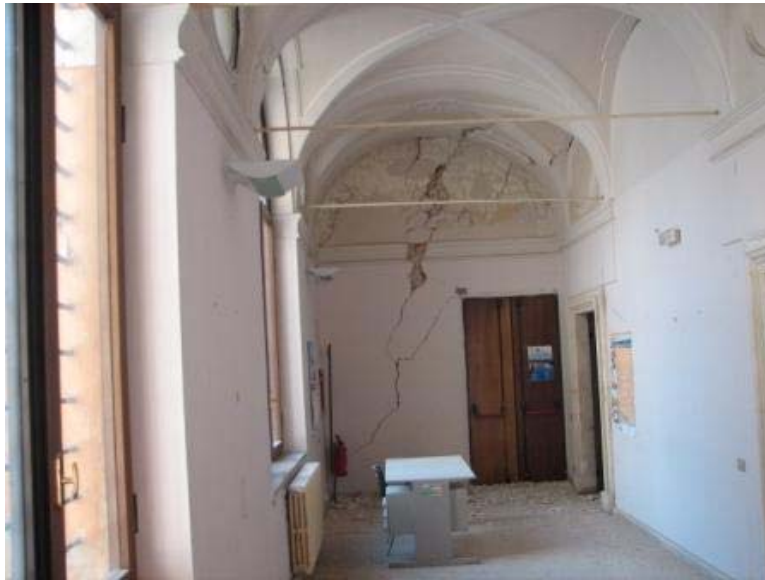
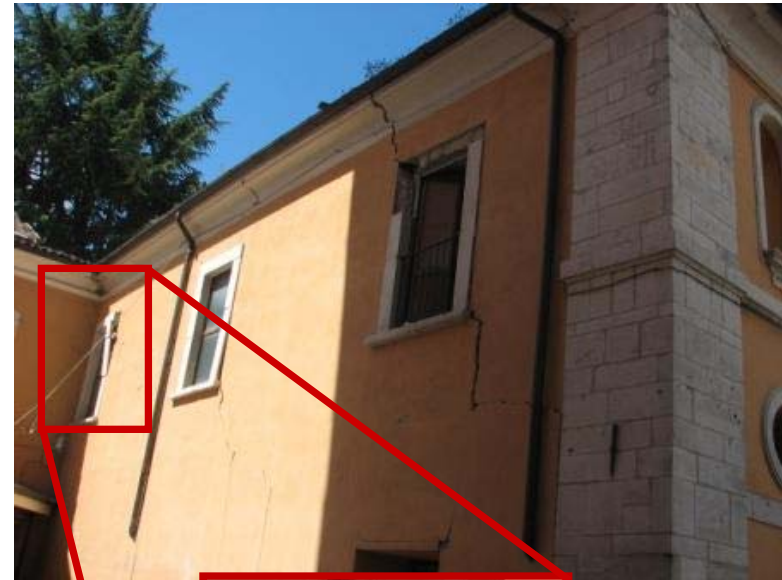
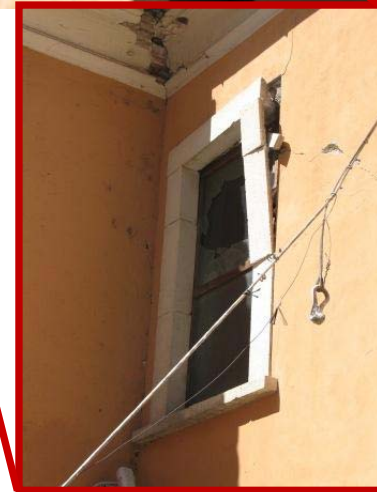
Damage to external walls

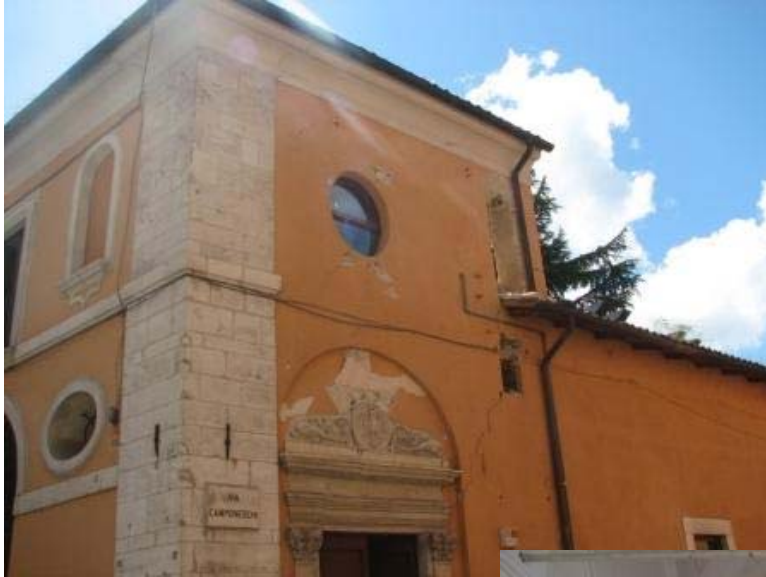
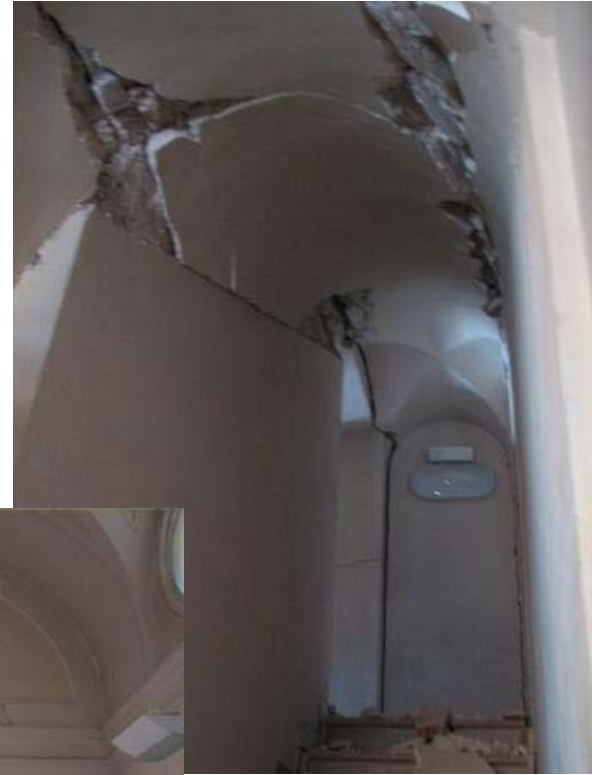
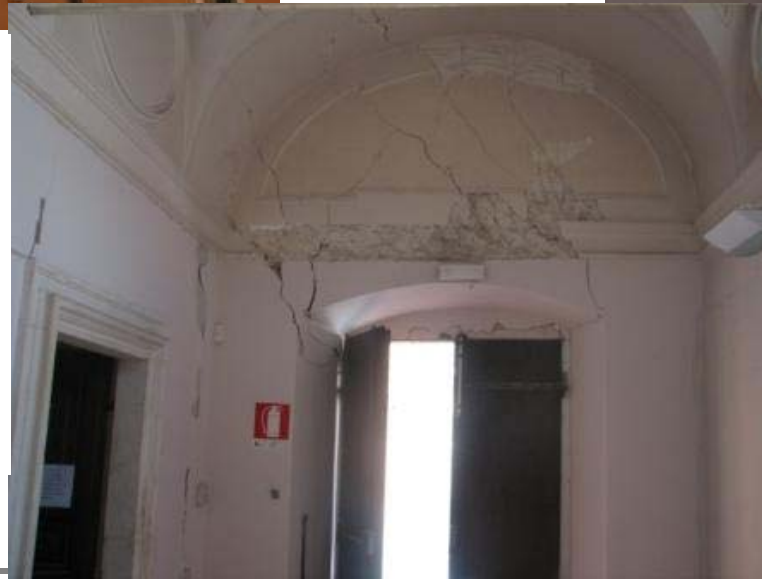
Damage to external walls
