Field reconnaissance following the April 6, 2009 L`Aquila Earthquake in Italy

Gian Paolo Cimellaro

Assistant professor,
Department of Structural and Geotechnical engineering,
Politecnico di Torino

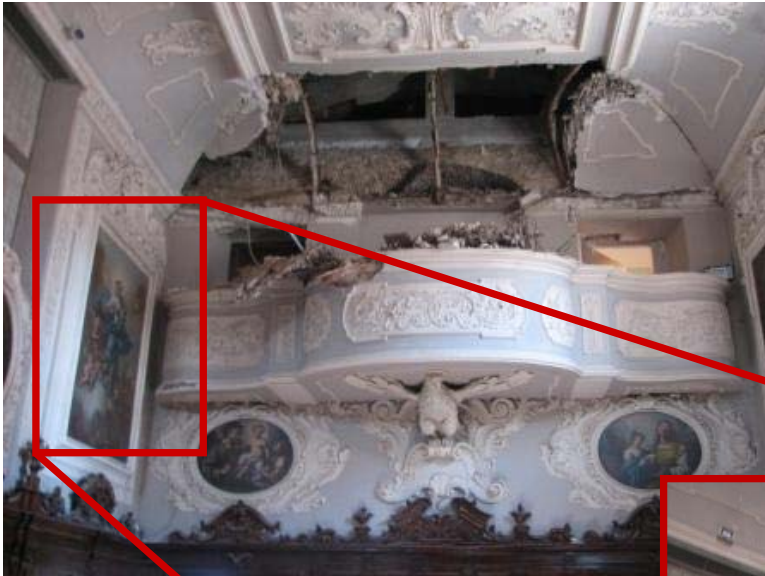
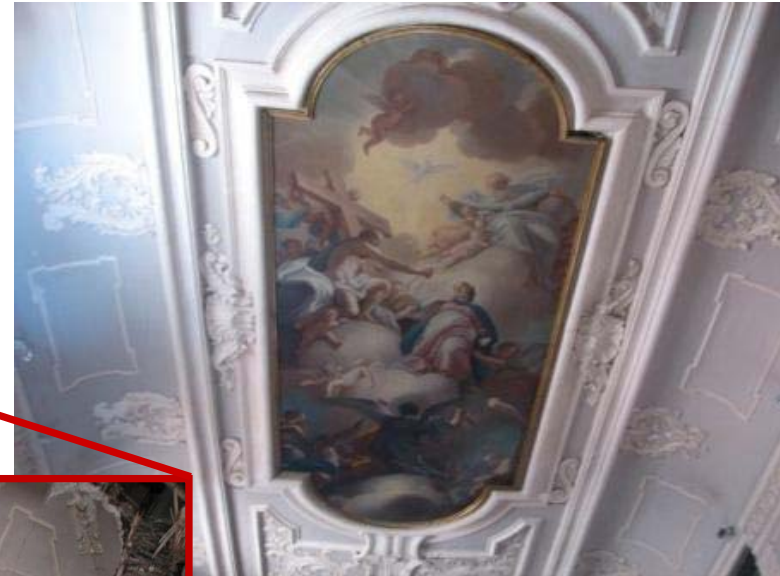
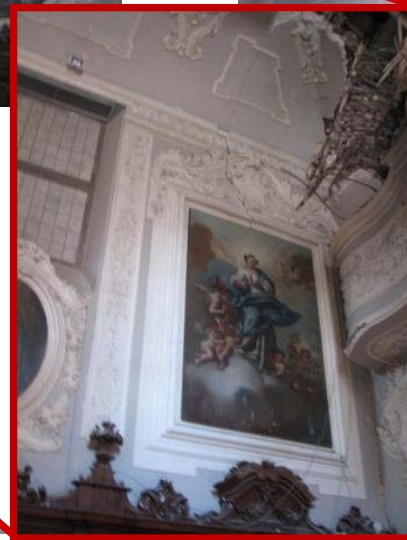
Partial collapse of the wooden cross vault

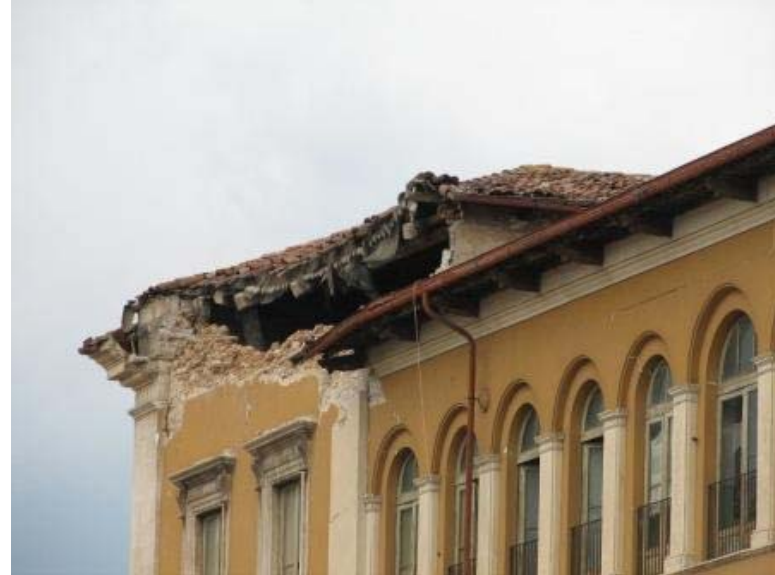
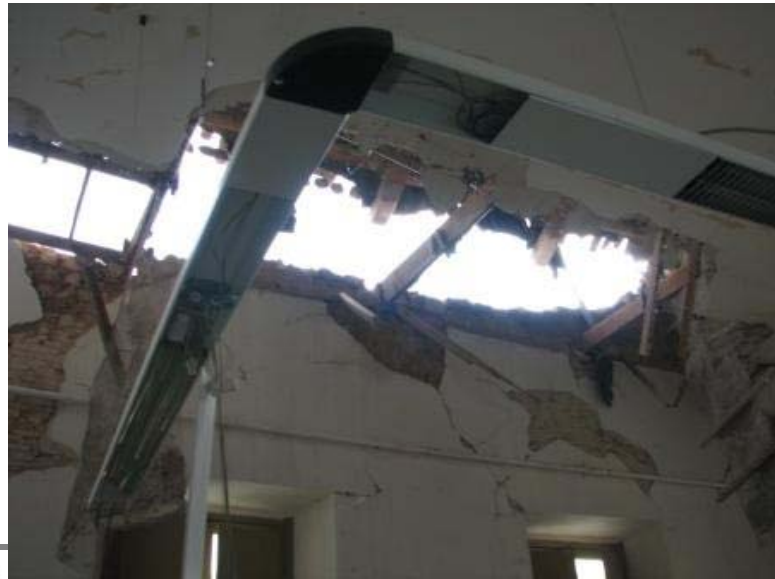
Damage to roof coverage

- Overturning of the upper corner lateral wall;
- Partial collapse of the roof cover;

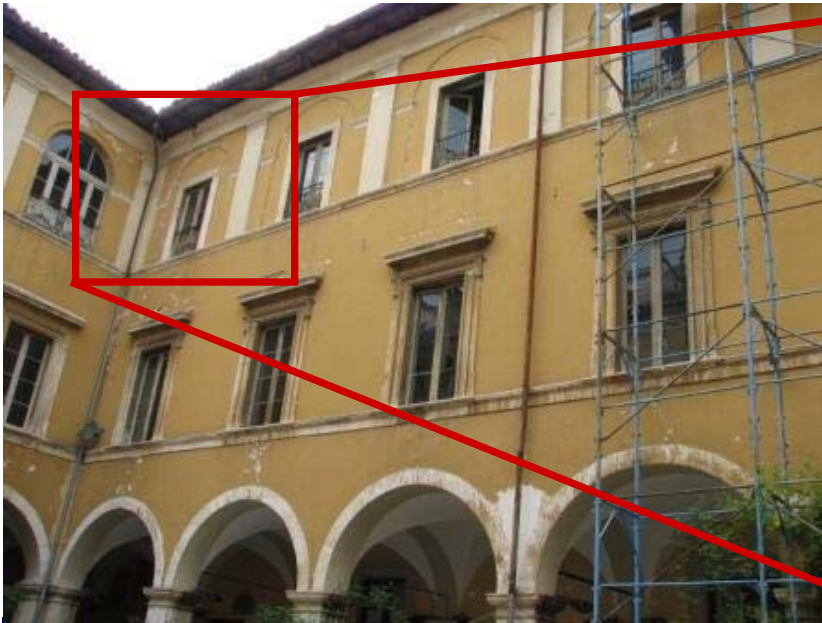
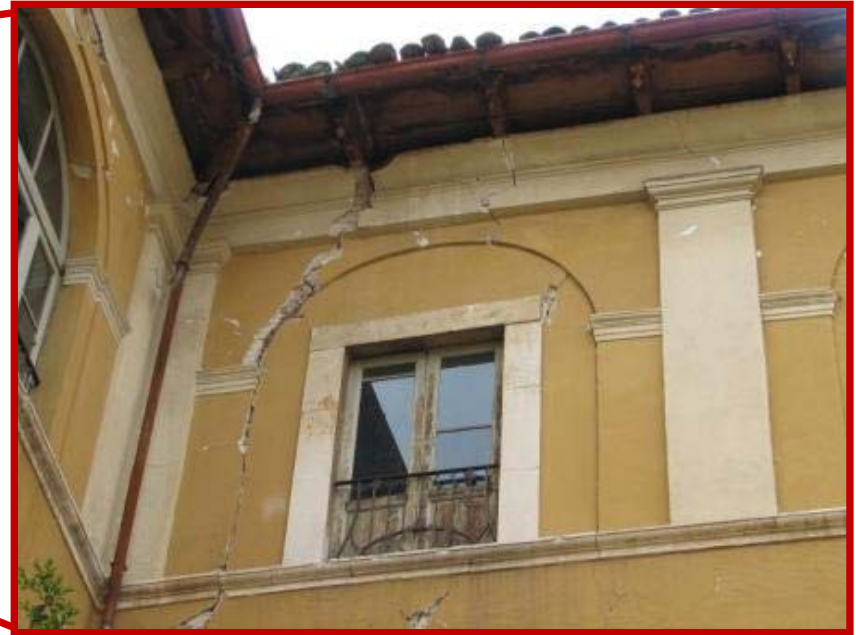
Overturning of the upper corner lateral wall

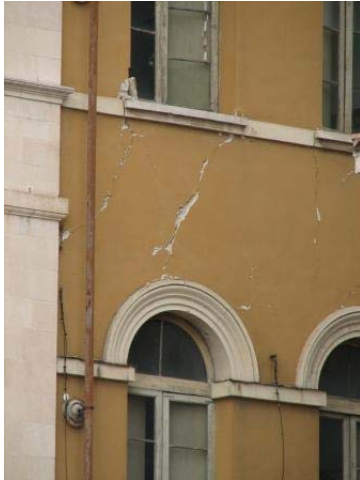
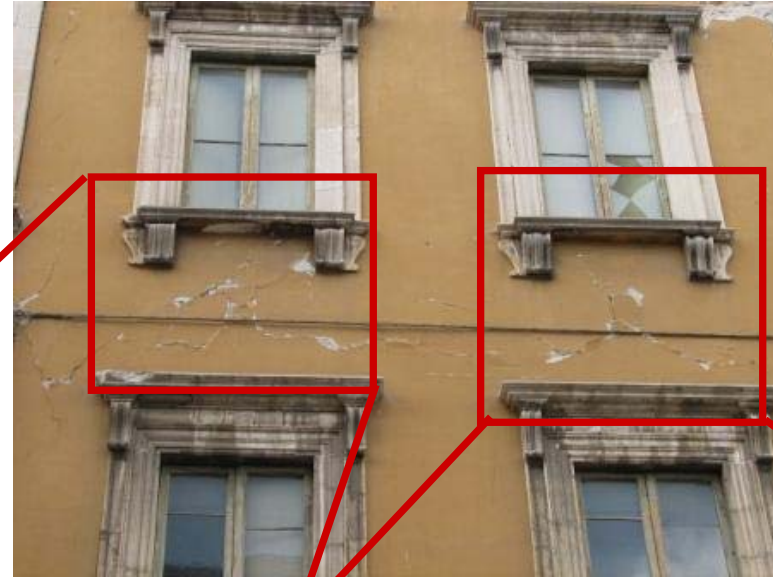
Damage in the wall strips

- typical cross cracks in the wall strips above and below the window openings of the external lateral wall;

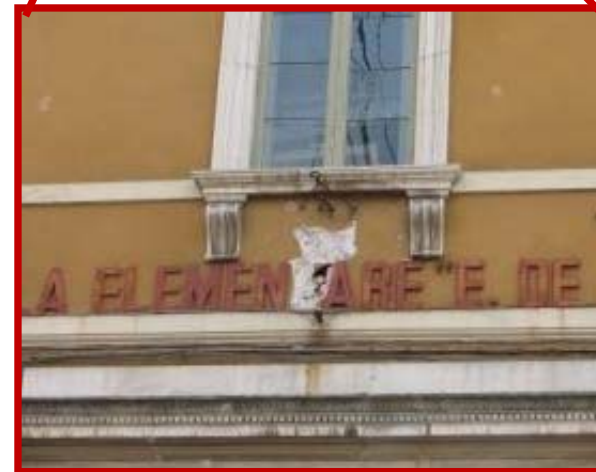
Hammering of the floor beams

- local damage in correspondence of the wall strips in the facade;

- damage to the front facade, due to the hammering of the floor beams;

- Floor slab not effectively connected to the wall masonry.

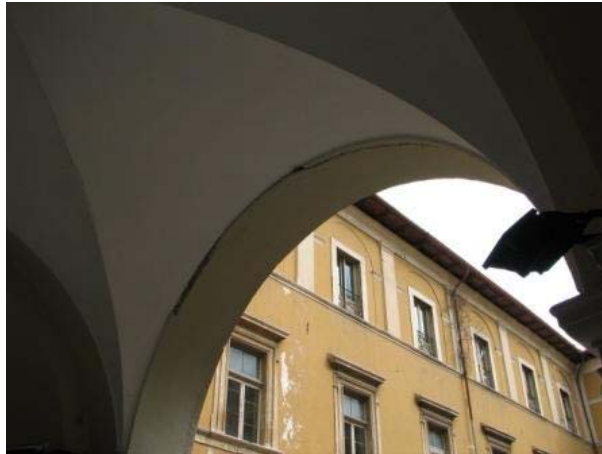
Damage to Arcades

- Overturning of the internal arcades "Loggiato" and of the columns;

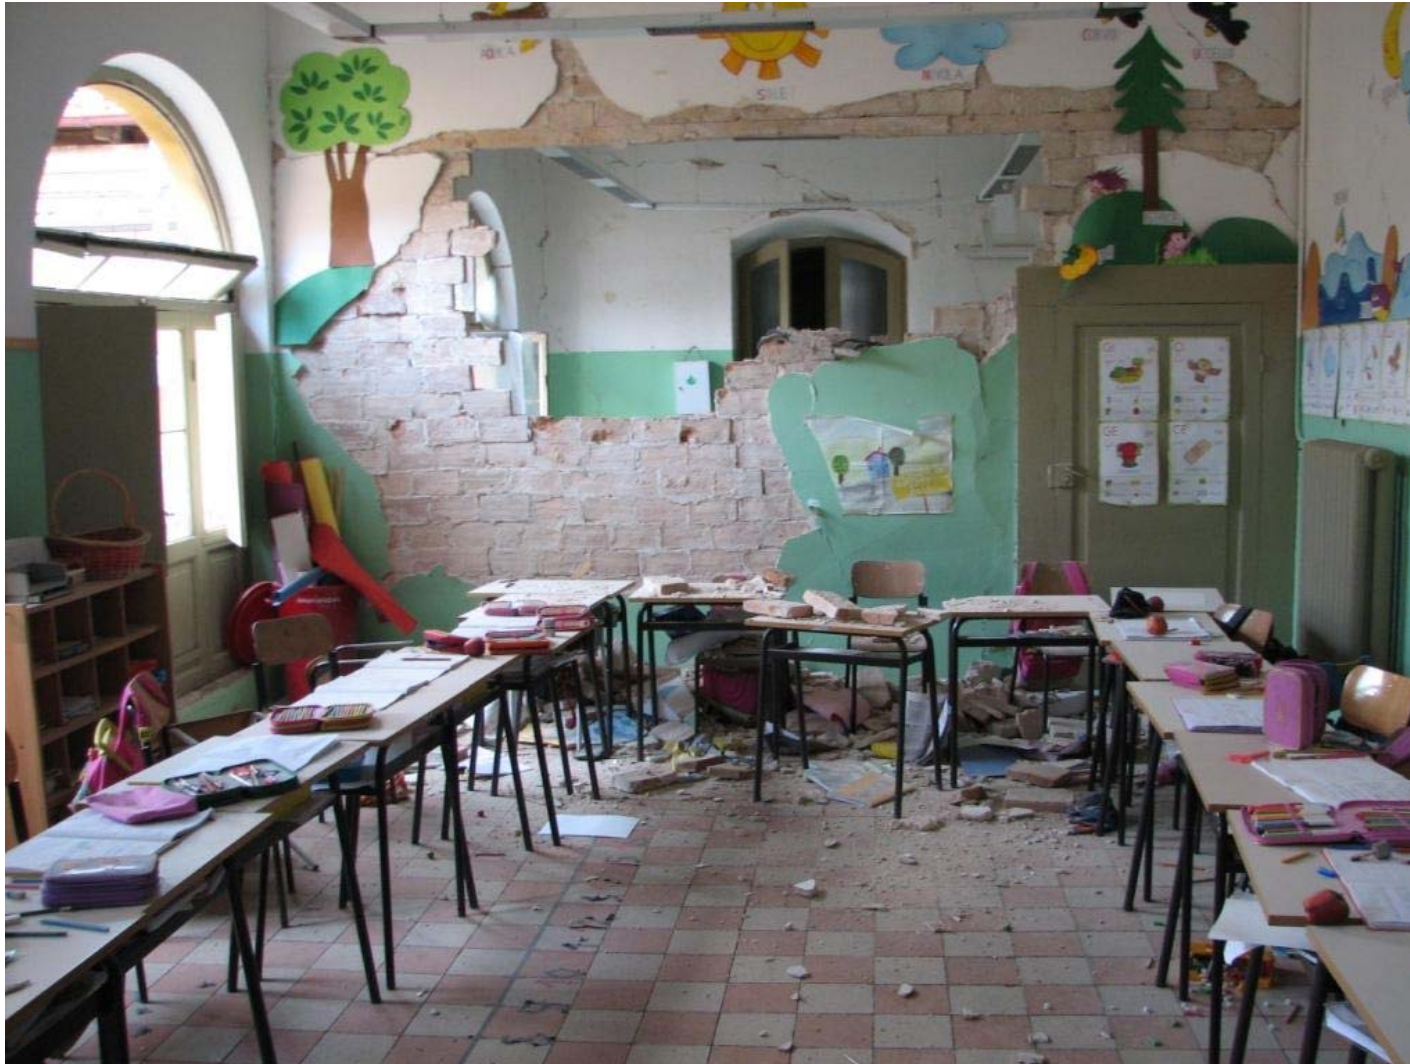
Damage in the internal partition walls

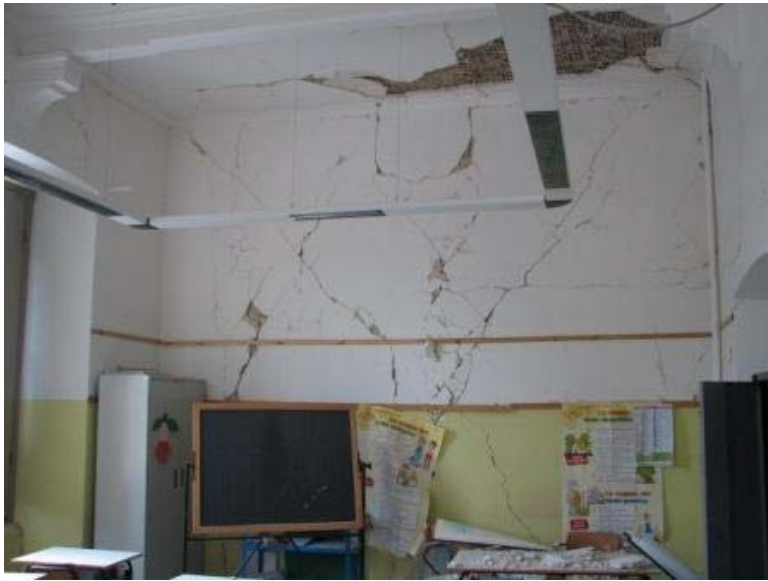
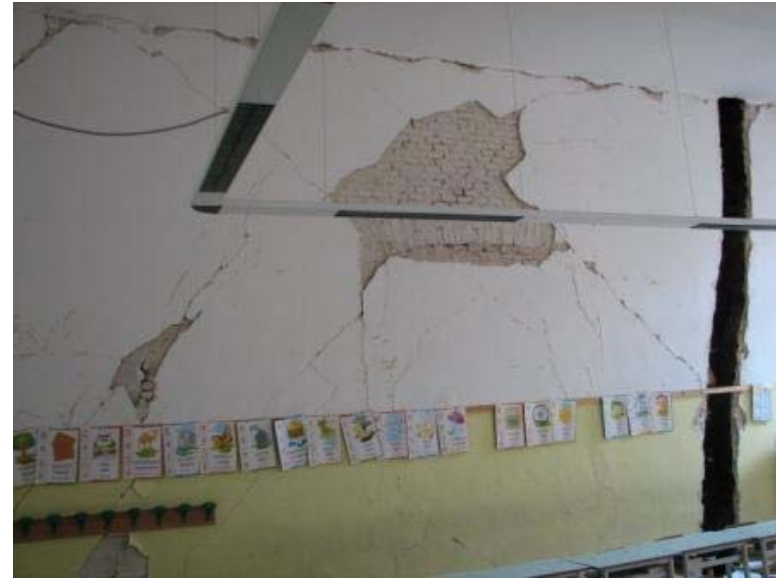
Damage in the internal walls

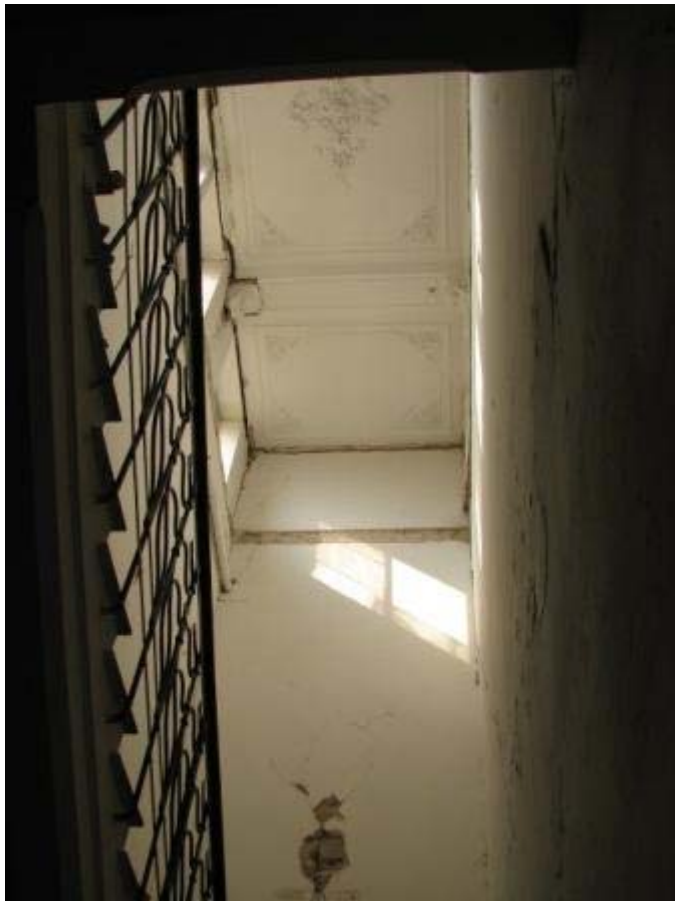
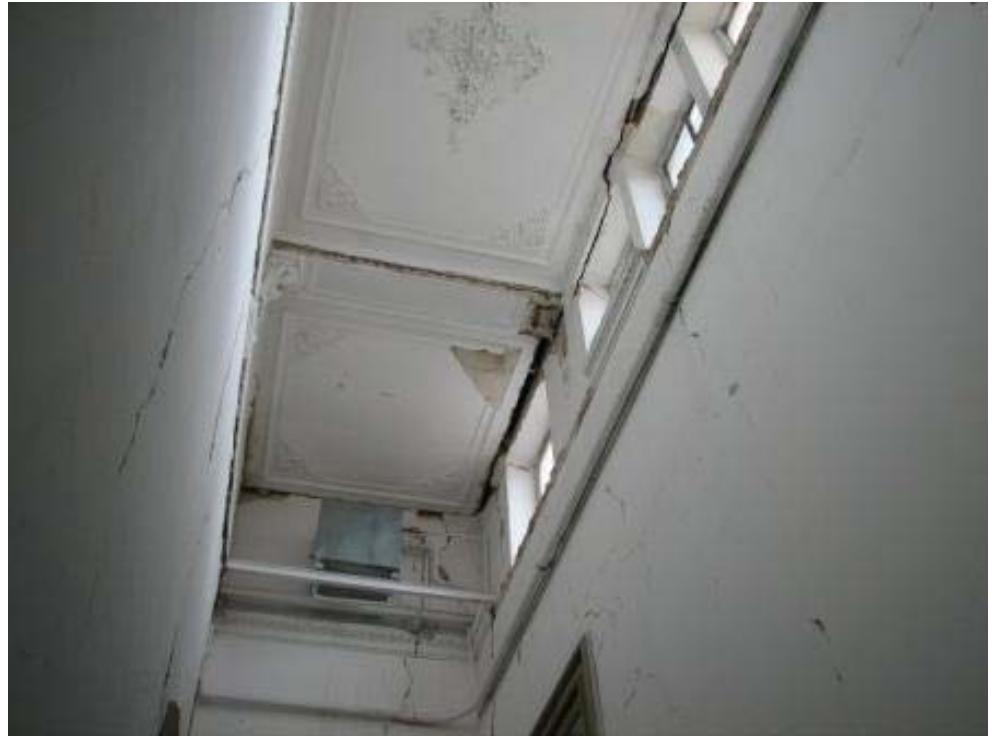
Damage in the stairs

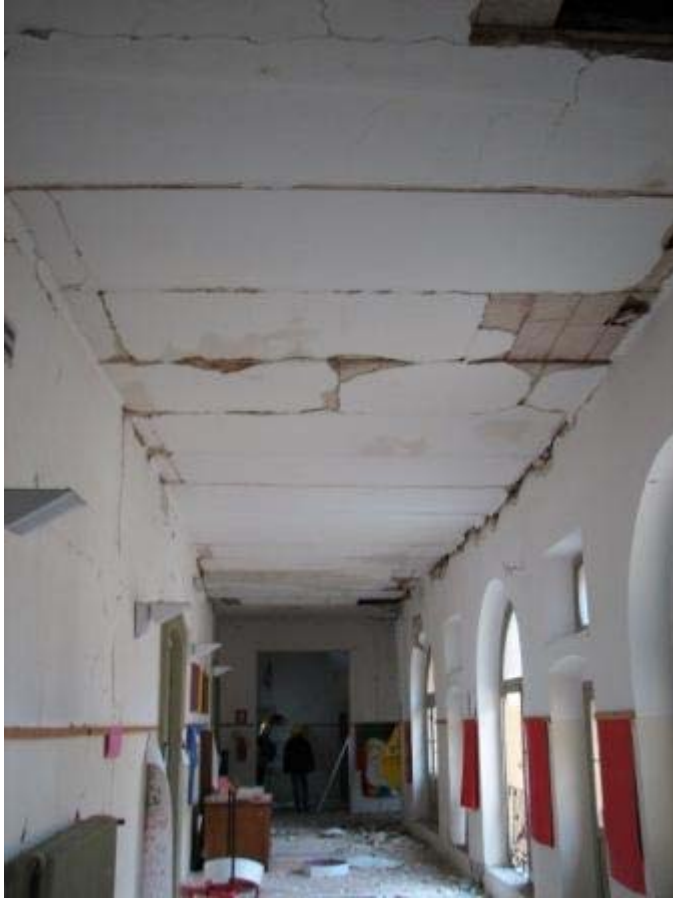
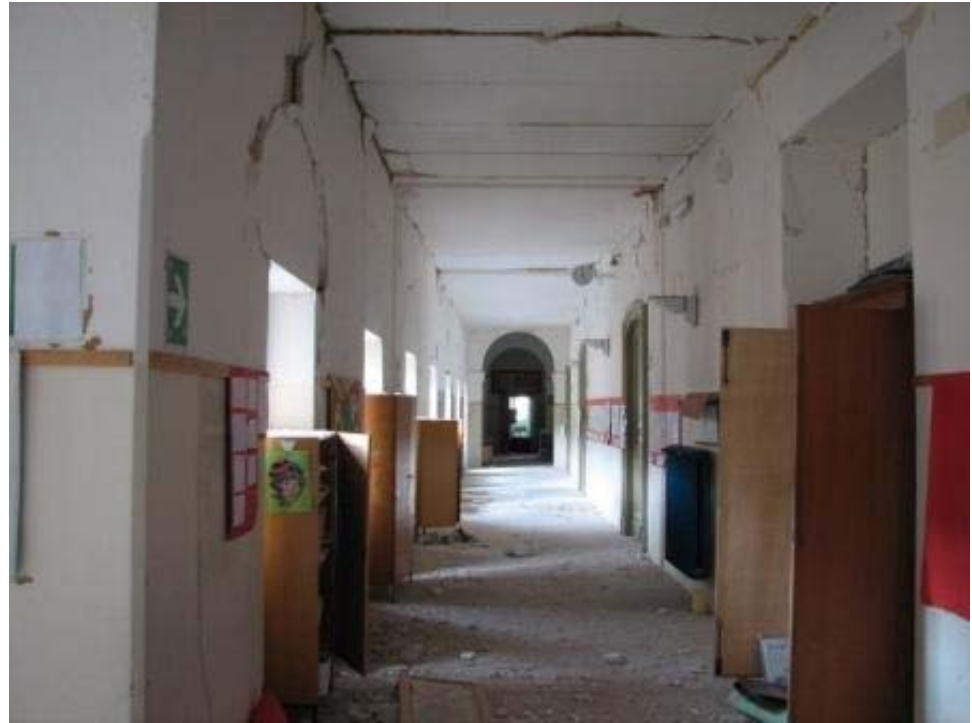
Damage to roof ceilings

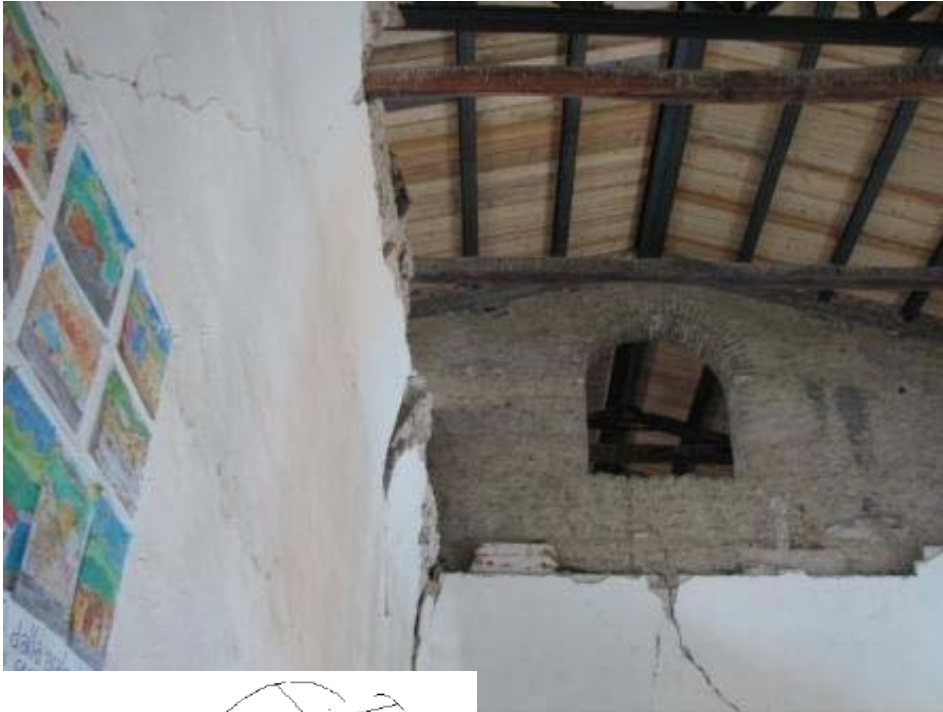
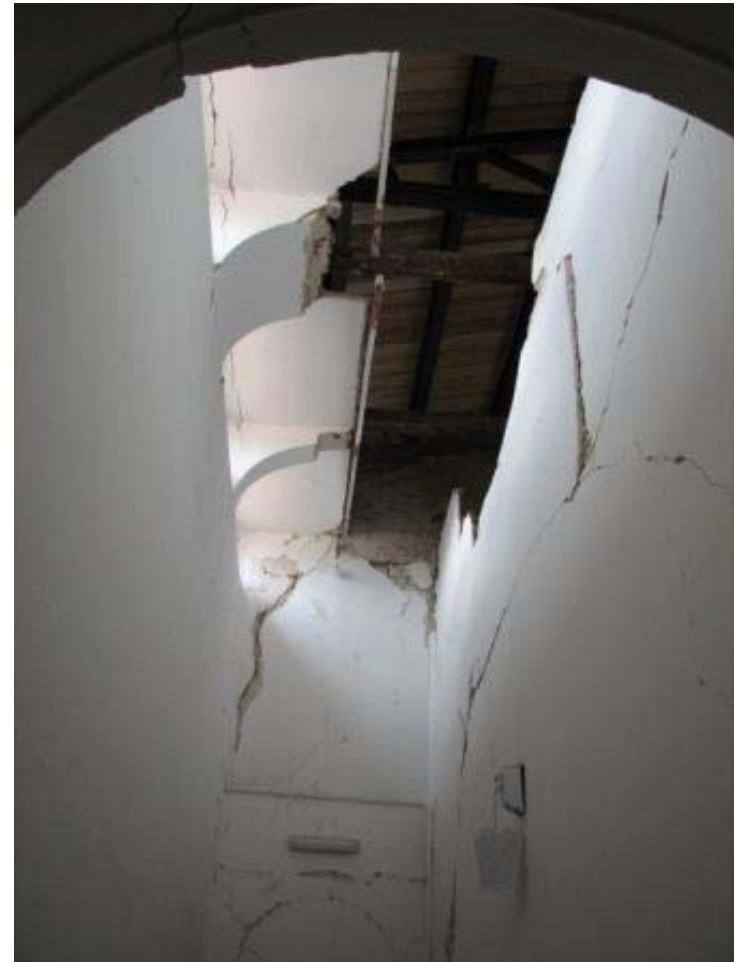
Collapse of the Vault

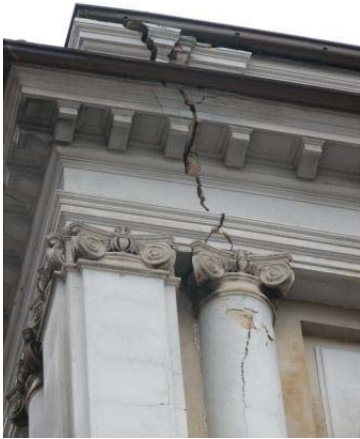
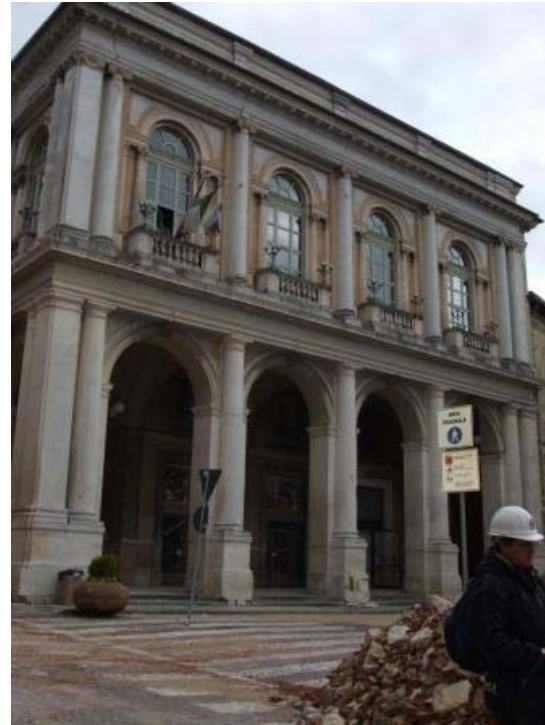
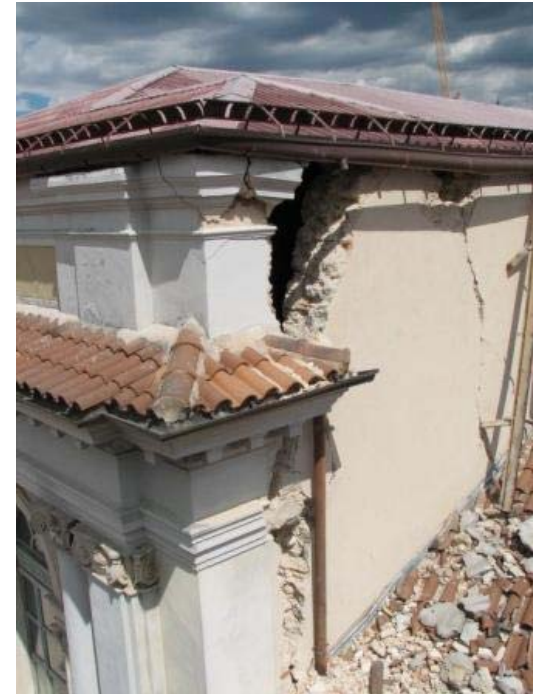
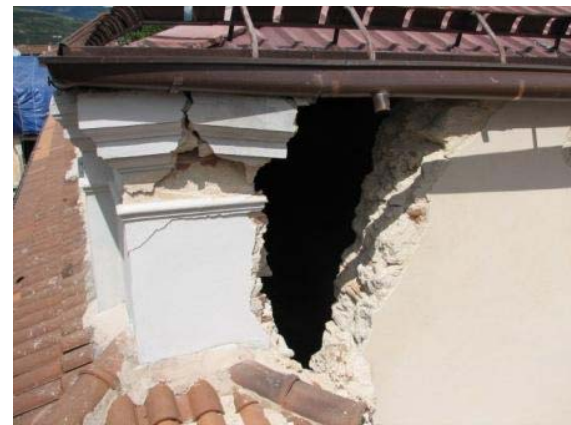
- Severe overturning of the façade with signs of compressions on the column of the ground floor;
- Severe shear cracks on the strip and keep walls;
- The internal vaults in the stairs are seriously damaged;

Overturning of the Facade

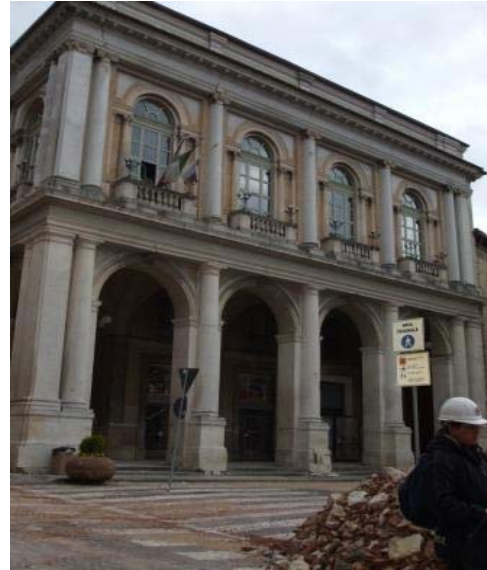
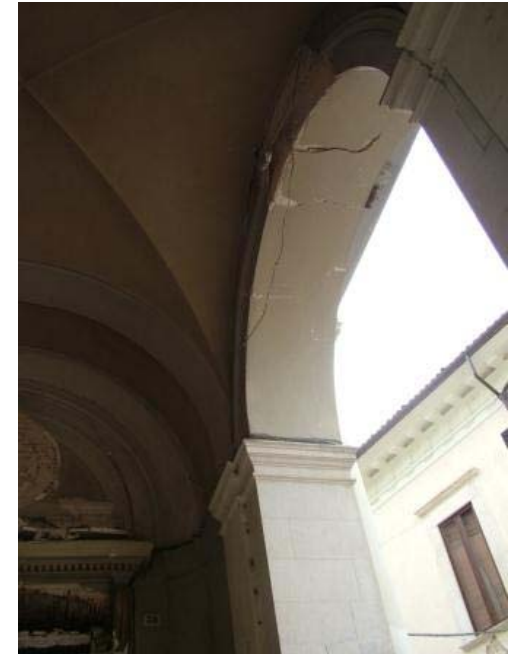
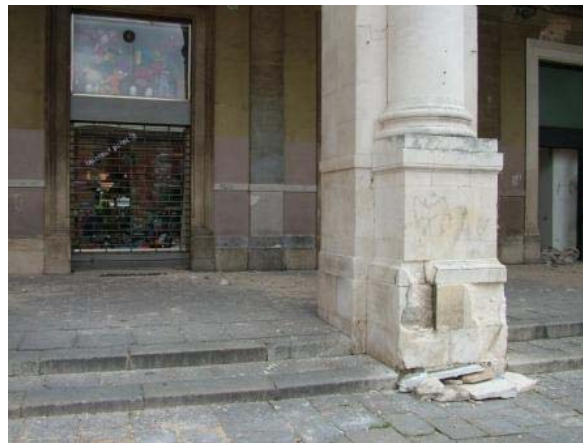
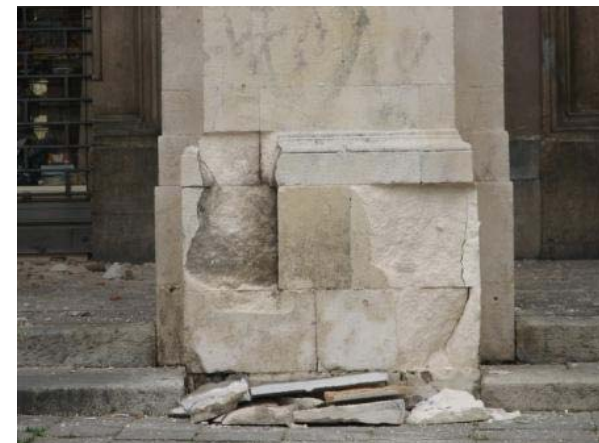
Compression in the columns of the facade

- Compression damage to the columns of the arcade due to the overturning of the façade;

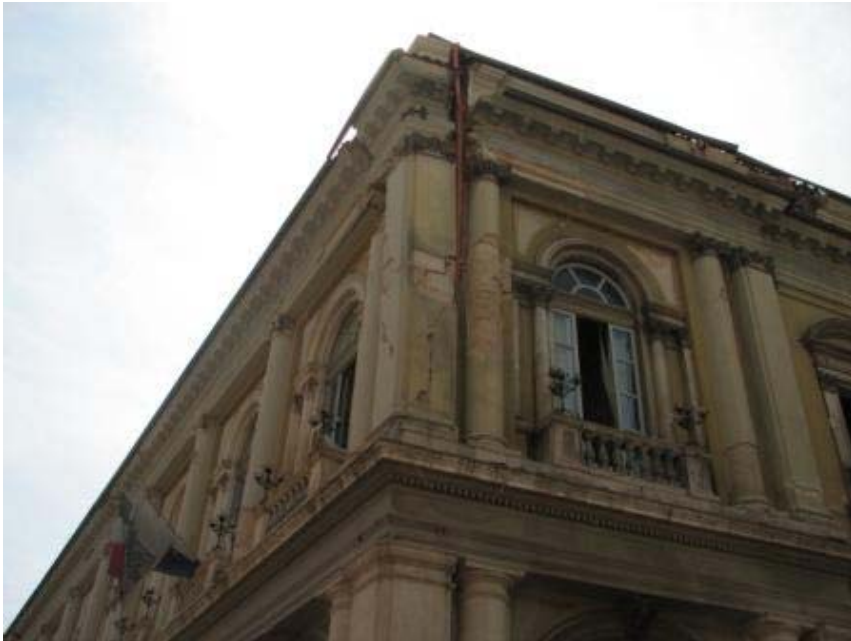
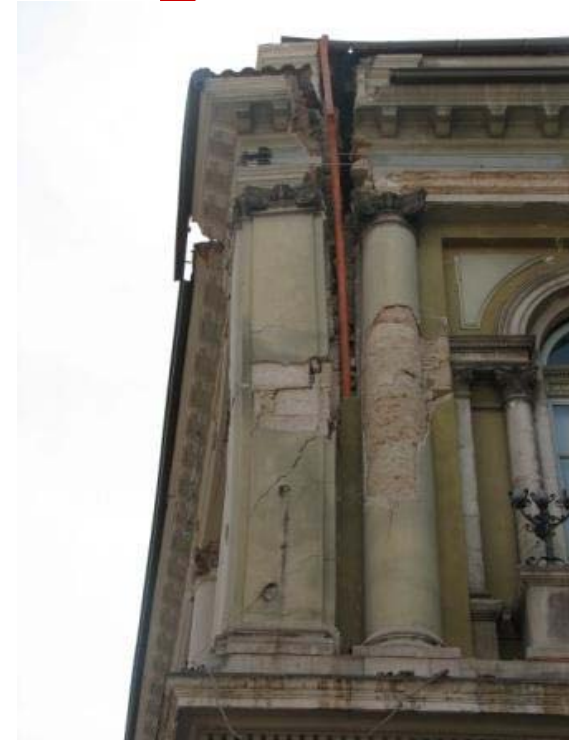
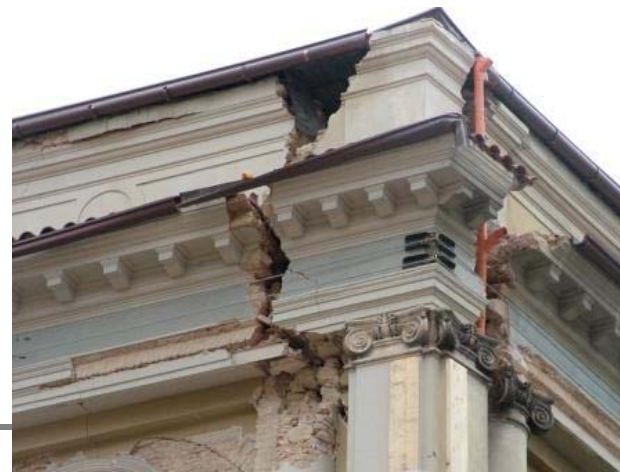
Composite overturning of the walls

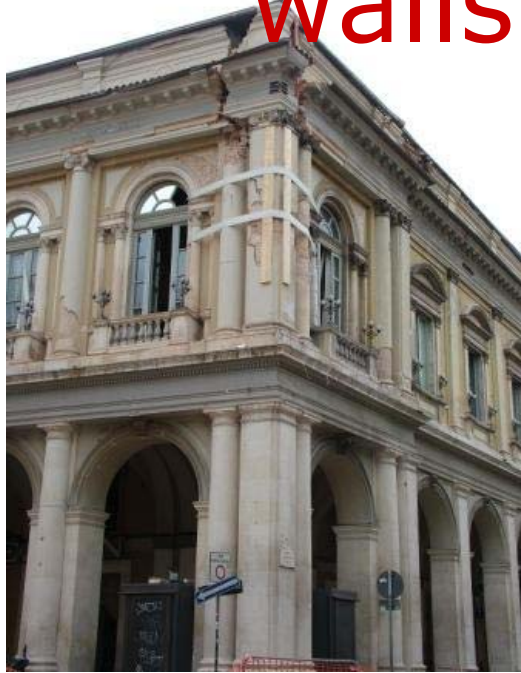
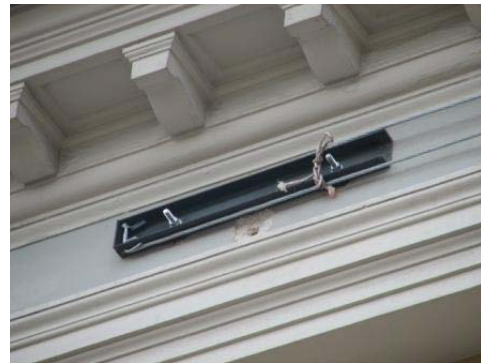
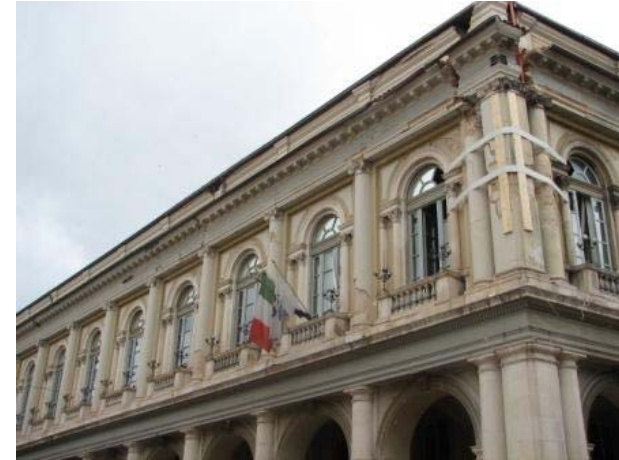
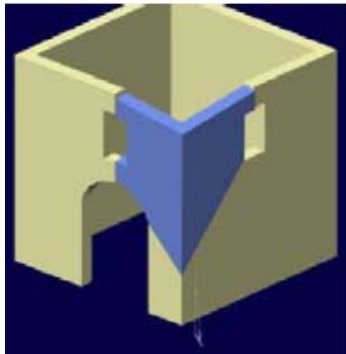
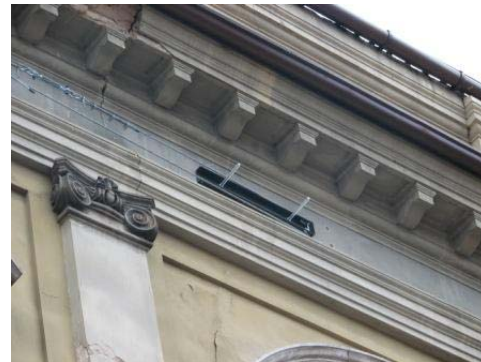
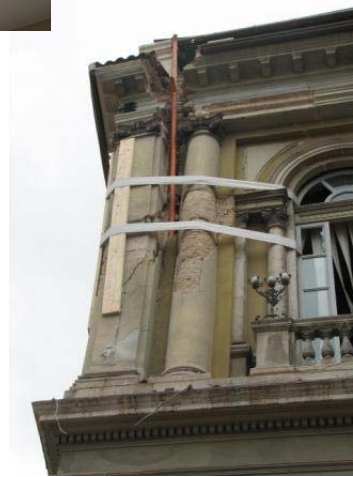
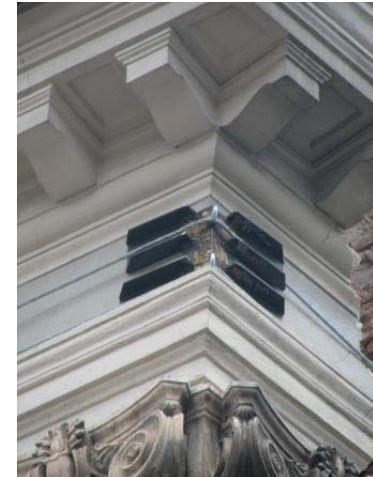
Composite overturning of the walls (Shore-up Intervention)

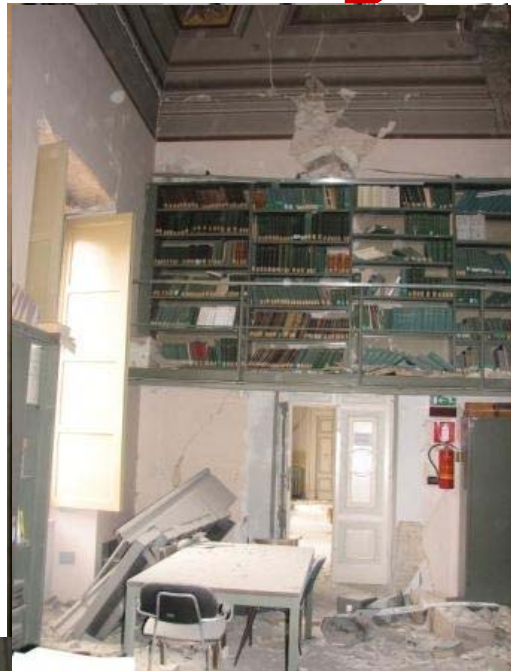
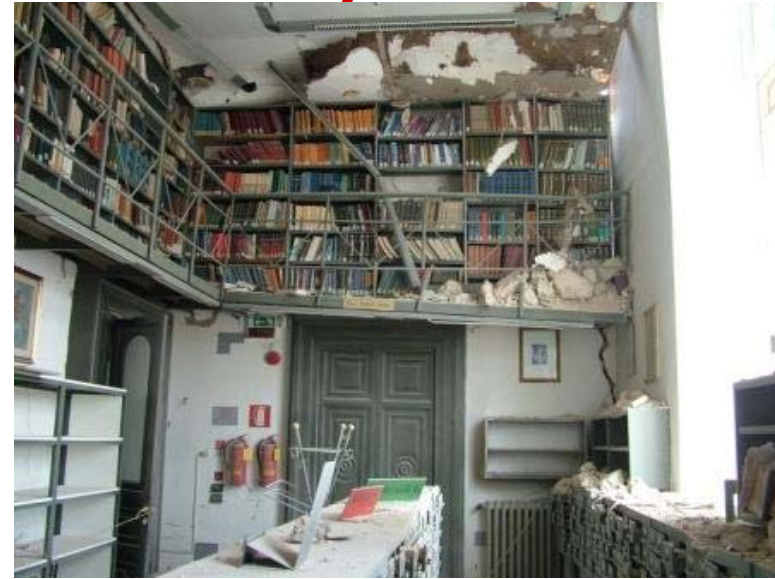
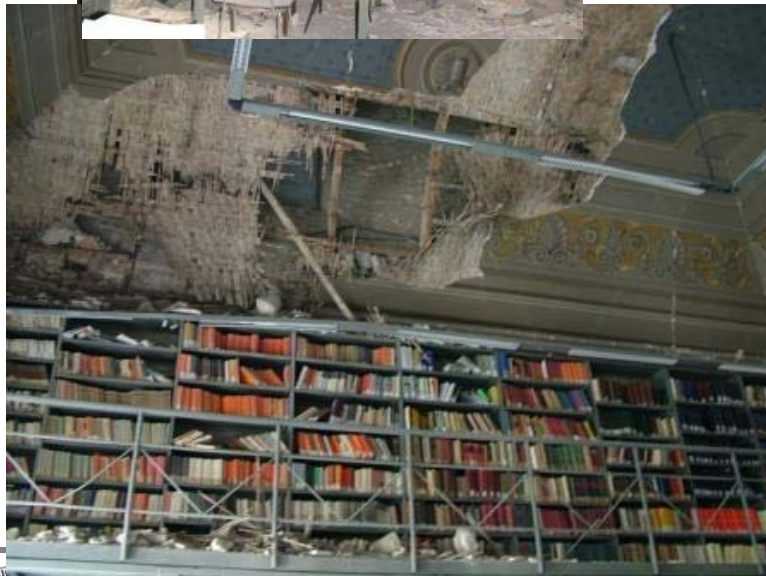
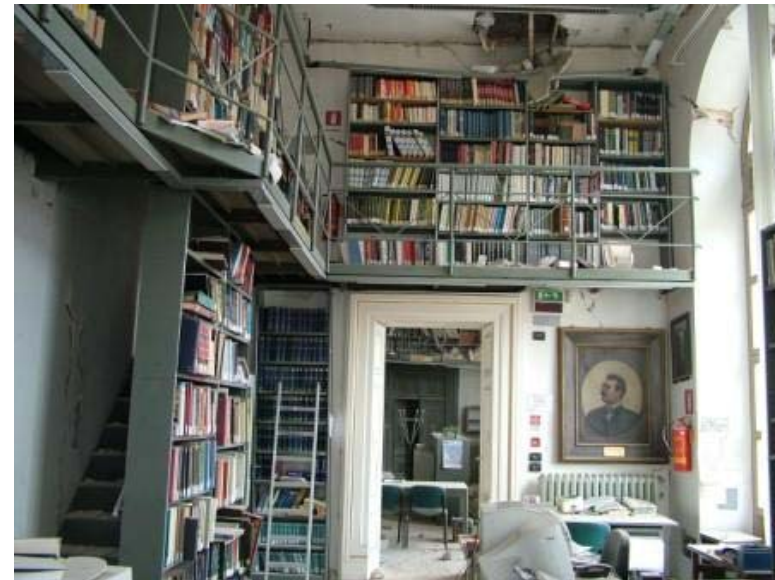
Damage to the library shelves

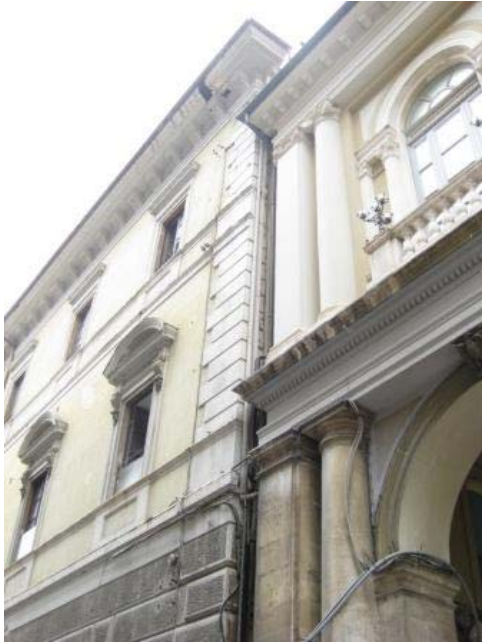
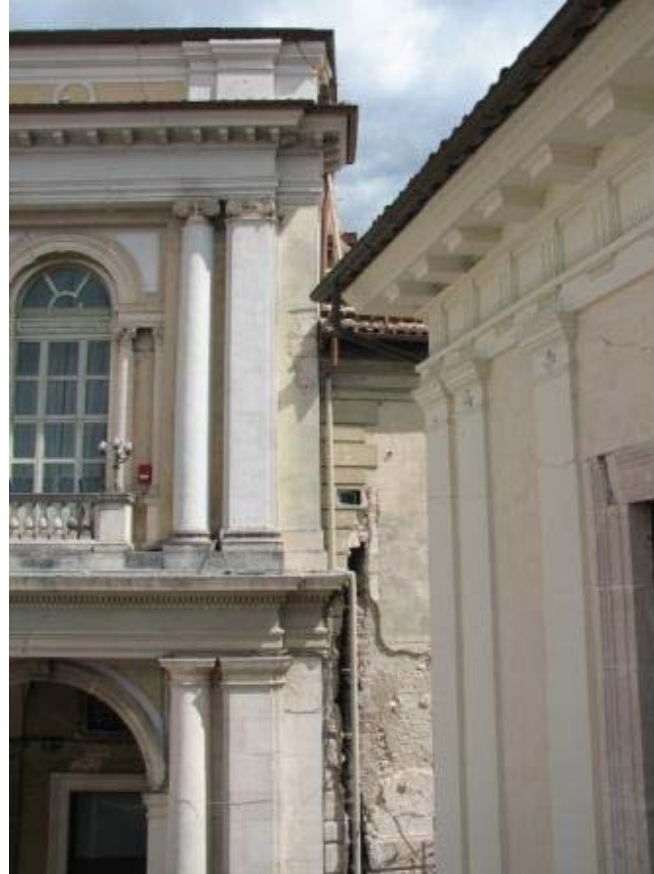
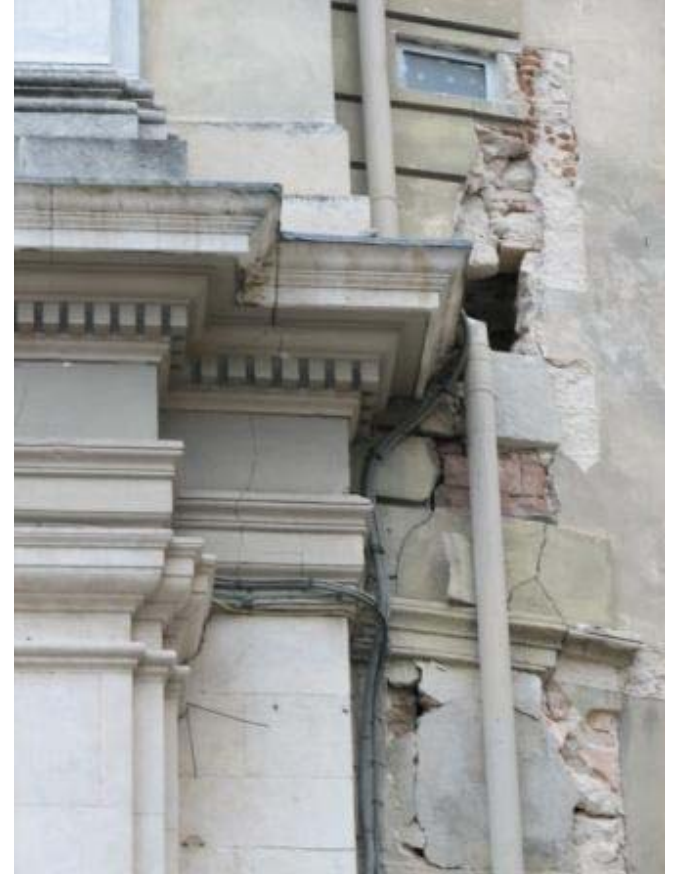
Pounding

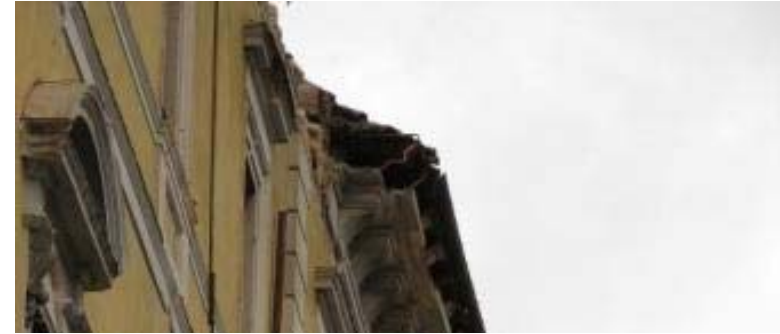
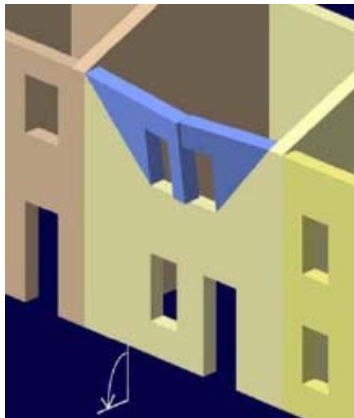
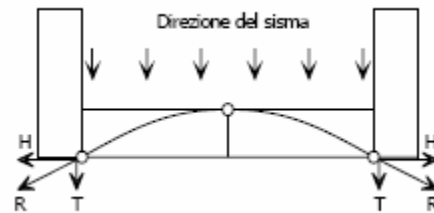
Total collapse of the vaults of the arcades

- poor construction of the masonry vaults.

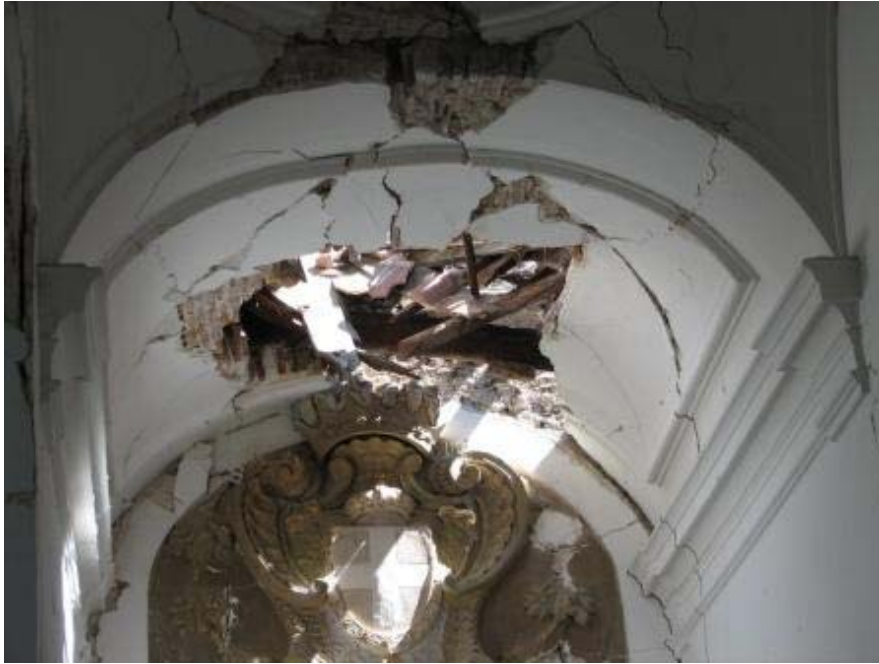
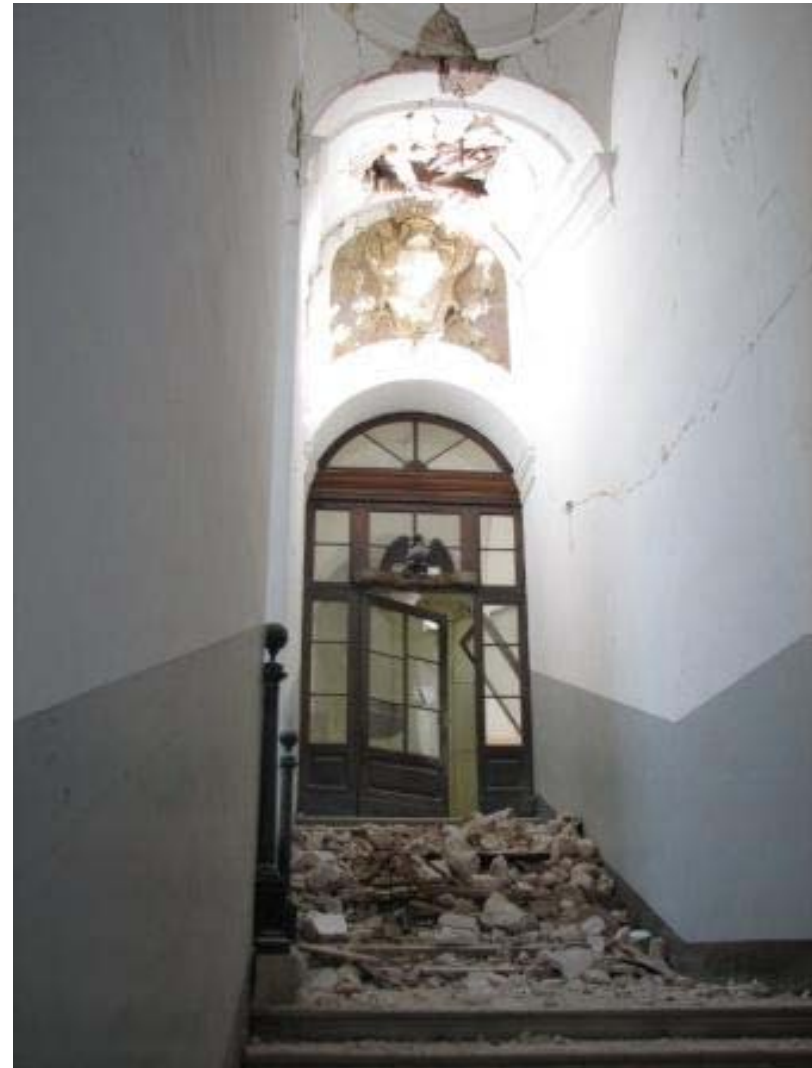
Damage for irregular shape

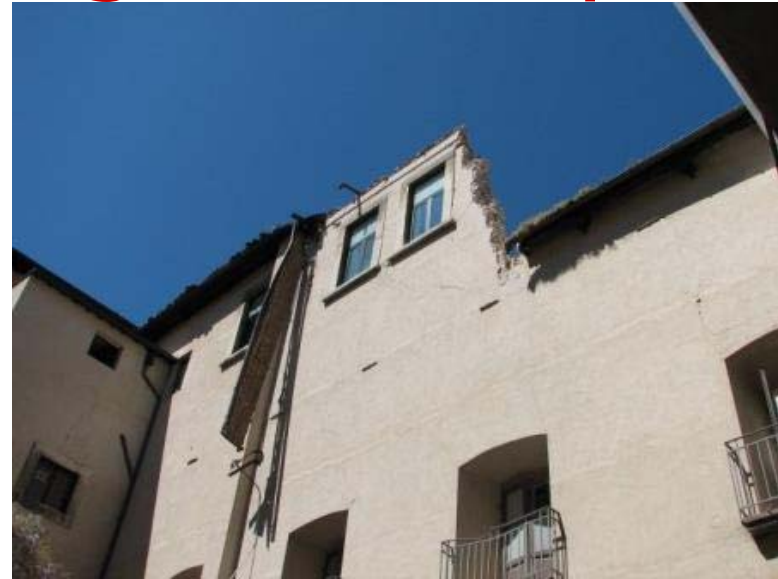
Structural causes:

- structural shape irregularities and poor masonry quality;

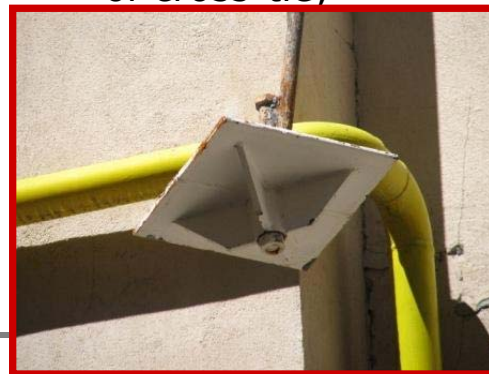
Total disconnection
of cross-tie;
