Field reconnaissance following the April 6, 2009 L`Aquila Earthquake in Italy

Gian Paolo Cimellaro

Assistant professor,
Department of Structural and Geotechnical engineering,
Politecnico di Torino

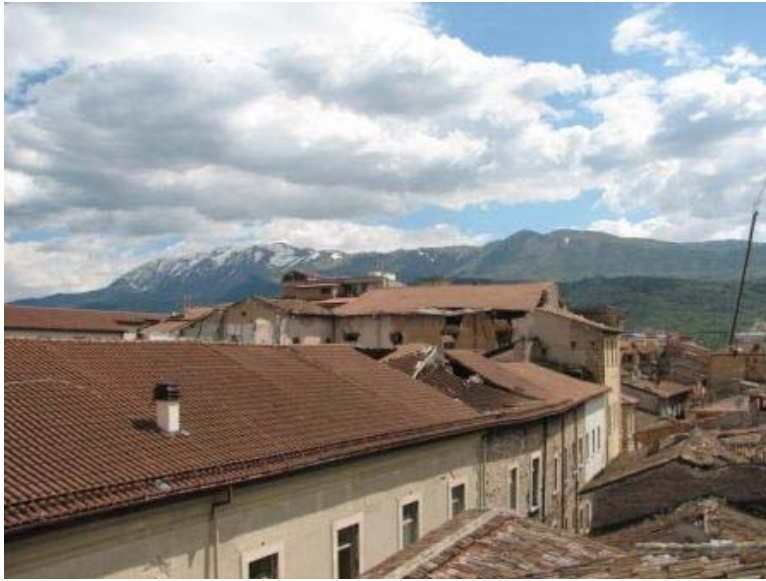
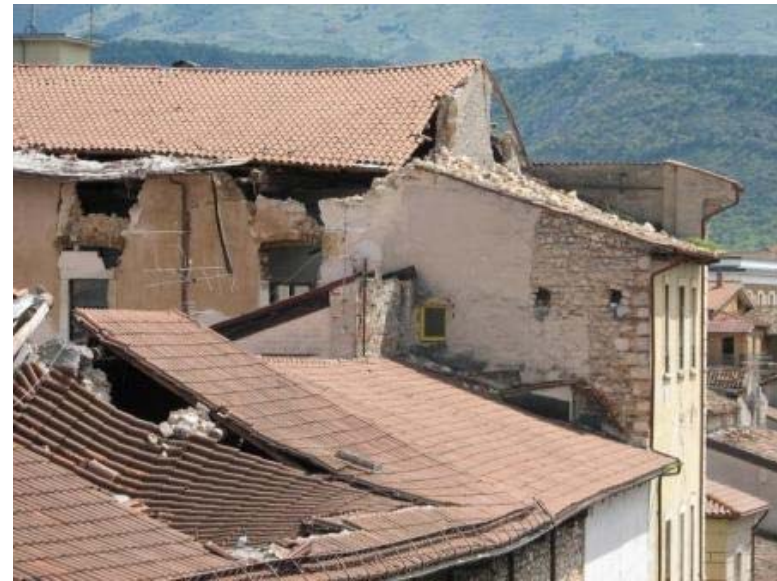
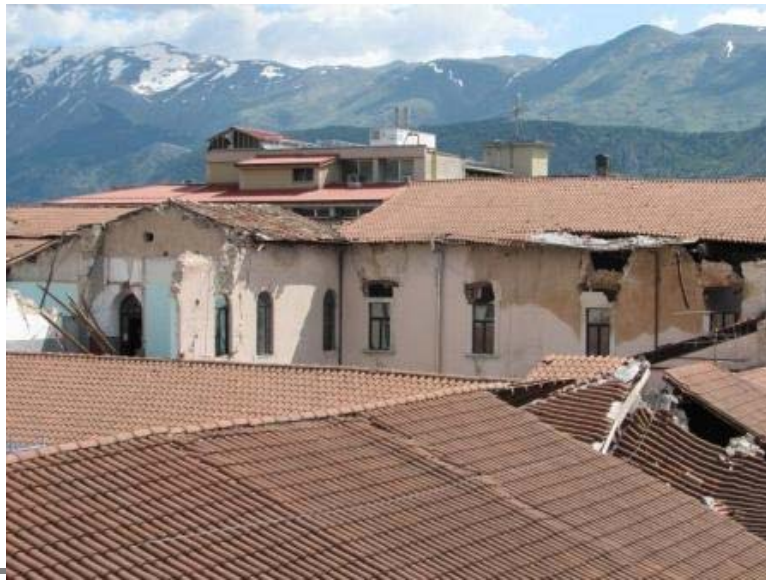
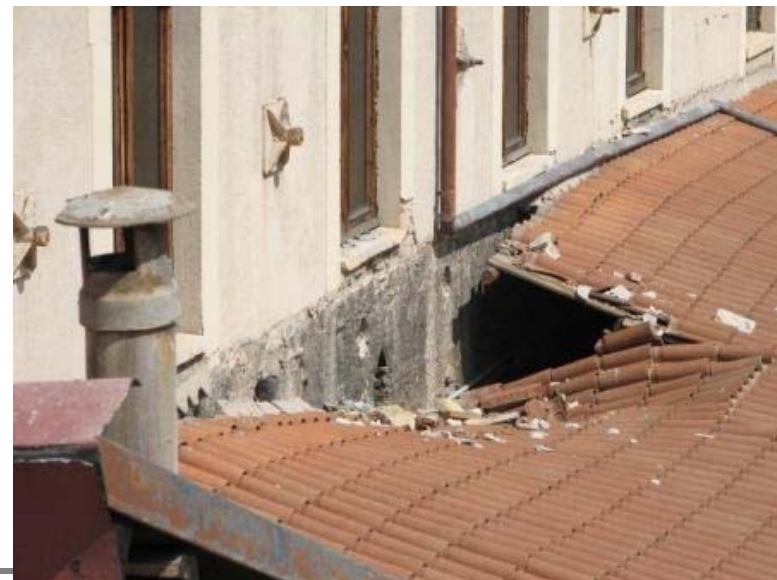
Damage to roof coverage

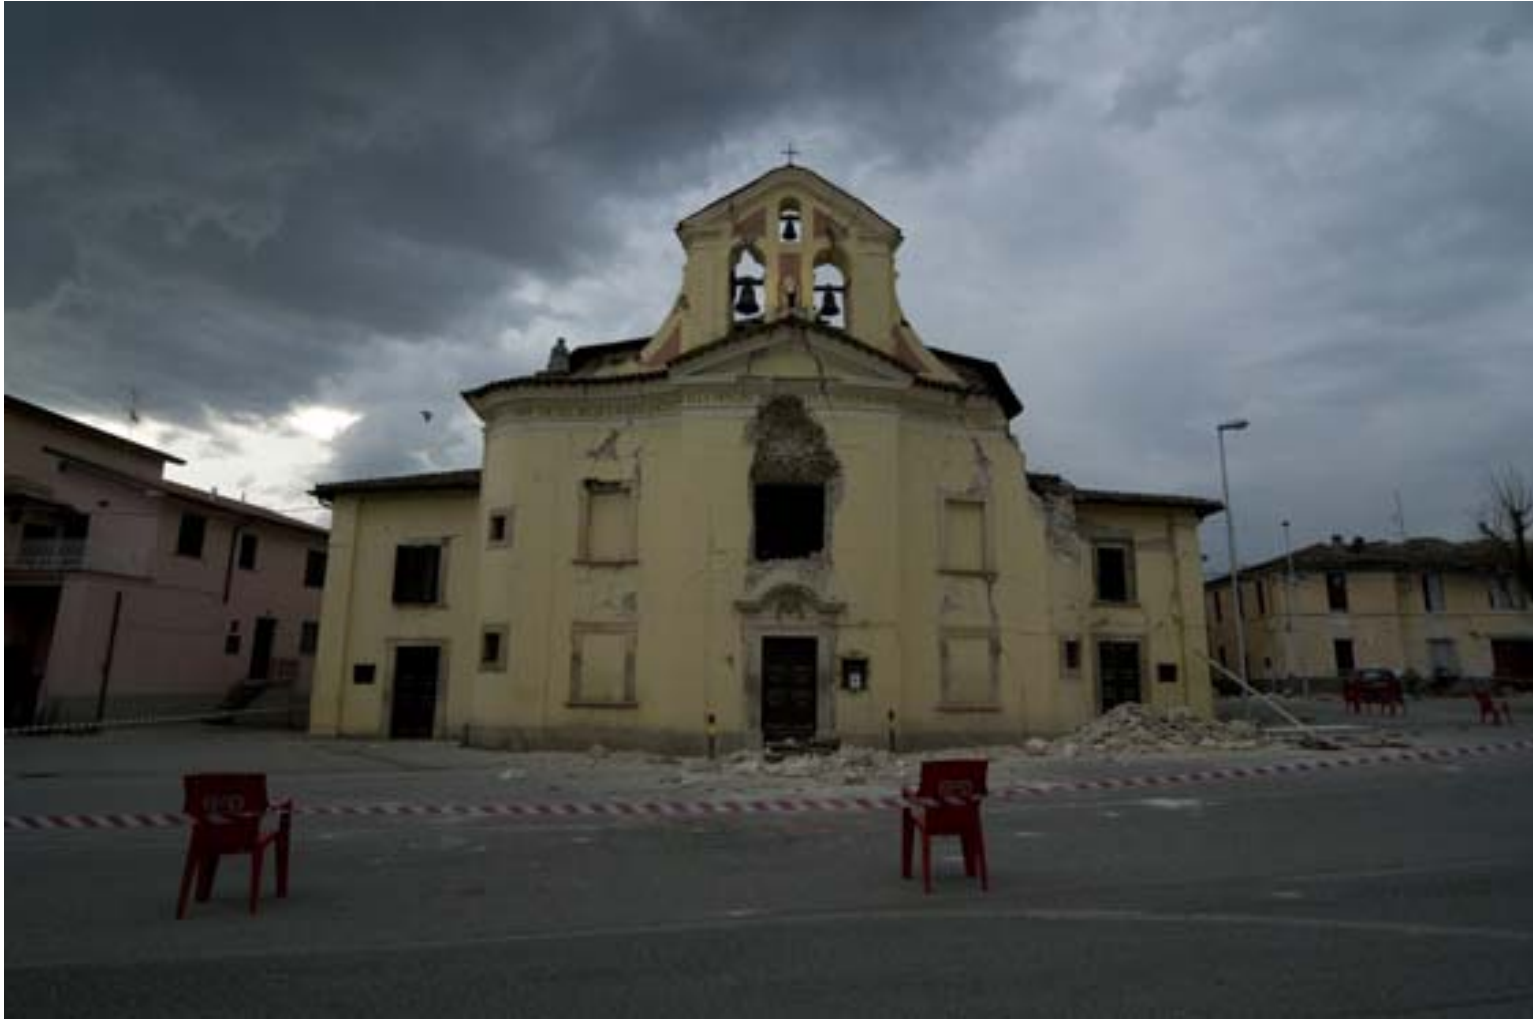
Damage in Paganica

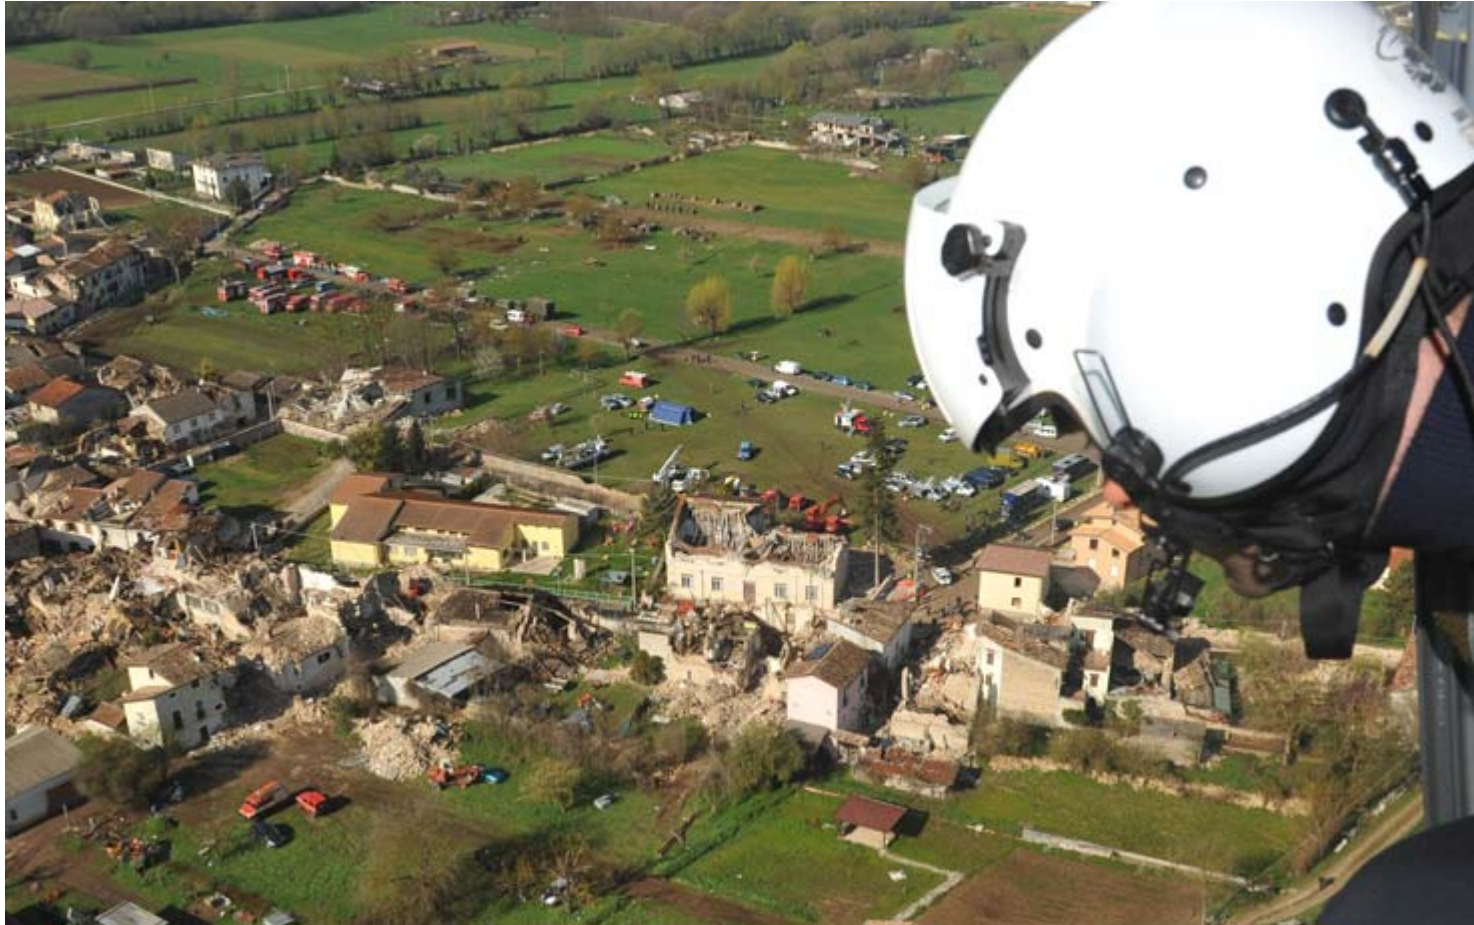
Damage in Onna

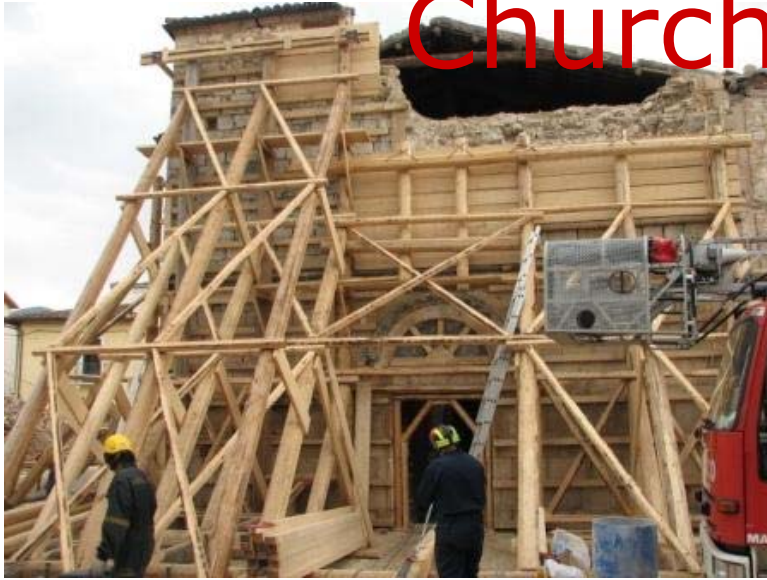
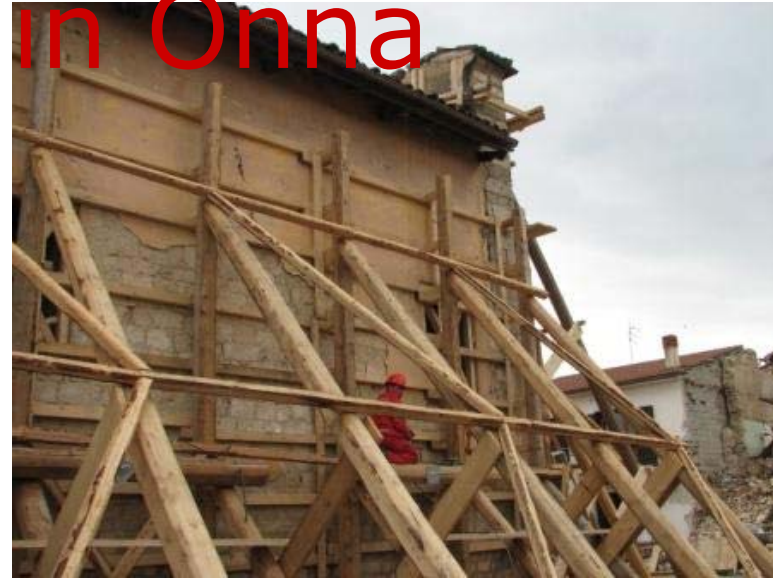
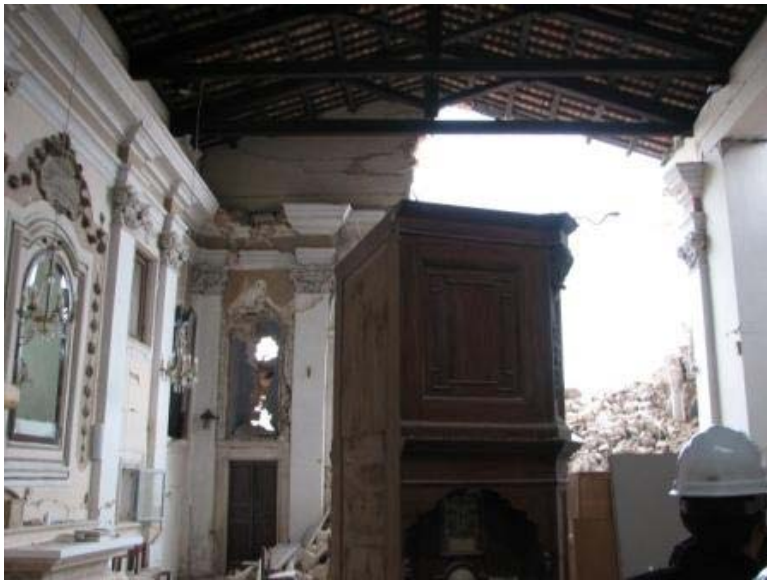
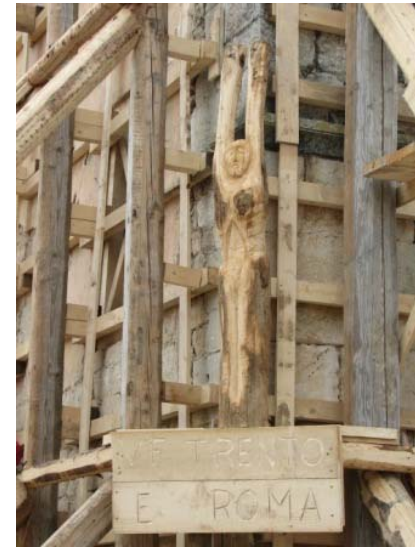
Shore-up intervention of a Church in Onna

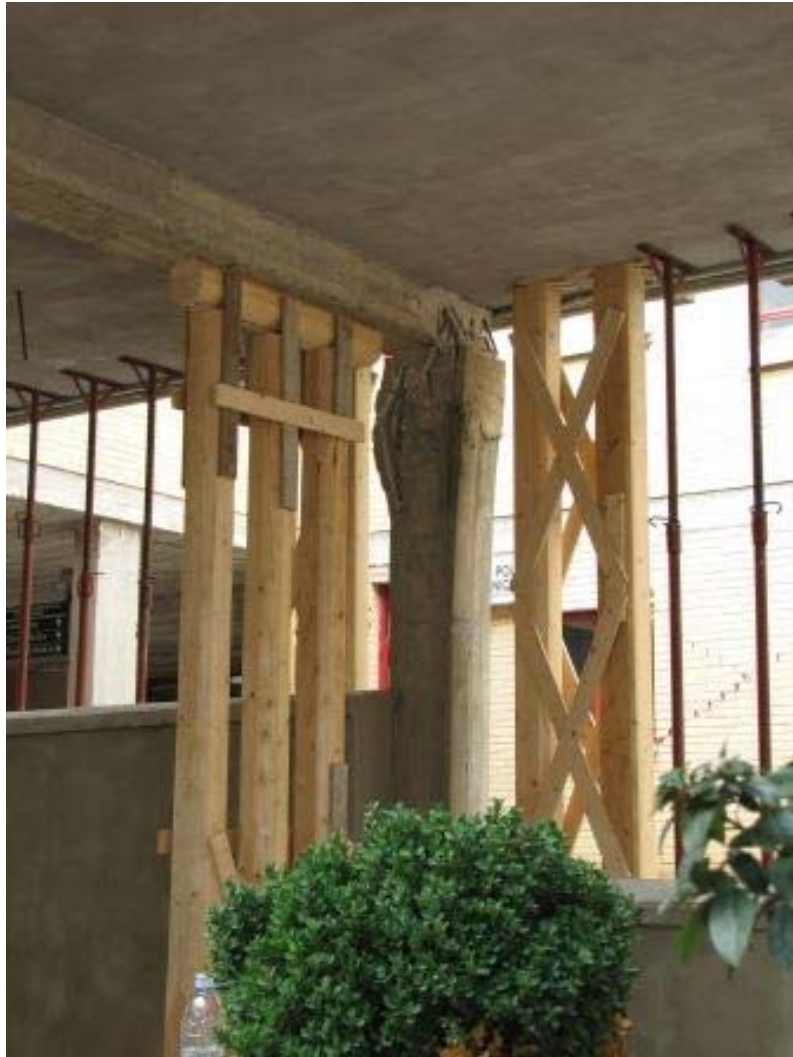
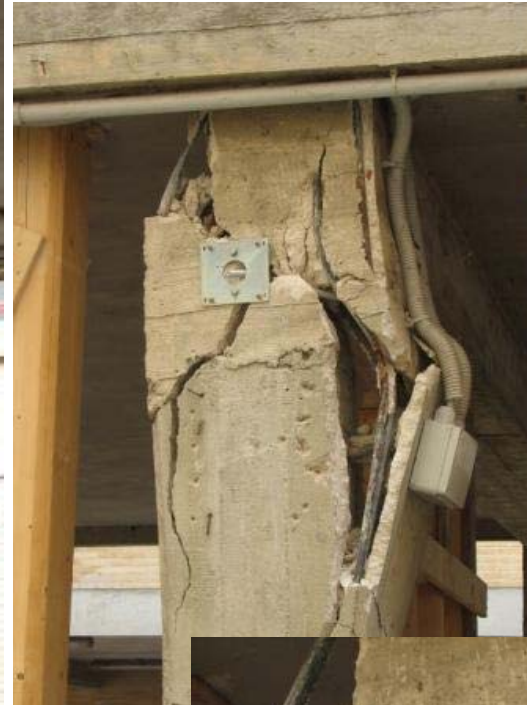
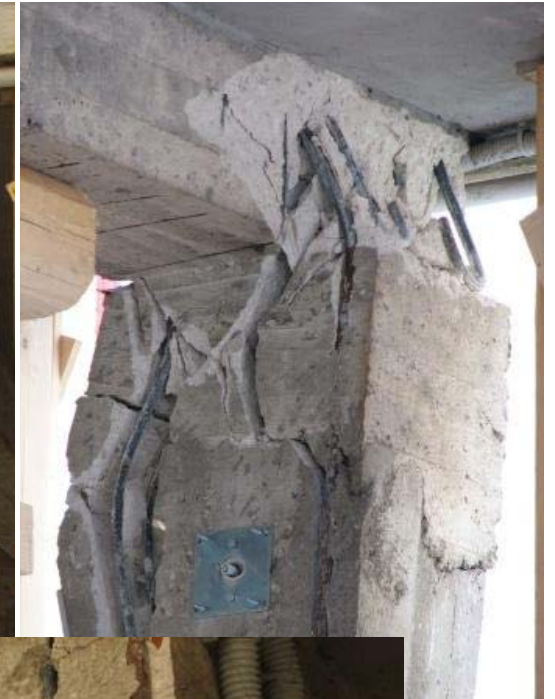
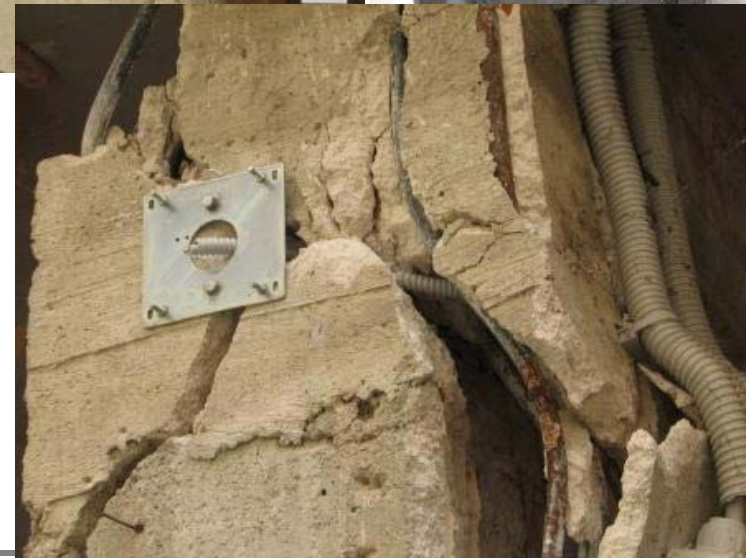
Damage to columns

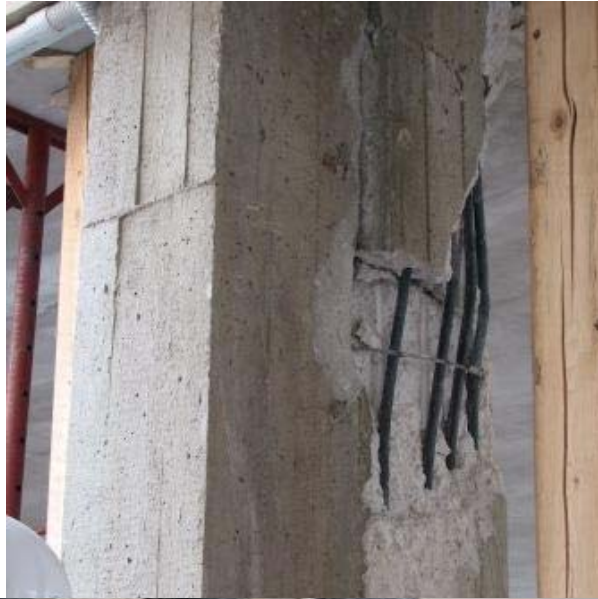
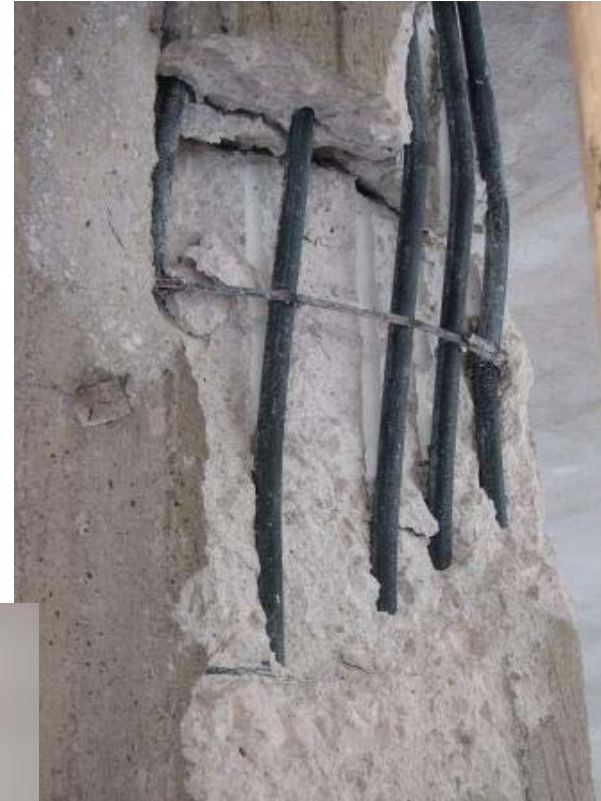
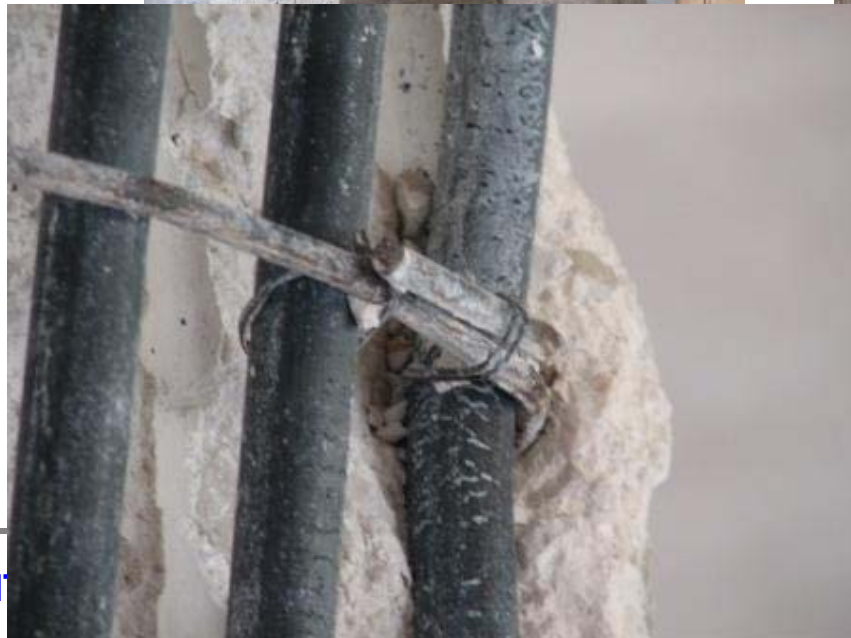
Damage to columns

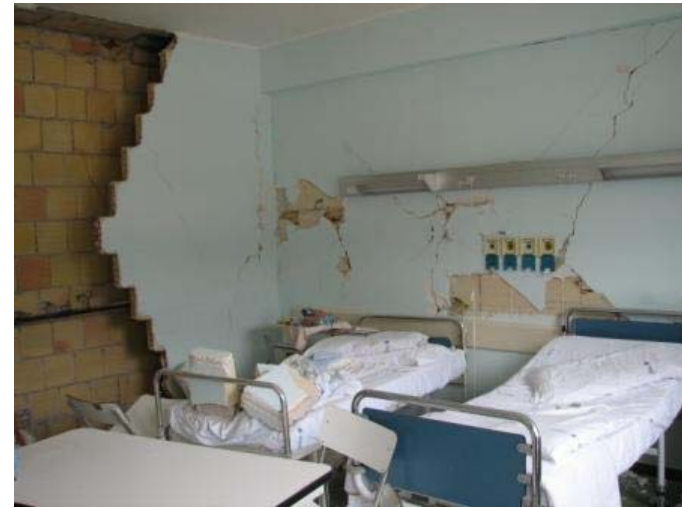
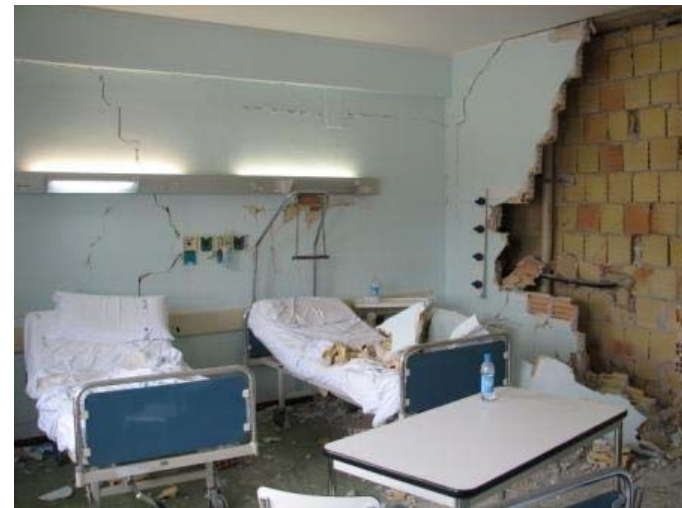
Damage to internal infill walls

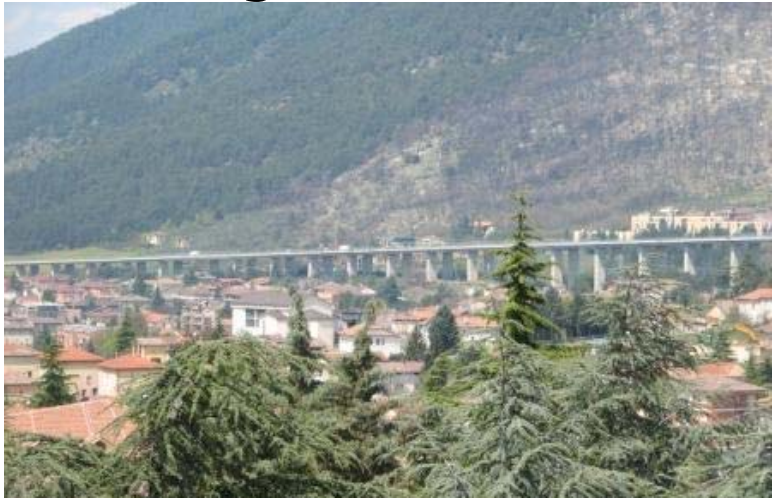
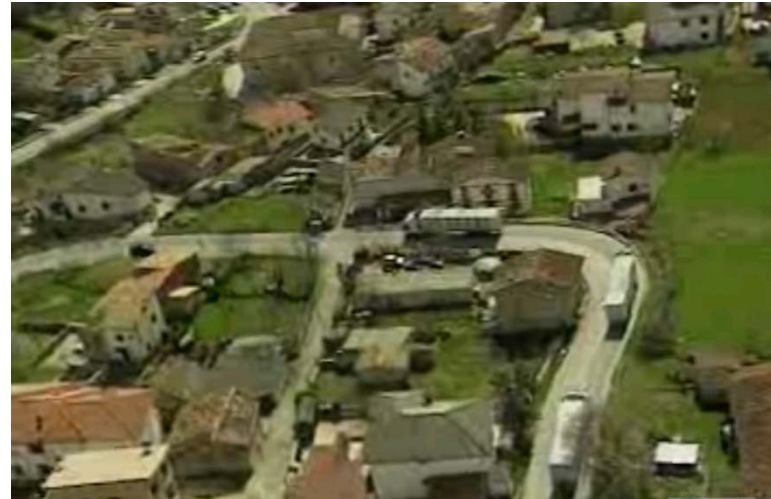
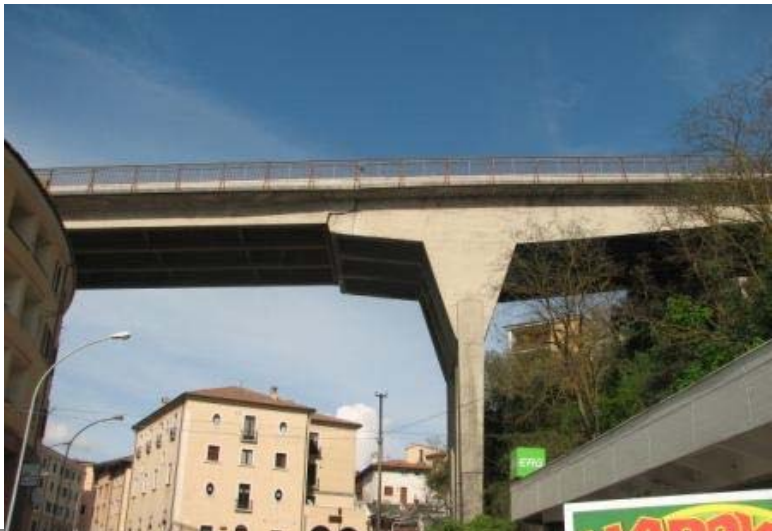
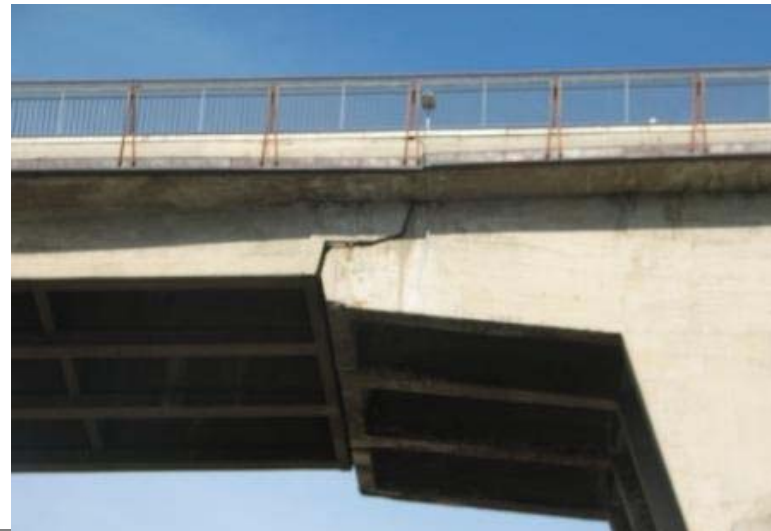
Road network

- Highway Teramo-L'Aquila interrupted
- Bridge closed

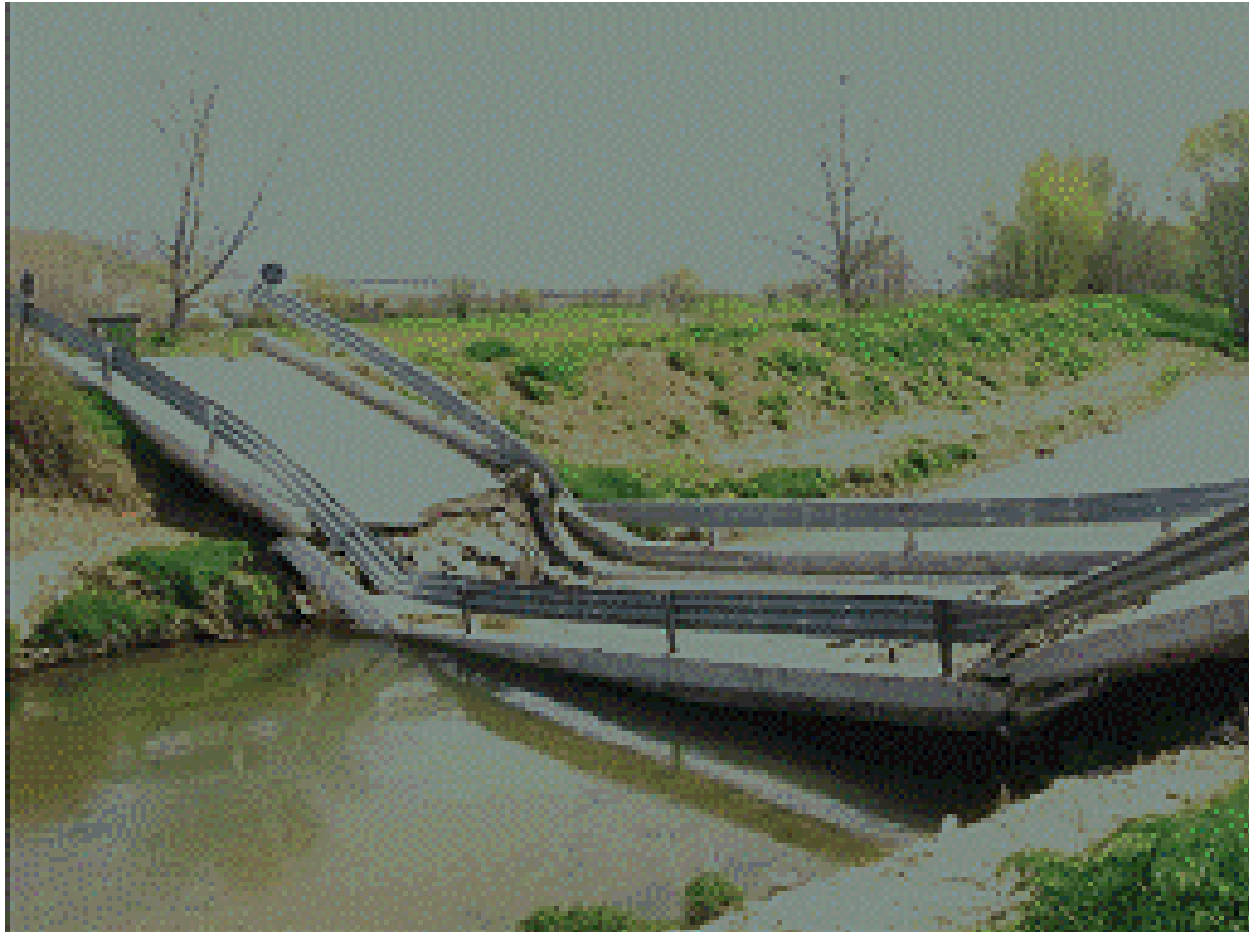
Bridge at Onna

- Bridge on the Aterno river

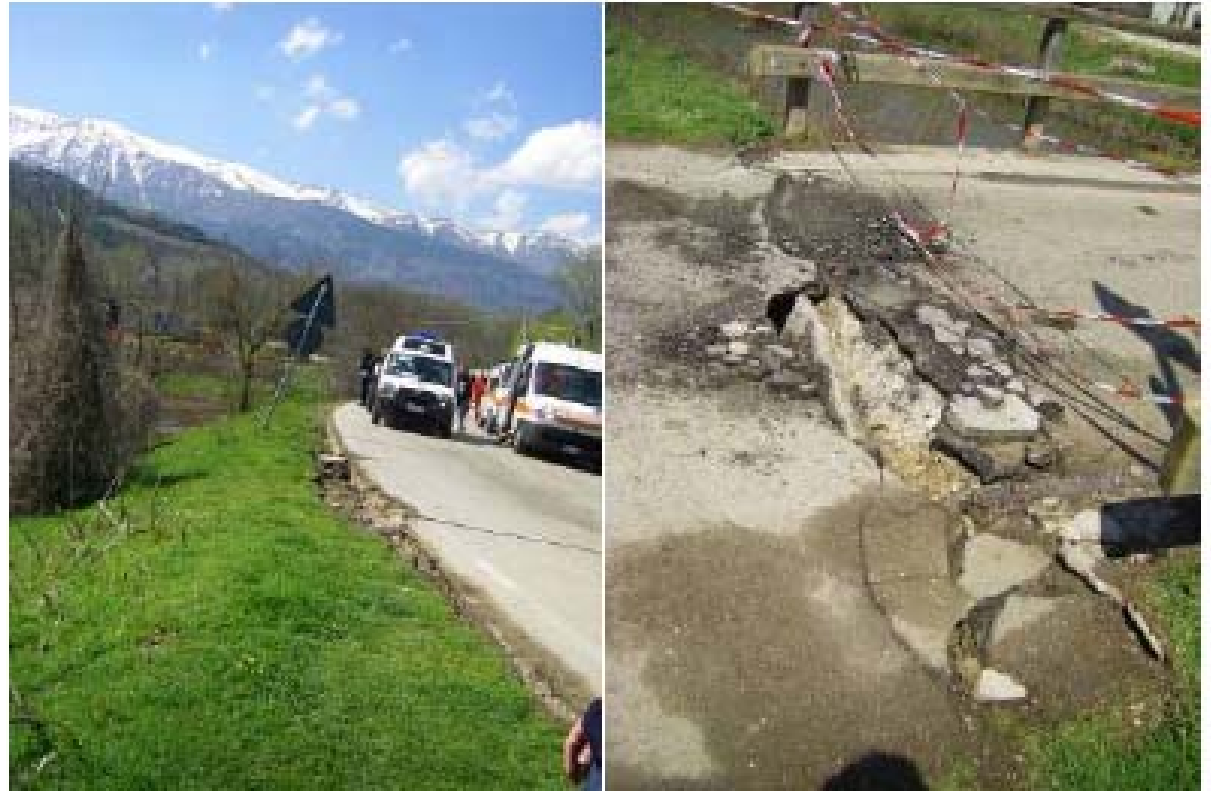
Figure Road Monticchio to Onna

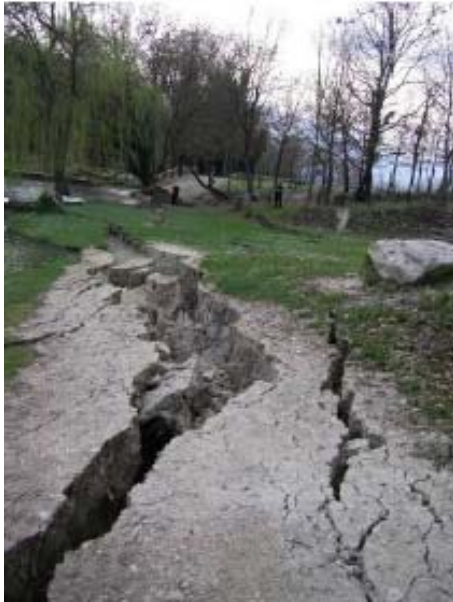
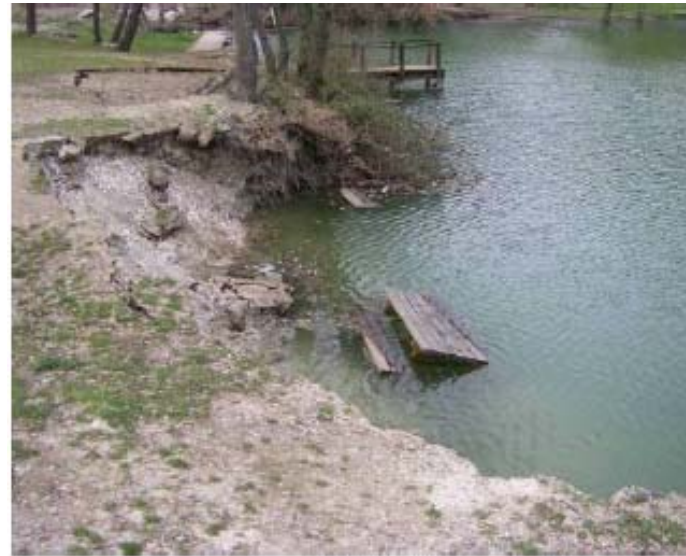
Partial collapse of shore lake

Figure Crack in the ground near the shore lake in San Demetrio dei Vestini

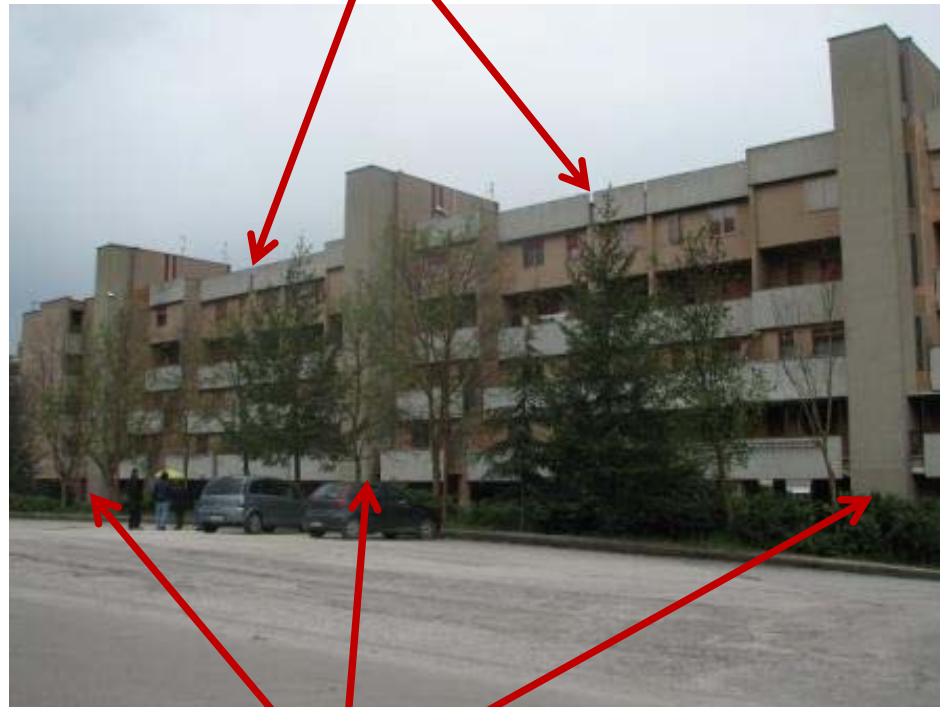
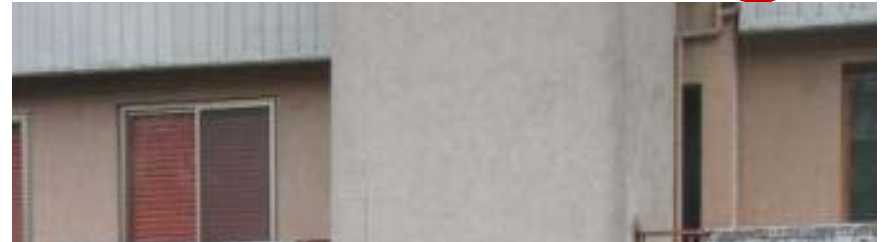
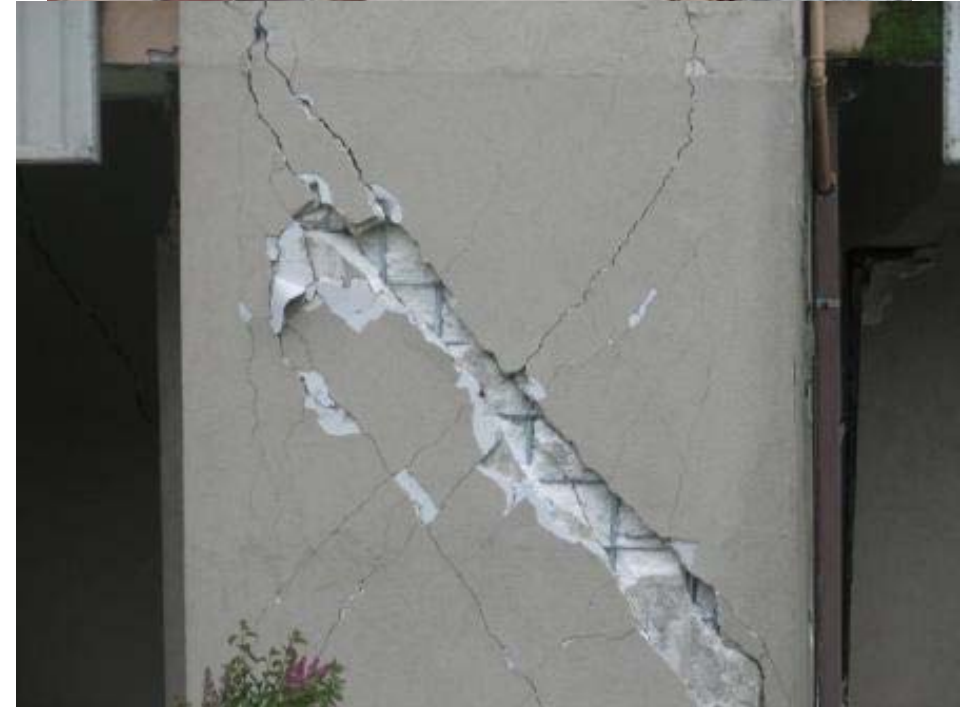
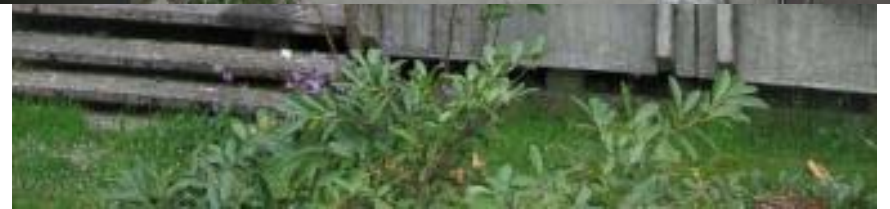
Shear wall concrete building

Disconnection joints
